2020.0 DEFENDER (LE), 419-01B

# ANTI-THEFT - PASSIVE (G2401030)

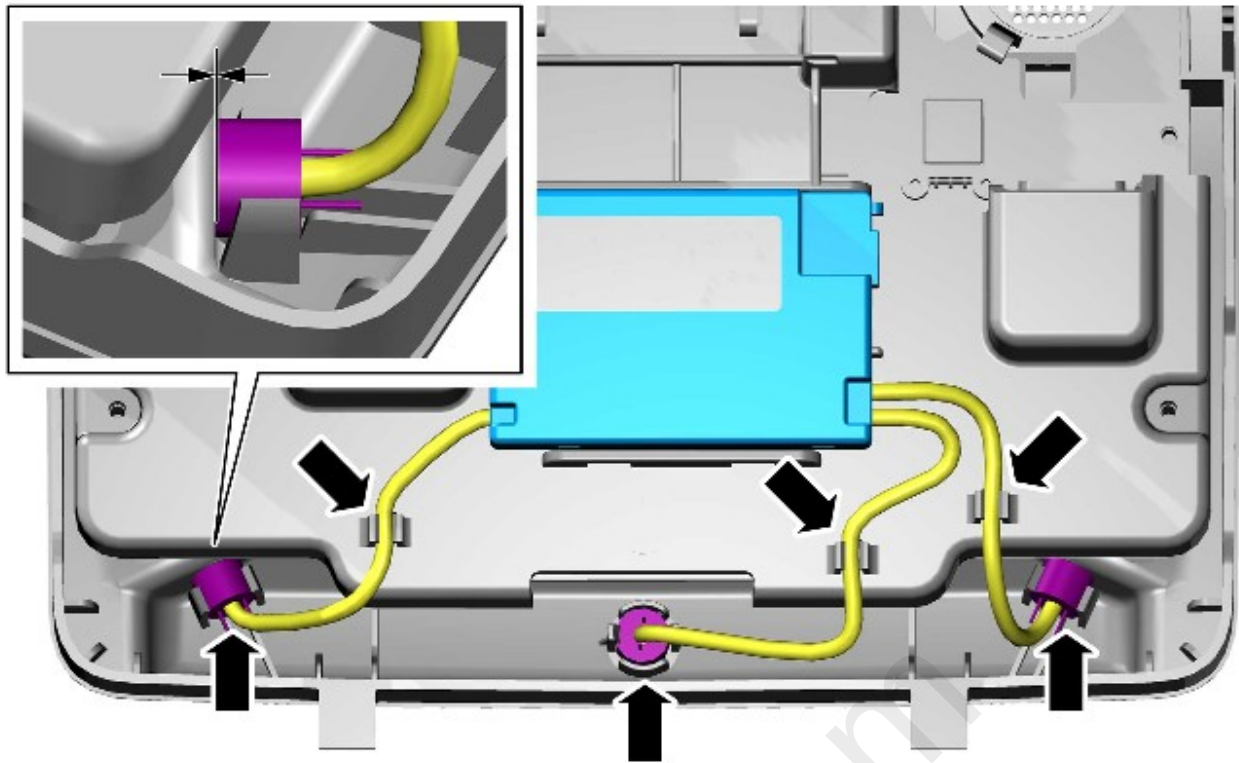
E267020

The volumetric sensor is located in a central position in the overhead console. The volumetric sensor allows the interior of the vehicle to be monitored when the vehicle is double locked. In cases where customers have reported "false-alarm" triggers of the vehicle anti-theft alarm and where the volumetric sensor has been identified as the last known alarm trigger (see diagnostic instructions below), this may indicate an issue with the installation of the volumetric sensor rather than an internal failure of the sensor itself.

In light of this, when first faced with this issue, the existing volumetric sensor should be carefully removed and refitted. Care should be taken to make sure that the sensor and associated connectors are installed correctly and securely. See illustration and video for correct installation, when installed conduct 'push-pull-push' on connections to make sure of correct engagement. Make sure the sensors are pushed fully home and abut against the console, there should be equal placement all around the sensor and it should not be angled when compared to the surface of the console, no large visible gap should be seen and any small gap should be equal all around the sensor when viewed from the front and the rear of the console, use a flashlight to aid with gap visibility, REFER to: [Overhead Console](#) (501-12 Instrument Panel and Console, Removal and Installation).

If the issue reoccurs after refitting of the volumetric sensor, then the sensor should be replaced.
