# Spark Plug Inspection

## Inspection

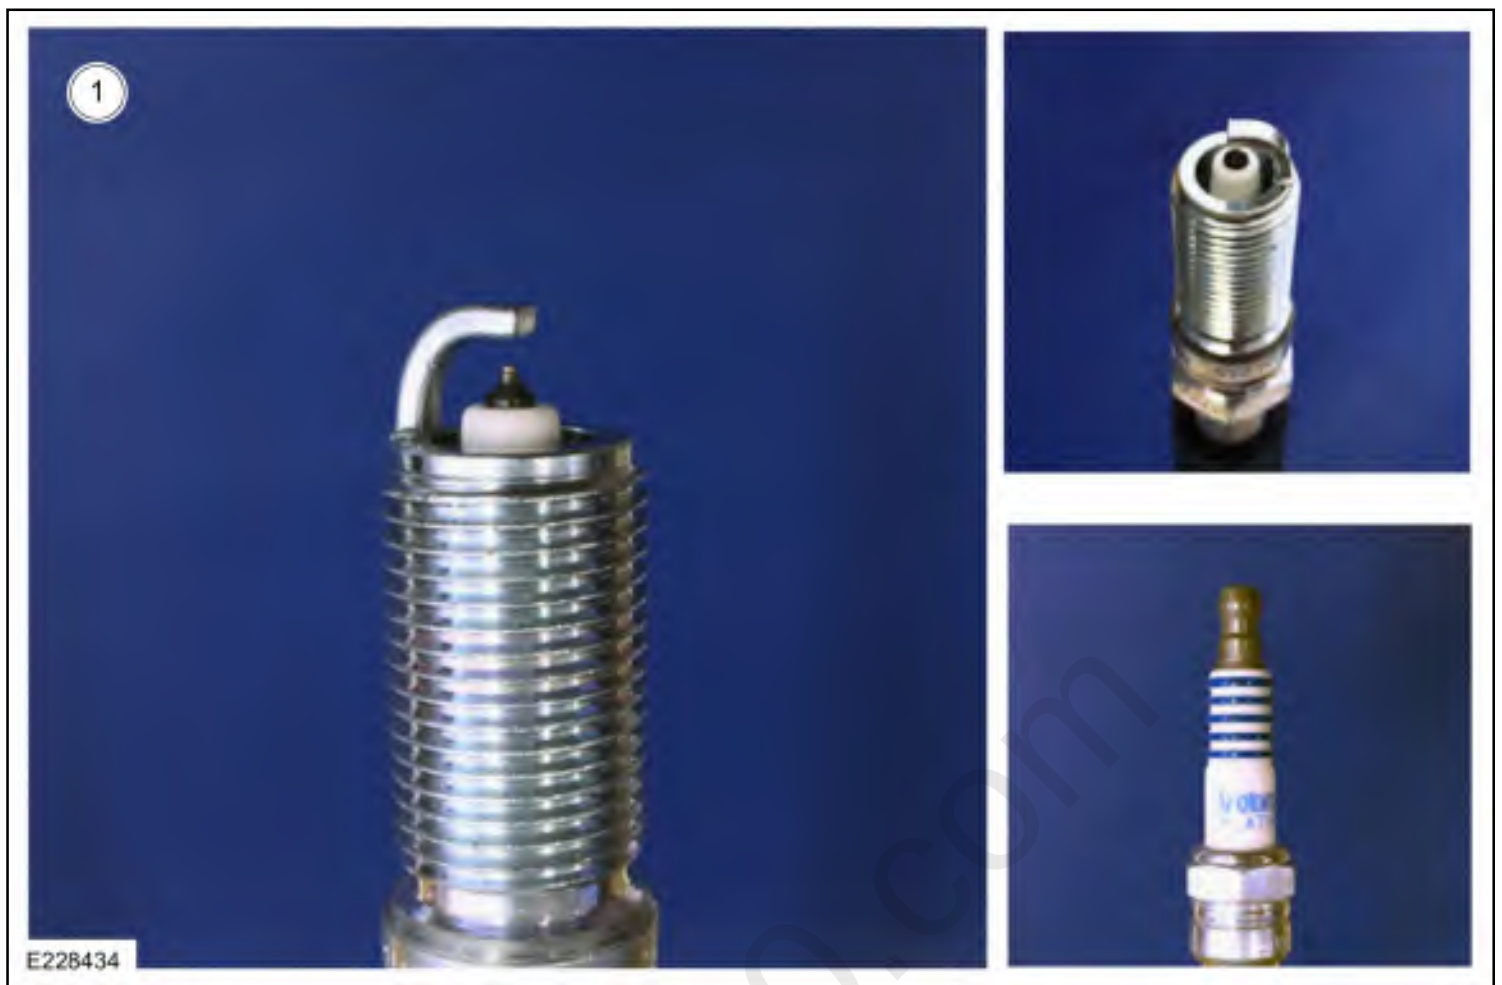
## Unfired

- An unfired spark plug should appear very clean with a pure nickel finish to the threads and ground strap. The center electrode ceramic insulator surface is often a matte or dull finish and pure white in color. The external primary insulator is often a polished white ceramic with appropriate stamping labels. Some spark plugs have a smooth barrel while others have a ribbed barrel insulator. Ford spark plugs almost universally use a ribbed barrel with glazed blue rib peaks. The Anti-Fouling silicone oil treatment used on all Ford spark plugs may be tinted pink. Some suppliers use this to designate the silicone oil has been applied.
- No corrective action necessary.

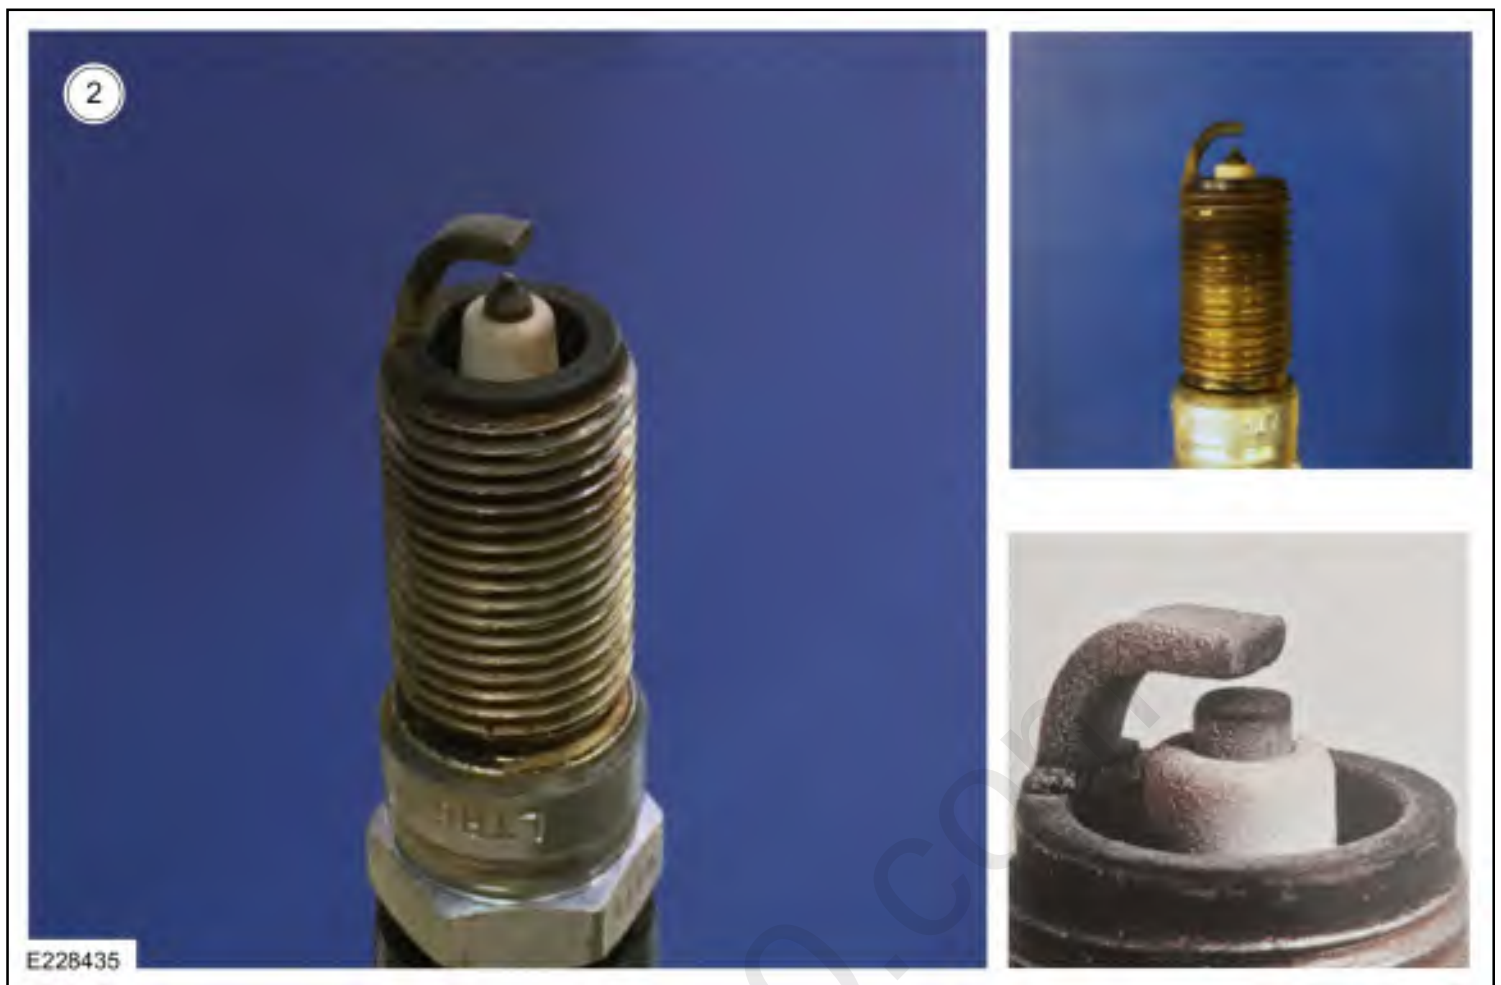
## Normal Burning

- A normal burning spark plug will often present with a white or slightly off-white (brown or light gray) color center electrode and clean or mildly discolored ground strap.
- No corrective action necessary.

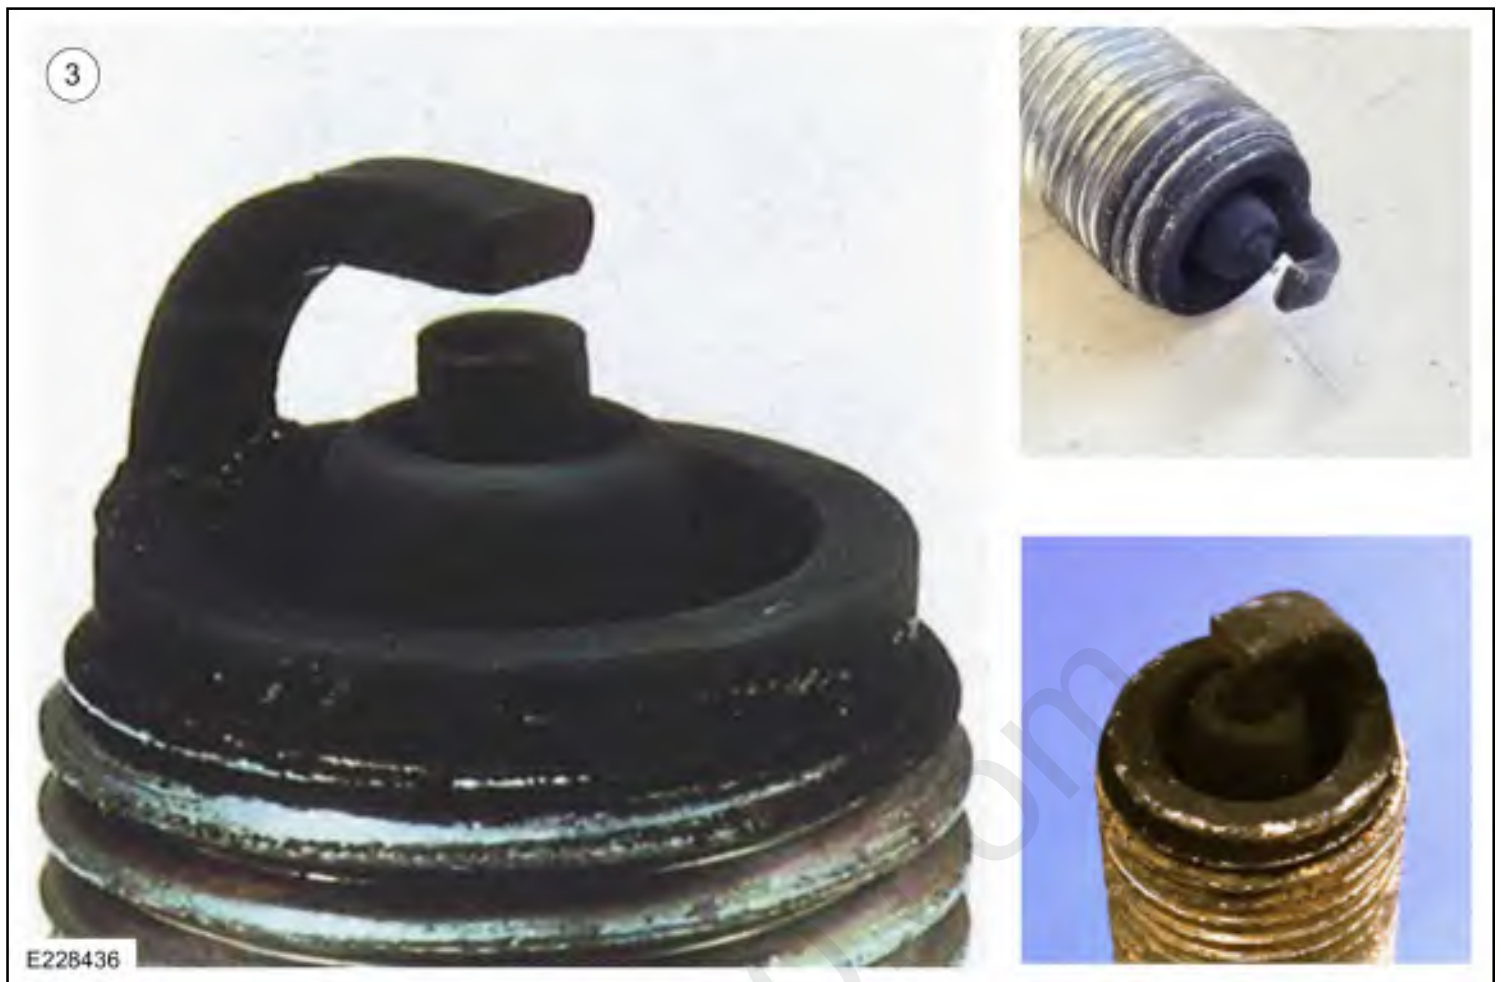
## Carbon Fouling

- Carbon fouling can cause engine misfire. As carbon deposits, created during incomplete combustion, adhere to center electrode insulator surfaces, insulator dielectric and isolation or shunt resistance are compromised. In the case that sufficient carbon deposits are present on the center electrode and insulator surface the primary conduction path can change from spark creation to shorting through carbon deposits. This is also known as spark leakage. Upon shorting through carbon deposits, available voltage delivered to the center electrode tip is reduced until no spark is delivered to the mixture and a misfire occurs. Proper Heat Range selection is necessary to avoid pre-ignition and carbon fouling. Even with the proper Heat Range, avoid excessive cold starts and/or excessive idling at cold engine temperatures without a warm-up drive cycle. For proper self-cleaning, be sure to warm the spark plug using a medium-load drive cycle. A normal operating temperature for a spark plug may be 450-850°C (842-1562°F), at which point carbon deposits will burn off during spark plug self-cleaning.

- A drive cycle of enough distance and rpm can clear the spark plugs of carbon fouling (ex: 4 mile drive at 3000 rpm).
- Should this fail, install new spark plugs.

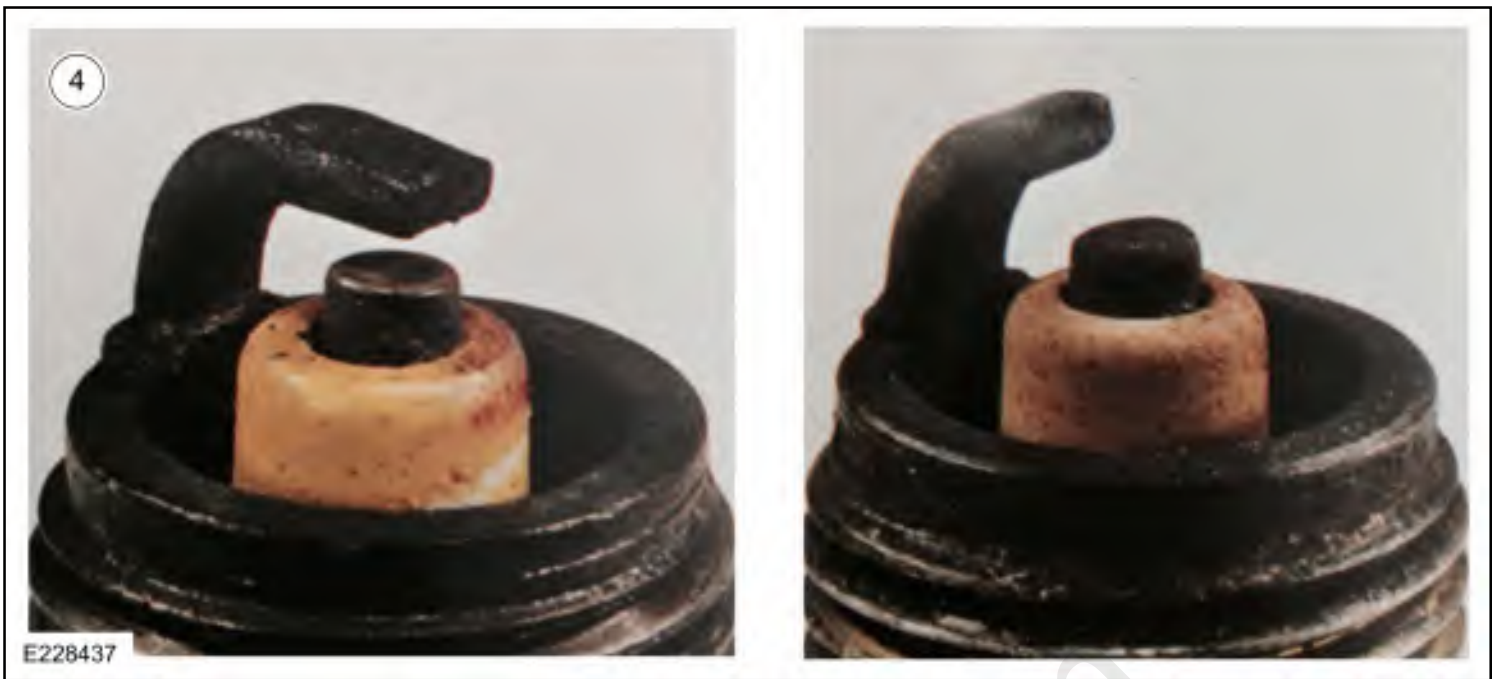
## Lead Fouling and Erosion

- Lead fouling can occur in engines that use leaded gasoline. In modern engine applications, this failure mode is rare, as TEL (Tetraethyllead) was removed from consumer use at fuel filling stations long ago. Lead fouling can occur on engines used in high compression racing engines and, in some limited cases, aviation applications. Spark plugs that have been used in the presence of lead are characteristically identified by a yellow/brown tinted center electrode insulator and can cause engine misfire at high engine speed and high load. Additionally, ground strap electrodes will often be worn in engines exposed to leaded fuel for extended periods of time. This failure mode is caused by the tendency for lead compounds to react chemically with nickel electrode materials at high temperatures. These chemical reactions often cause increased brittleness and reduced material strength in the ground electrode.

- Alert the customer to avoid using leaded fuel and/or octane enhancer.
- Inspect the CMS (catalyst monitor sensor) and the HO2S for evidence of lead damage.

- Install new spark plugs.

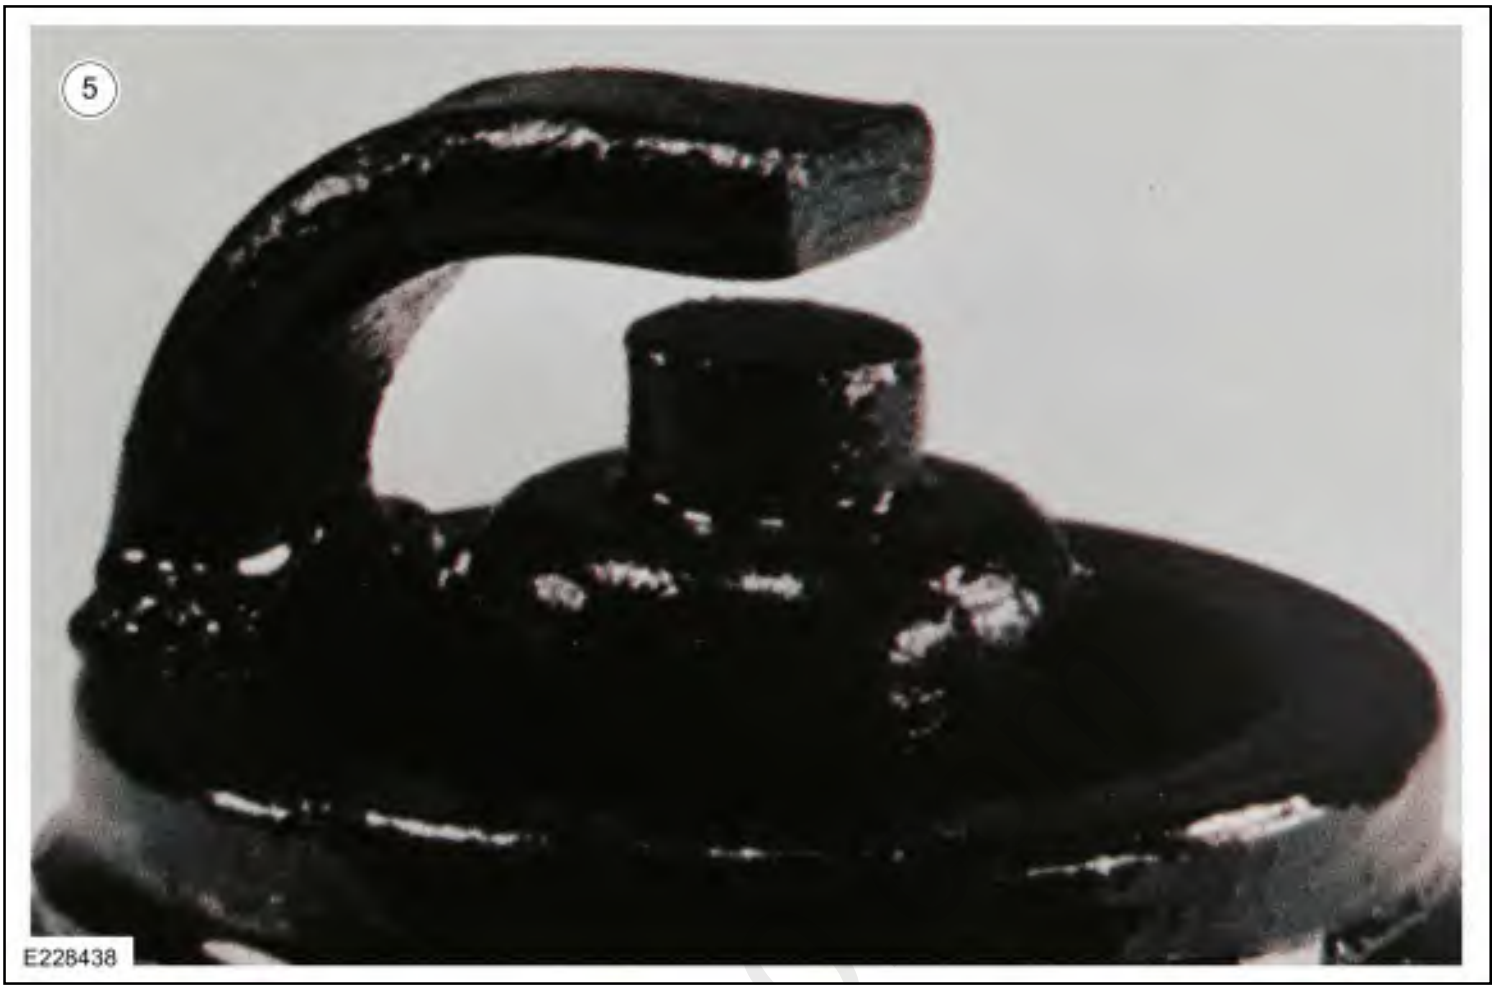
### Coolant/Oil Wet Fouling

- Wet fouling is most often caused by excess fuel, oil, or coolant within the combustion chamber during operation. Spark plugs that are wet fouled often cause poor starting and misfiring. Often, a wet fouled spark plug is indicative of additional mechanical issues within the engine system such as a compromised head gasket, oil leakage past the control ring, or valve train leakage. In certain cases, other causes could be low compression, vacuum leaks, overly retarded timing, or improper spark plug heat range. The primary cause of misfire is the low resistance path created by oil, fuel, or coolant deposits. Wet materials provide a lower resistance path for spark leakage from the high voltage center electrode to ground. When driving with a coolant leak for an extended time, the plug may be cleaned.

- Check for wet, black deposits on the insulator shell bore electrodes, caused by excessive oil entering the combustion chamber through worn rings and pistons, excessive valve-to-guide clearance or worn or loose bearings.

- Correct the coolant or oil leak concern.
- Install new spark plugs.

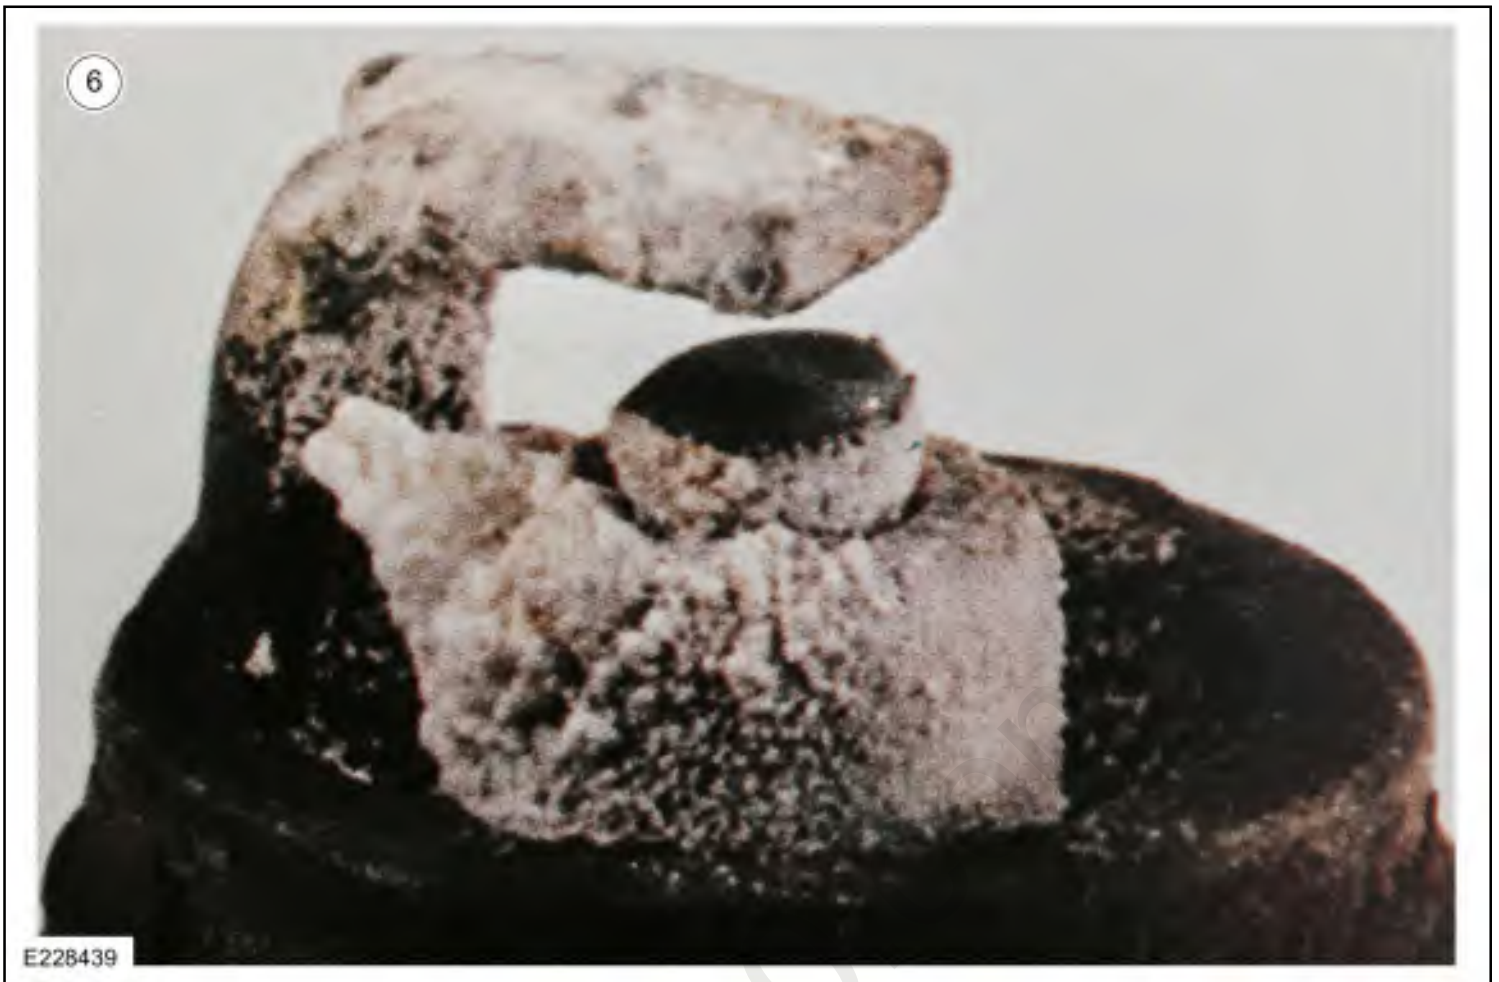
## Deposit Buildup

- The presence of deposits on the spark plug can be indicative of oil leakage or poor fuel quality. Often, these ashy coatings cause misfires as a low resistance path from center electrode to ground is created.
- Correct the oil leak, if necessary.
- Inform the customer of possible poor quality fuel.
- Install new spark plugs.

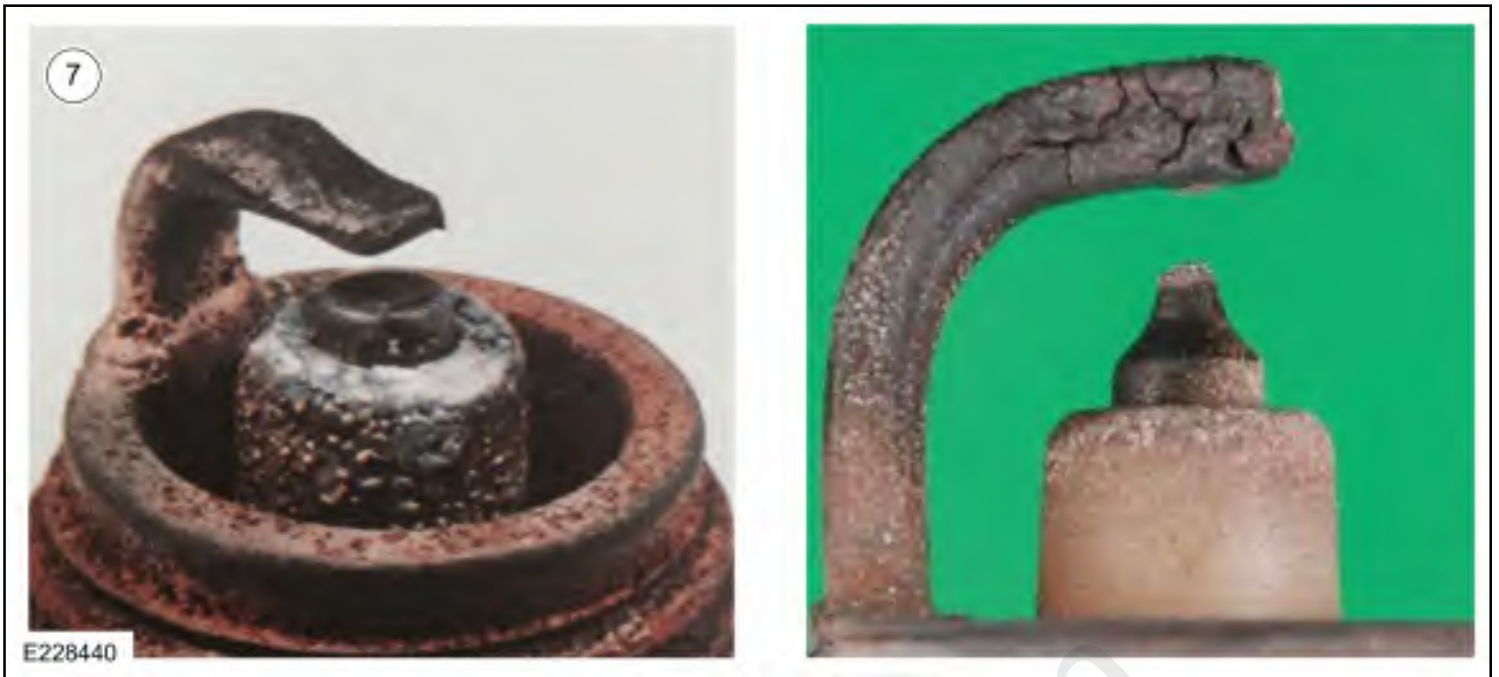
### Abnormal Erosion/Corrosion/Oxidation

- Often, eroded, corroded, or oxidized spark plug conditions occur as a result of leaded gasoline, which reacts with electrode materials (see Lead Fouling). These symptoms appear as pitted, cracked, or eroded electrodes and on occasion will display with a green cast if copper oxidation is heavy. These conditions result in increased, improper spark plug gap and yield poor performance. More recently, the use of Ethanol fuel blends of E85 (85% Ethanol) can create this Oxidation condition. The Heat Range selection for E85 applications typically is 1 range colder due to added spark advance used to make up for the loss of performance. The hotter tip temperatures combined with the rapid thermal cycle on the electrode surface initiates surface cracks and eventual oxidation based corrosion.

- Verify E85 isn't being used in a vehicle not designated for E85 usage (Flex Fuel Vehicle).
- Install new spark plugs.

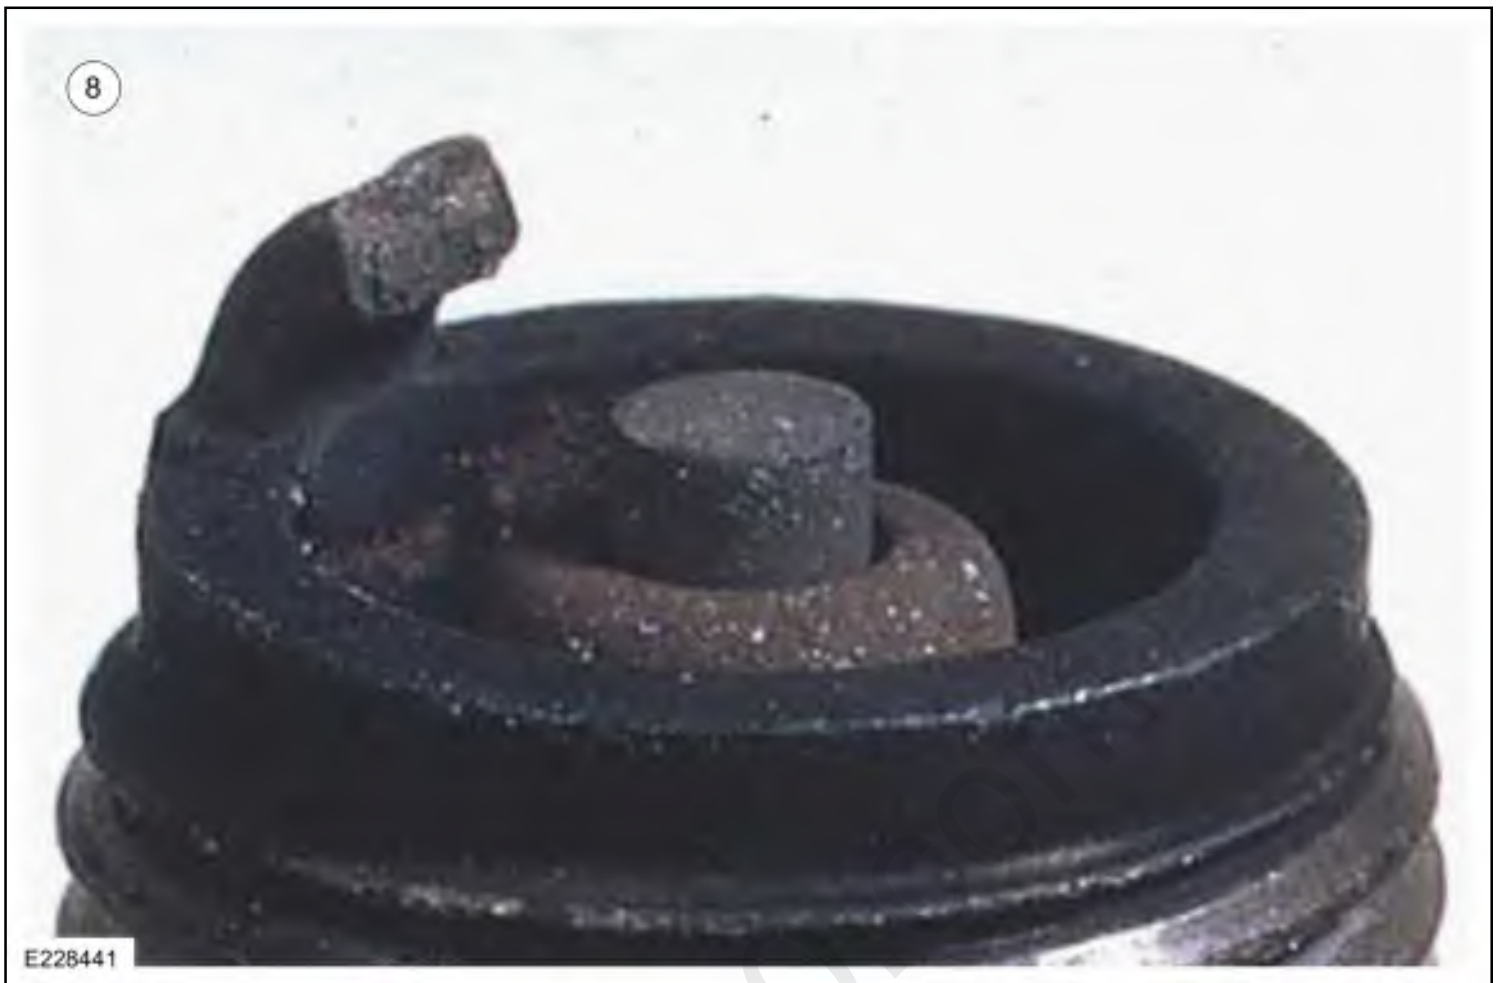
## Ground Electrode Breakage

- Ground electrode breakage can be caused by pre-ignition or any other excess shock load. Ground electrode breaks may be caused by incorrect ignition timing, wrong type of fuel, or unauthorized installation of a reduced thermal conductivity Heli-Coil insert in place of the spark plug threads.
- Confirm the proper fuel and ignition timing.
- Confirm the proper heat range of spark plugs.
- Confirm that the cylinder head threads have not been repaired with a Heli-Coil thread repair kit.
- Install new spark plugs.

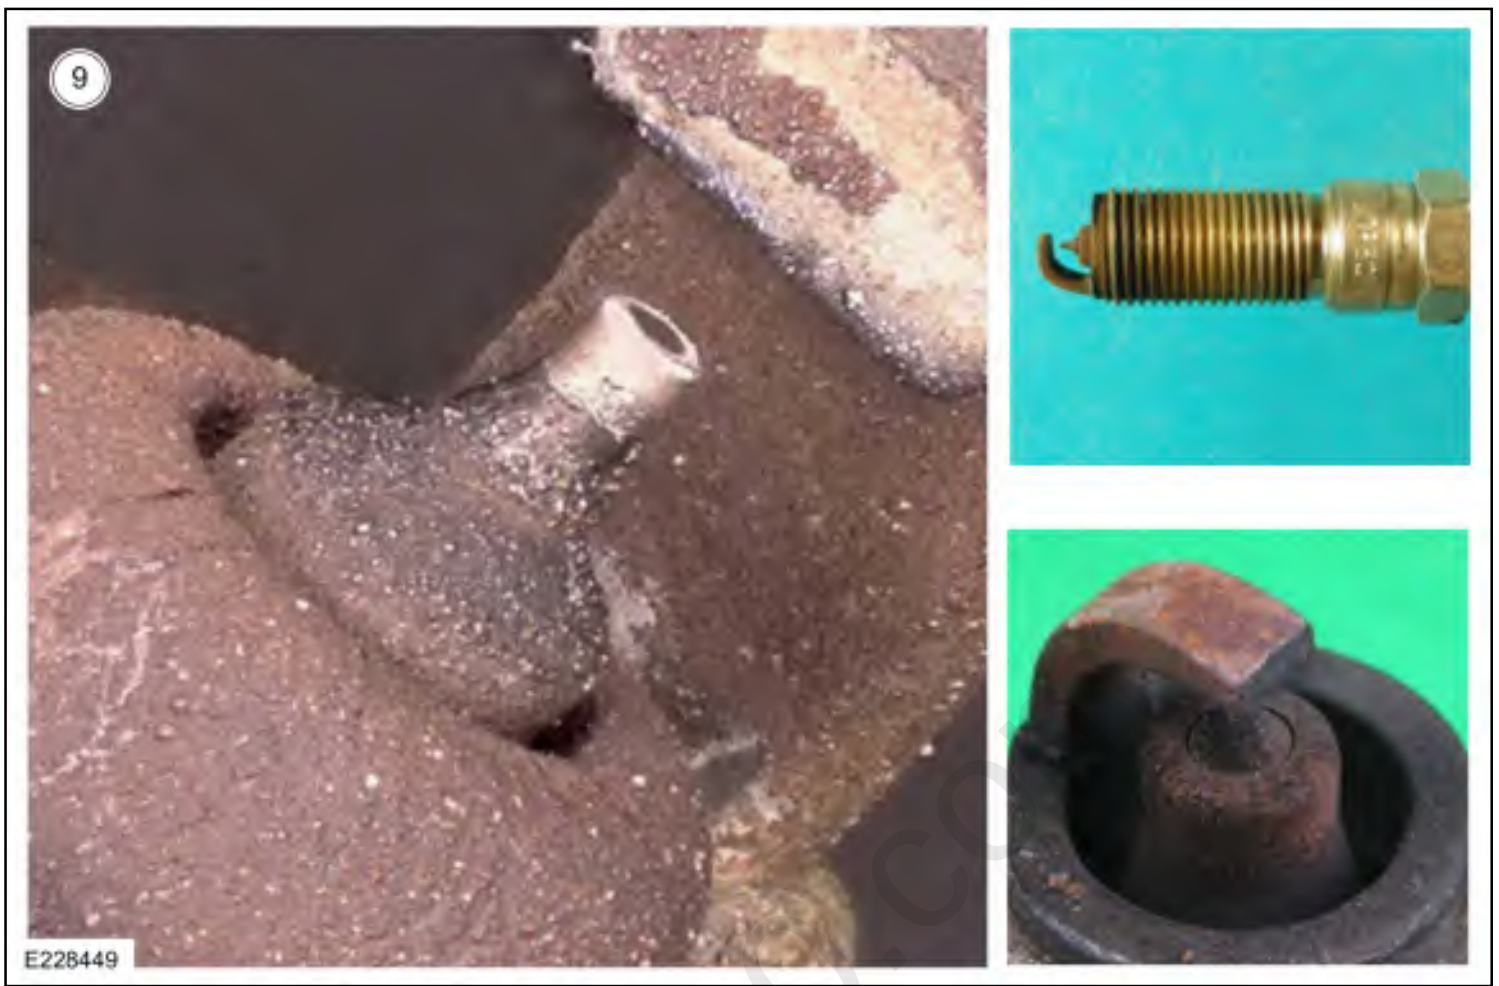
### MMT Fouling (Hot Plug Fouling)

- MMT (Methylcyclopentadienyl Manganese Tricarbonyl) is often used as an octane booster in combination with poor quality fuels to bring octane levels within acceptable limits. If excess Mn (Manganese) levels are present in the fuel during combustion, Mn deposits can foul the combustion chamber, catalytic converters, and spark plugs. Mn in higher concentrations can lead to pre-ignition and engine misfire. Mn deposit become conductive as the surface exceeds  $\sim 550^{\circ}\text{C}$  ( $1022^{\circ}\text{F}$ ). For this reason the failure mode is referred to as Hot Plug Fouling. As MMT is high in manganese, a reddish coating will be present on the spark plug insulator and ground electrodes. The reddish coating is often covered up by carbon fouling if the spark plug is to the point of misfire.

- Advise the customer to avoid use of leaded fuel and/or octane enhancer.
- Inspect the CMS and the HO2S for evidence of MMT damage.
- Install new spark plugs.

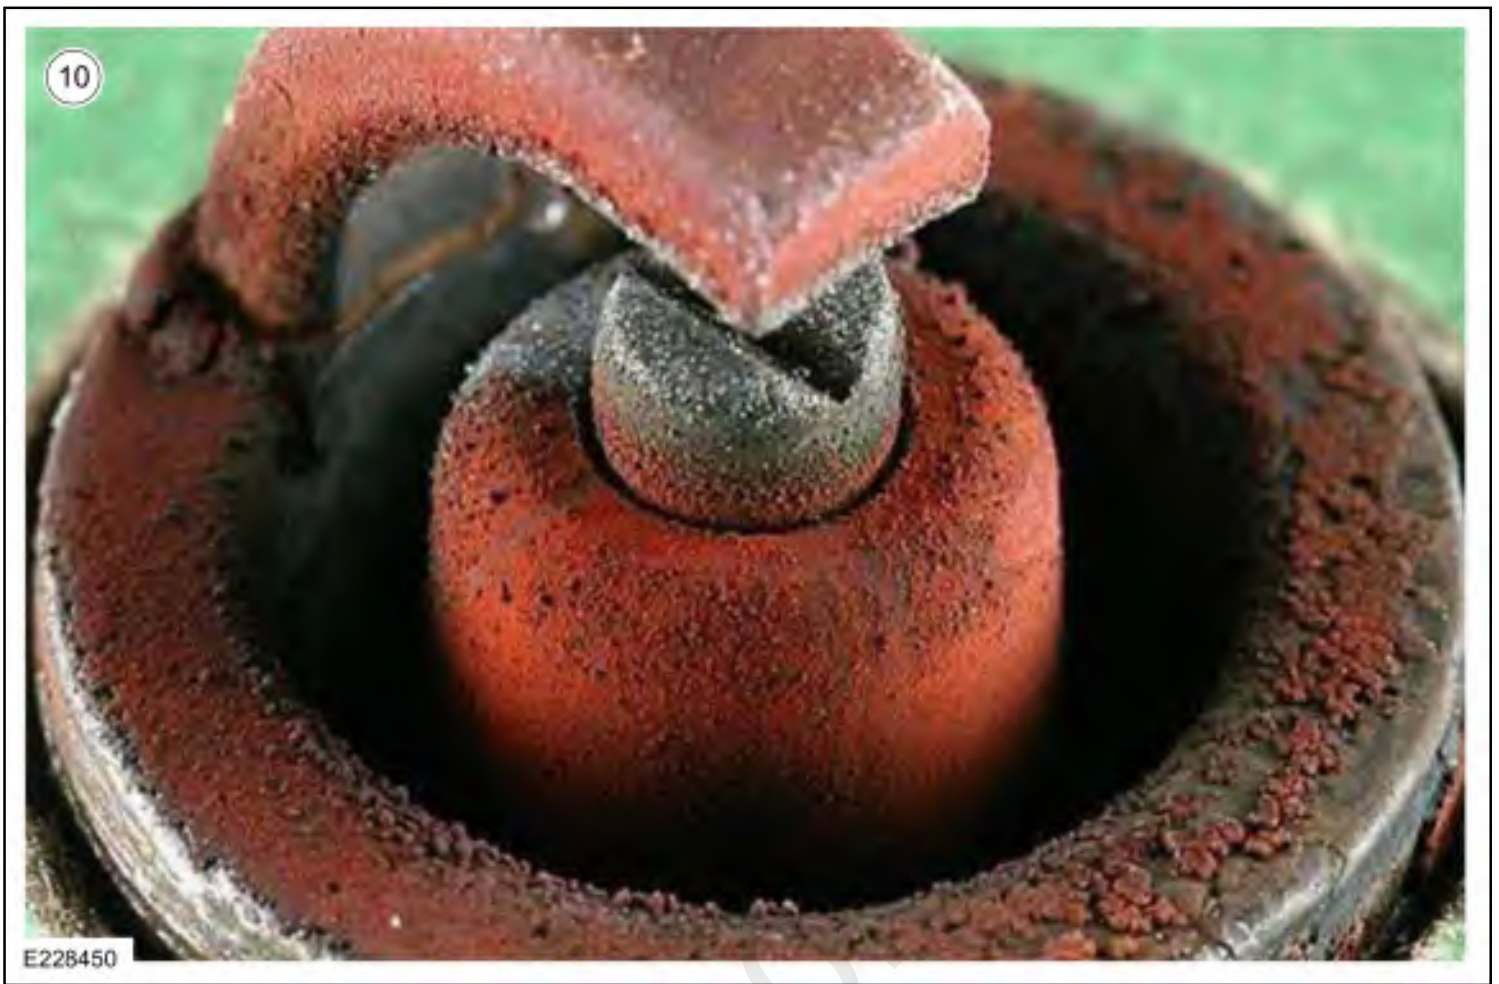
### Ferrocene Fouling (Hot Plug Fouling)

- Ferrocene (metallocene) is an organometallic compound often used in place of MMT as an octane booster and presents itself with a bright orange surface color. If excess ferrocene levels are present in the fuel during combustion, ferrocene deposits can foul the combustion chamber, catalytic converters, and spark plugs. Deposit become conductive as the surface exceeds  $\sim 450^{\circ}\text{C}$  ( $842^{\circ}\text{F}$ ). For this reason the failure mode is referred to as Hot Plug Fouling. Ferrocene in higher concentrations can lead to pre-ignition and engine misfire.
- Advise the customer that they may be using leaded fuel and/or octane enhancer. Ask them to stop.
- Inspect the CMS and the HO2S for evidence of ferrocene damage.
- Install new spark plugs.

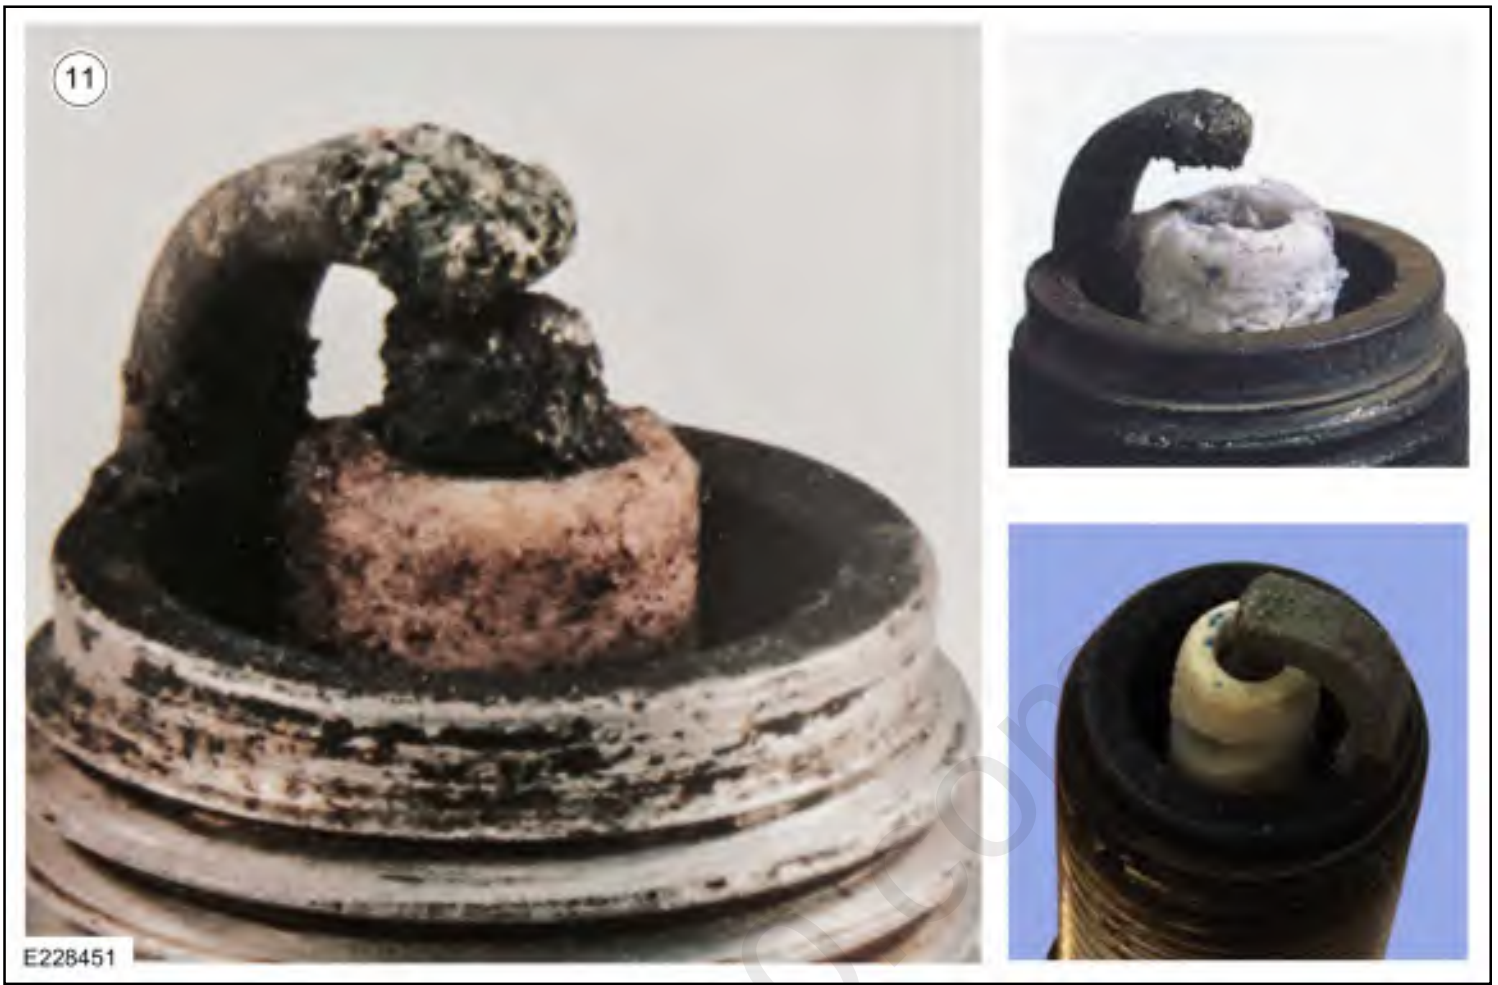
### Overheating and Melted Electrodes

- Symptoms of overheating include white or light gray spots and a bluish-burnt appearance of the electrodes. This is caused by engine overheating, wrong type of fuel, loose spark plugs, spark plugs with an incorrect heat range, low fuel pump pressure, or incorrect ignition timing. Fused deposits present with melted or spotty deposits resembling bubbles or blisters and are indicative of sudden acceleration.
- Confirm proper fuel and ignition timing.
- Confirm proper heat range of spark plugs.
- Check the coolant system for leaks and blockages, and check water pump for malfunction.
- Repair coolant system and refill coolant, as necessary.
- Install new spark plugs.

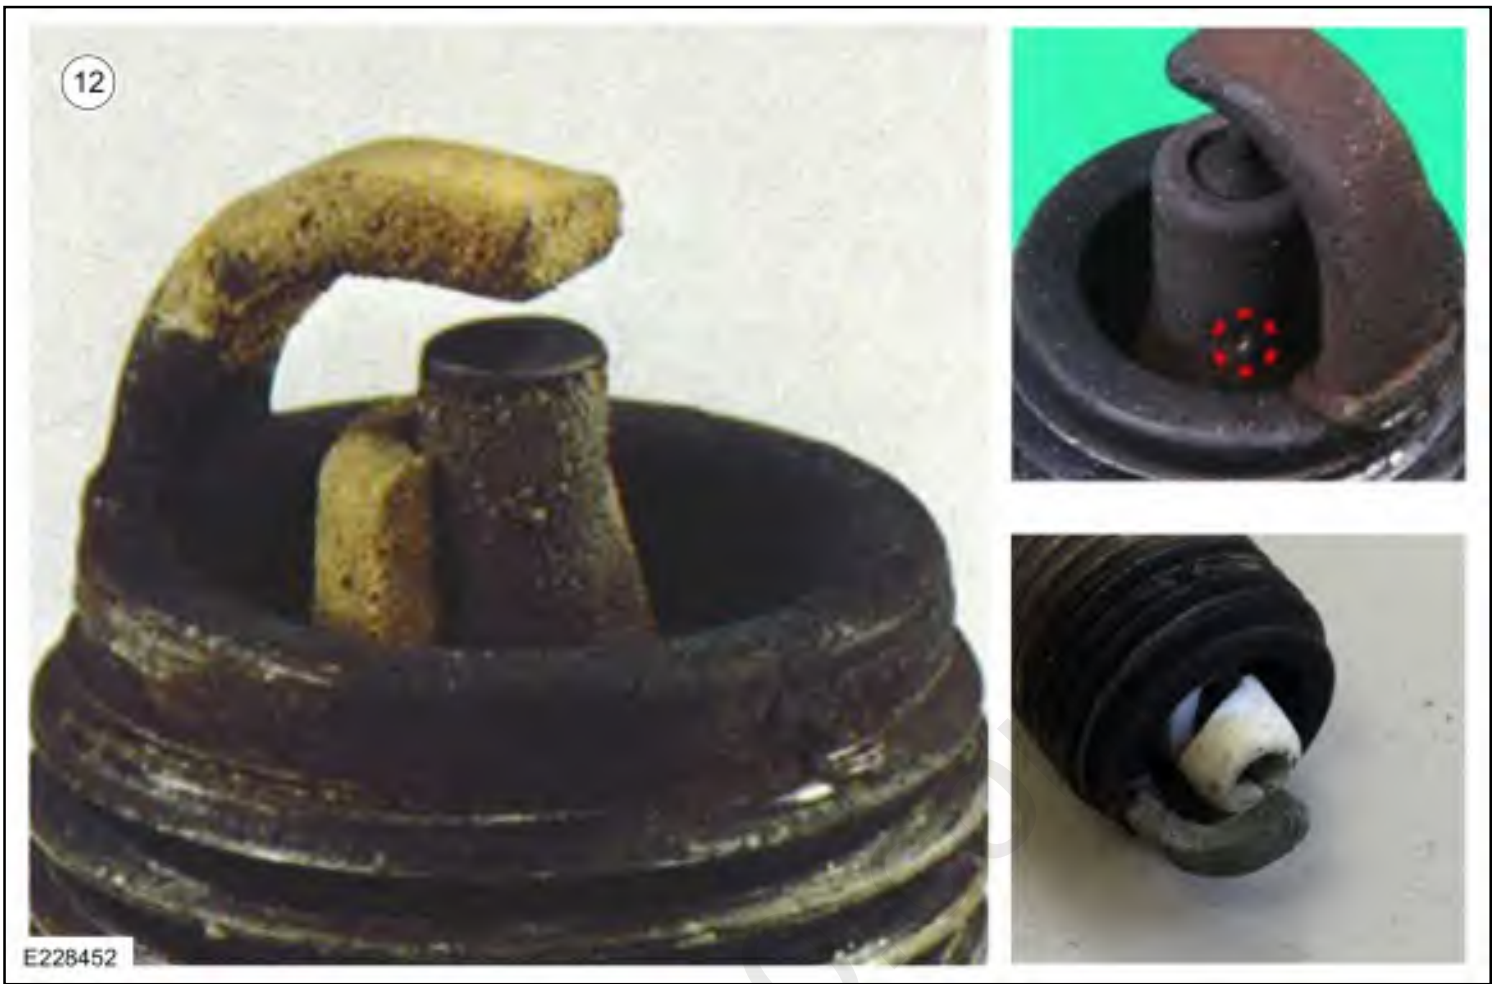
## Insulator Damage and Breakage

12. **NOTE:** *Upper right hand insert shows dielectric puncture typically due to excessively worn gaps.*

- Center electrode insulator breakage is often caused by a sudden thermal shock due to sudden heating or cooling. It can also be caused by mechanical load from an external source (droppage) or can even be caused by pre-ignition events where side loading from combustion pressure shock waves is strong enough to fracture the ceramic insulator material. Hotter heat range spark plugs have a longer insulator to reduce the spark plug fouling risk, but are also weaker to fracture during low speed pre-ignition events due to increase bending moment arm. Oil or Sulfur Oxide migration between the center electrode and the inner diameter of the insulator can cause internal outward force sufficient to create a “u” shaped fracture. See Sodium/Oil Migration section for further detail of this failure mode.
- Install new spark plugs.

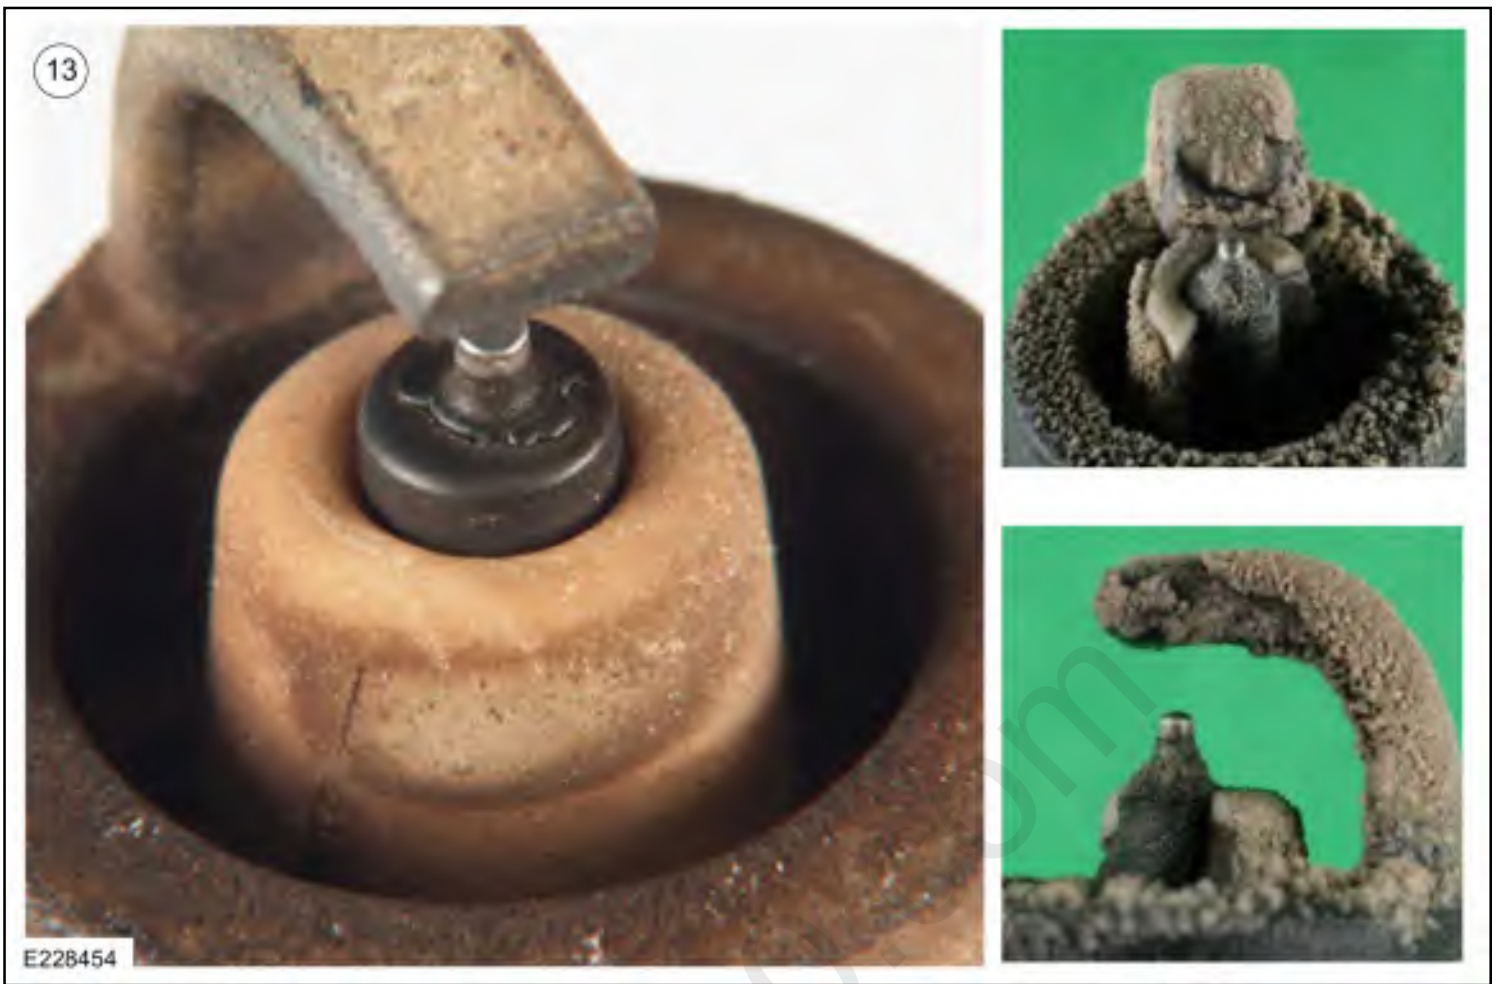
## Sodium/Oil Migration

- In the case of oil migration, misted oil is absorbed into the combustion chamber during charge intake. For cylinder deactivation, valves remain closed and oil within the chamber does not combust. Misted oil adheres to the spark plug surfaces and oil penetrates into the clearance volume between the insulator and center electrode via capillary action. During cylinder reactivation, oil near the surface is burned off, while soot (carbon deposits) is generated within clearance volumes due to incomplete combustion. During spark plug reheating, the center electrode thermally expands at a much greater rate than the insulator, causing compressive stresses within the center electrode and tensile stresses on the electrode insulator exterior. These stresses can fracture the ceramic insulator if sufficiently high. In sodium migration, sodium sulfate is created during combustion and deposits form in the clearance volume between center electrode and insulator. Currently, the source of sodium sulfate is not known, although it is believed to originate from E100 fuel. Present theory suggests that failure is caused by electrode/insulator locking, where electrode and insulator are mechanically joined by the sodium sulfate. During cool down, the electrode contracts and increases in diameter, which pushes (via sodium sulfate) against the insulator and causes failure in the same manner as seen in oil migration.

- Install new spark plugs.

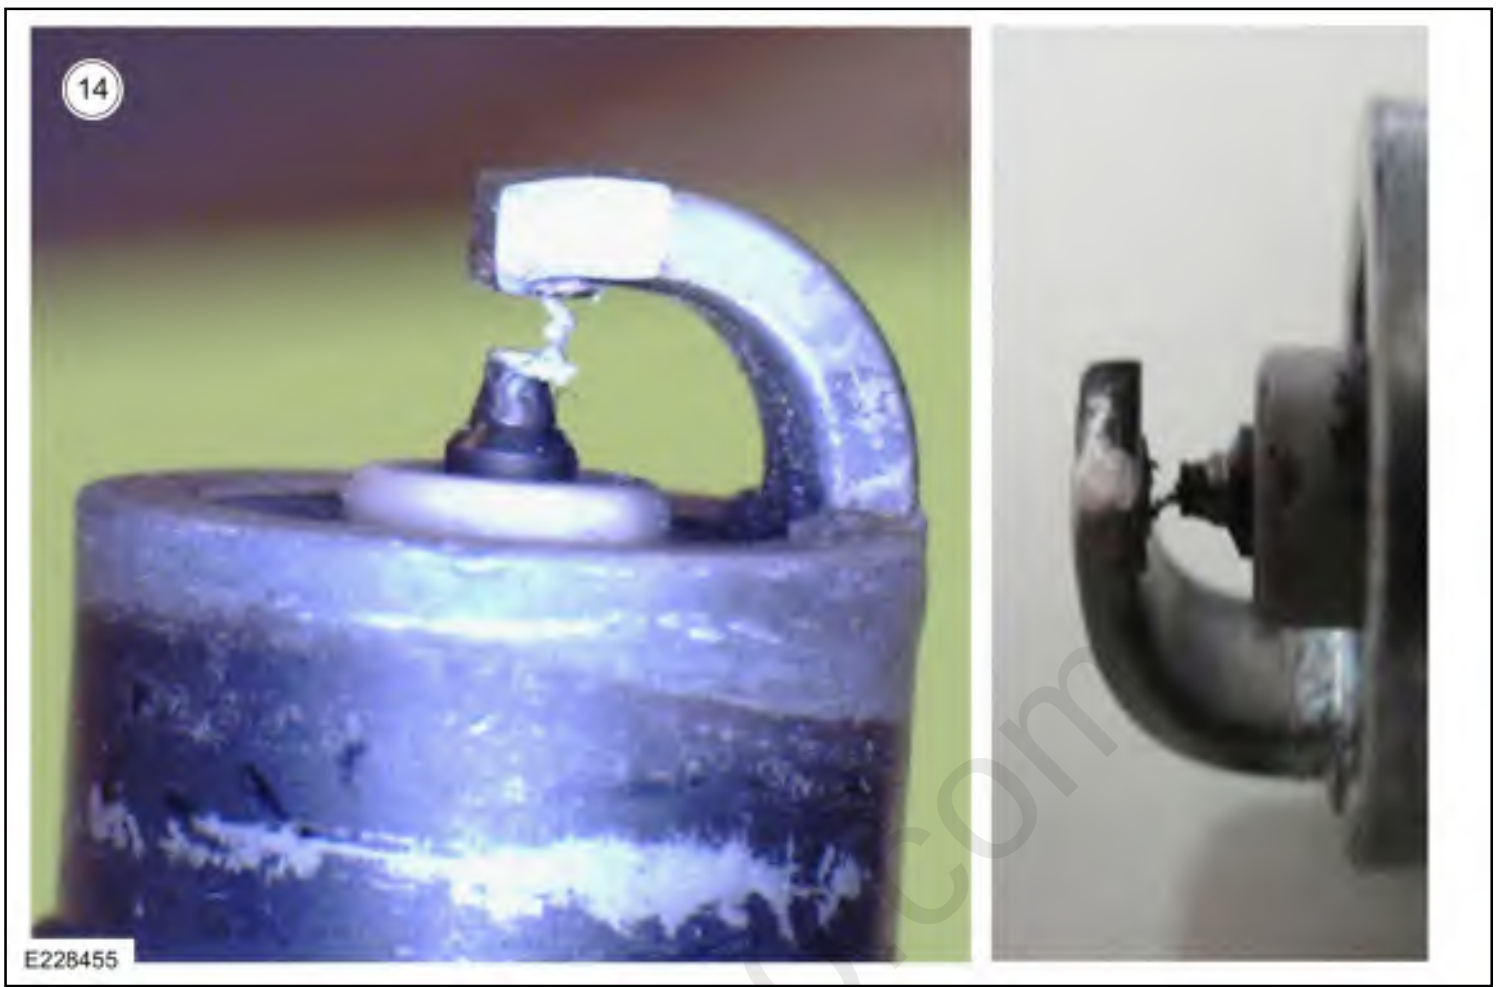
## Bridged Gap

- A bridged spark plug gap is often caused by fuel droplets present in the ion gap when spark is commanded. The spark event conducts through the fuel droplet leaving behind a carbon fiber. Other contributors include deposit build up on the electrode surface which is indicative of carbon or oil fouling. Often, this condition can present itself after many low and medium load cycles. Carbon deposits within the combustion chamber can break free during sudden applications of high load, lodge within the spark plug gap, and provide a dead short to ground.
- Install new spark plugs.
- A drive of between 4-10 miles targeting 3000 rpm will bring the plug to self-cleaning temperature.
