# Spark Plug Inspection

## Inspection

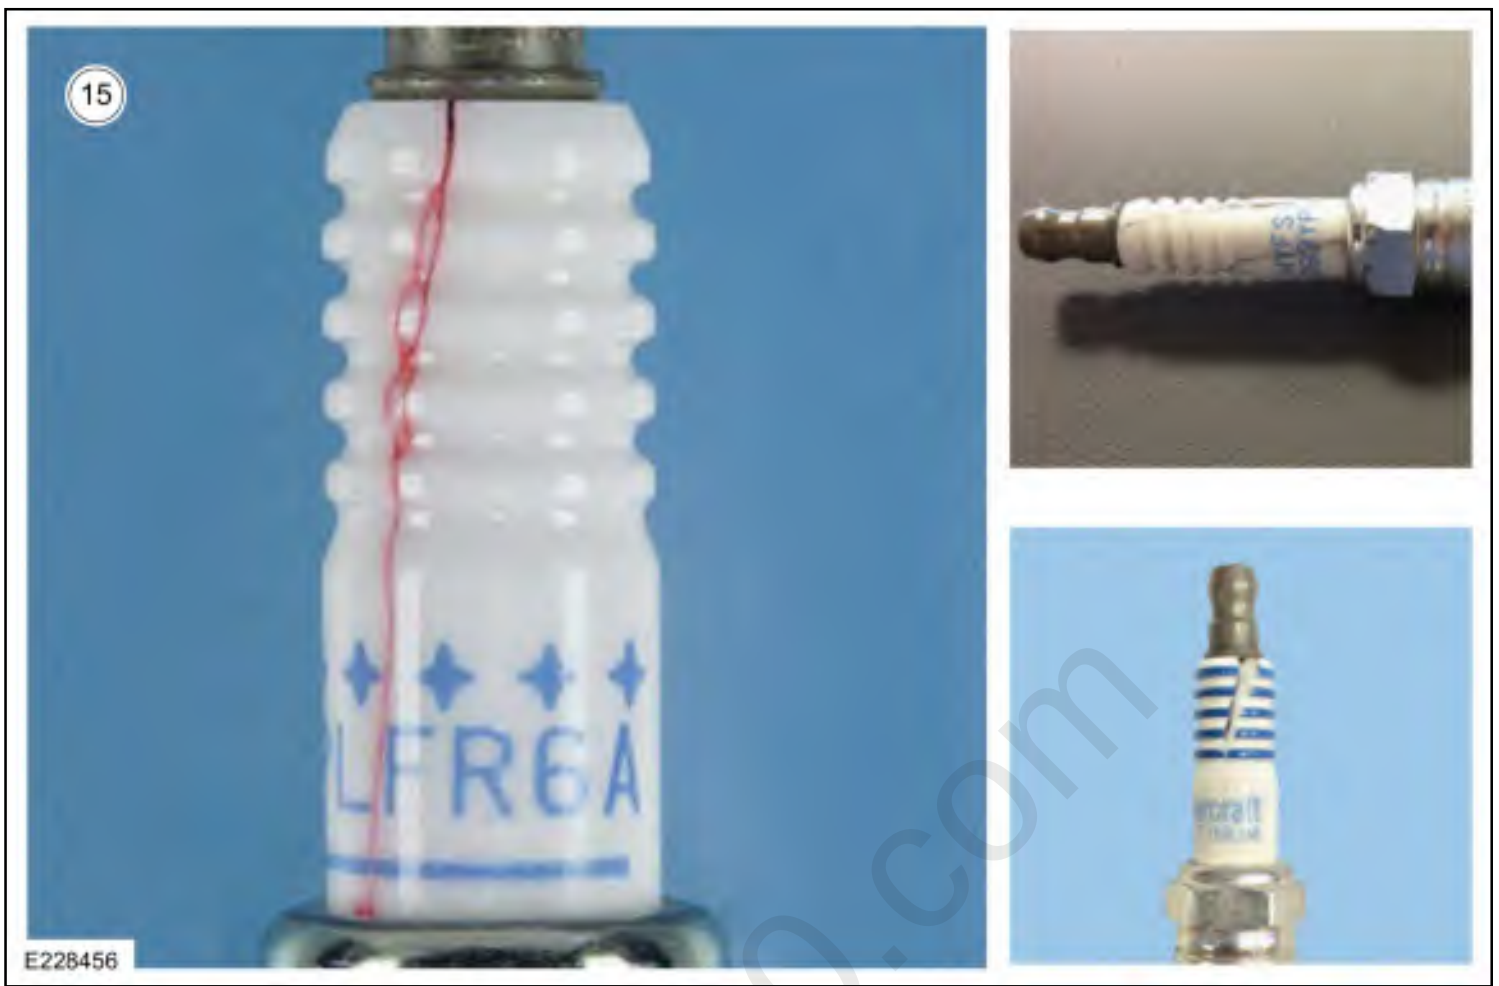
## Wrench Breaking Cracks

- Wrench breaking cracks are typically caused either by side load or torque applied from a socket of incorrect size. Impact loading can and will often crack the insulator shell as the porcelain is very brittle with very little strength under tension. Force direction is often easily determined as the ceramic often cracks vertically (although typically asymmetric about the centerline).
- Avoid using anything but a spark plug socket and hand tools to better prevent these cracks.
- Install new spark plugs.

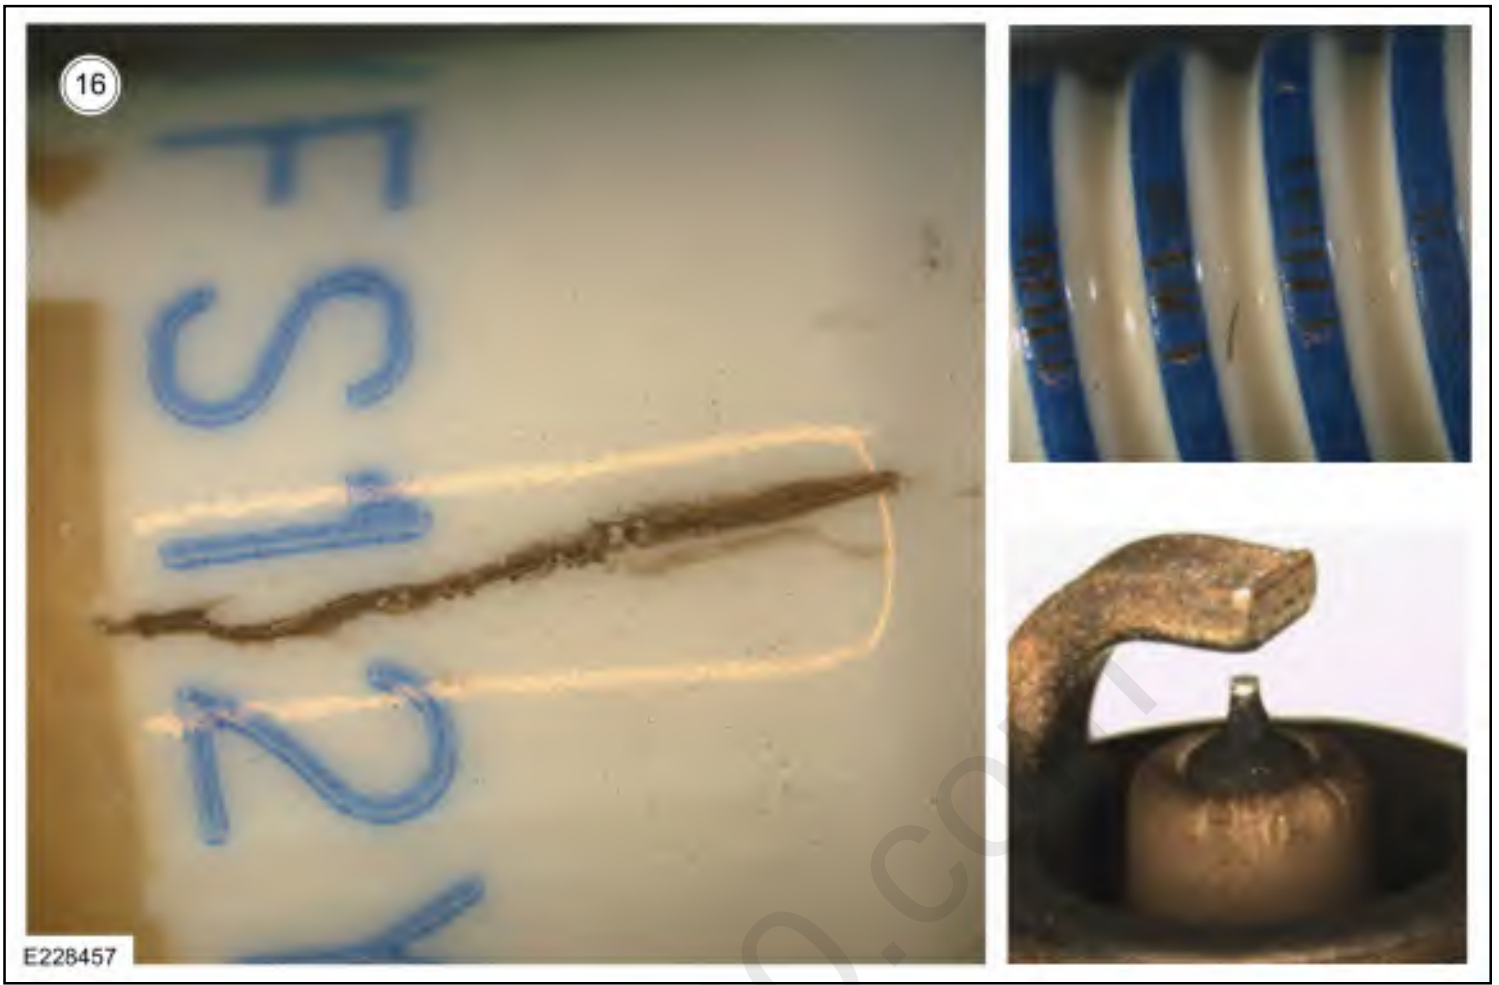
## Tracking/Flashover

- Tracking marks are markings left behind when a high voltage discharge occurs from electrode to ground through something other than the air gap at the spark plug end. Most often, these discharges occur along the primary insulator (under/near the boot) and on the center electrode insulator. These discharges typically scorch the porcelain ceramic and leave a brown burned visual indicator. In the primary photo, a large brown scorch mark is apparent. In the upper secondary photo, track marks are present along each rib. In the lower secondary photo, which shows a case of typical carbon fouling, track marks are present along the primary center electrode insulator as the spark current tracked along the insulator until it jumped sideways to the metal shell.

- Install new spark plugs.
- Install new ignition coil boot (if tracking is above the hex).
- If tracking is present above the hex, both of the above parts must be changed at the same time because the track is present on both components. If only one is changed, the problem will persist and a return visit is very likely.

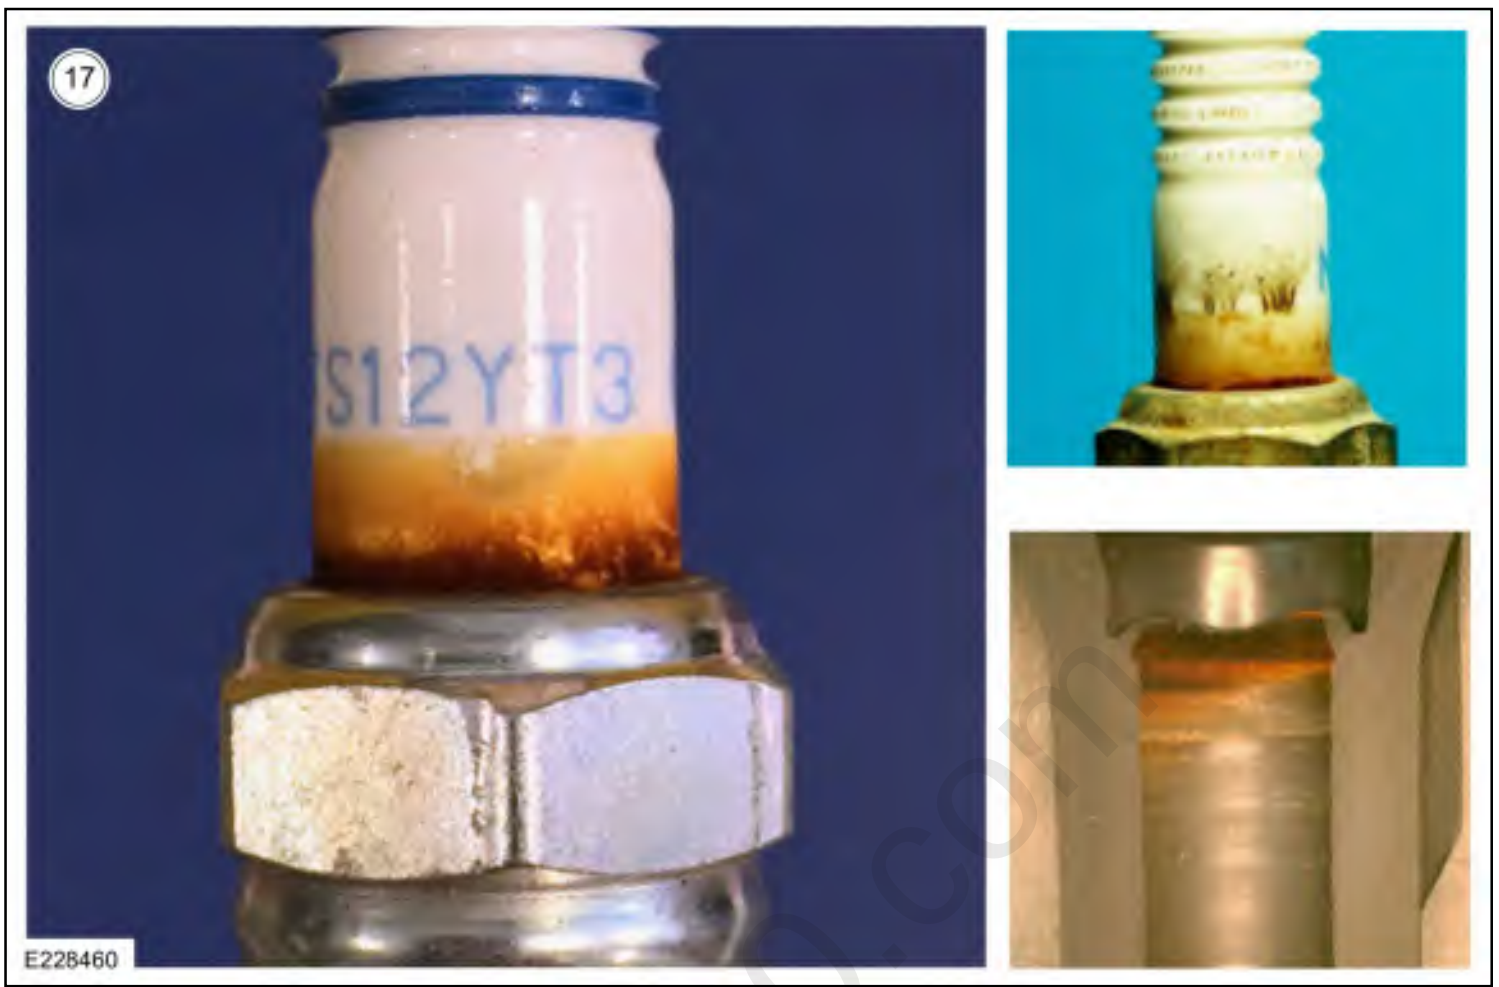
## Corona Stain

- A brown stain near where the insulator joins the metal shell of the spark plug is often called a corona stain and is produced when oil particles present in the air near the engine adhere to the insulator surface. Corona discharge occurs when high voltage applied to the conductor on top of the spark plug causes an insulation breakdown of the air gap between the insulator and metal shell. Corona stain does not affect spark plug performance. In the upper right photograph, tracking marks are present indicating evidence of flash over on ribs, but stop once the corona stain is reached. This suggests the corona stain is not conductive, even in the presence of high kilovolts during normal operation. The lower right photo demonstrates corona staining on the inside of a boot.
- No corrective action is necessary if only a corona stain is present.

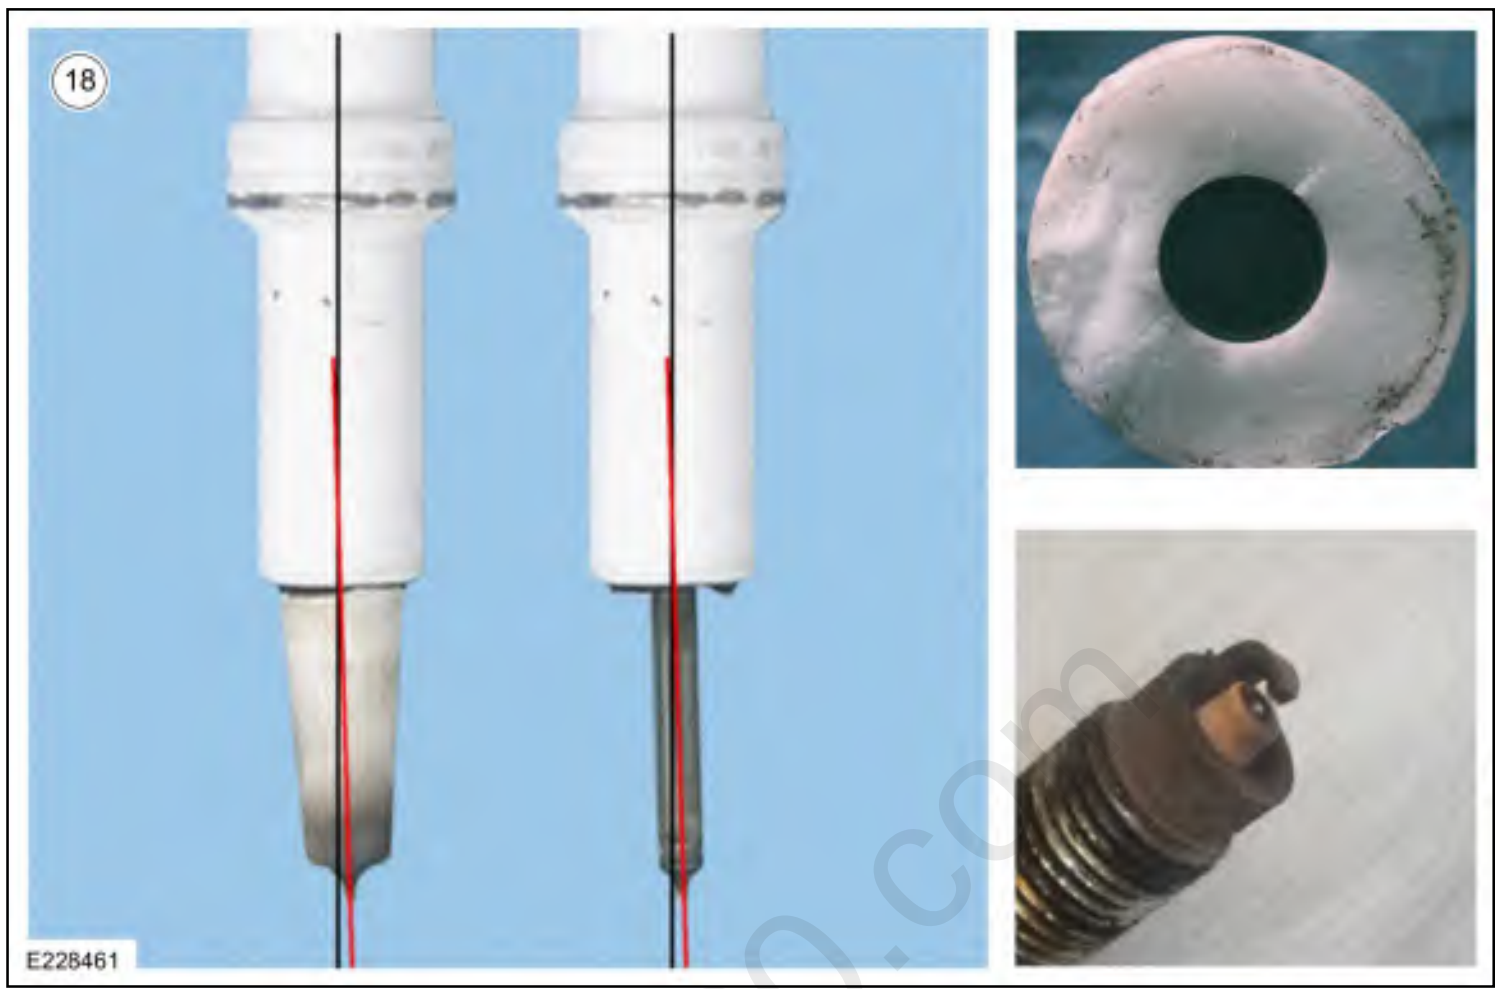
### Center Electrode Bending/Breaking from Pre-Ignition Events (Rattler)

- Under extreme pre-ignition events, a shock wave traveling across the combustion chamber can bend the center electrode and break the center electrode porcelain insulator. Under these extreme circumstances, a “rattler” can be formed where the center electrode insulation breaks free of the spark plug and rattles under vibration. In the photos, a bent center electrode is highlighted in the main photo while the upper secondary photo shows the fracture surface of a broken insulator and the lower secondary photo shows a spark plug with a detached center electrode insulator.
- Install new spark plugs.

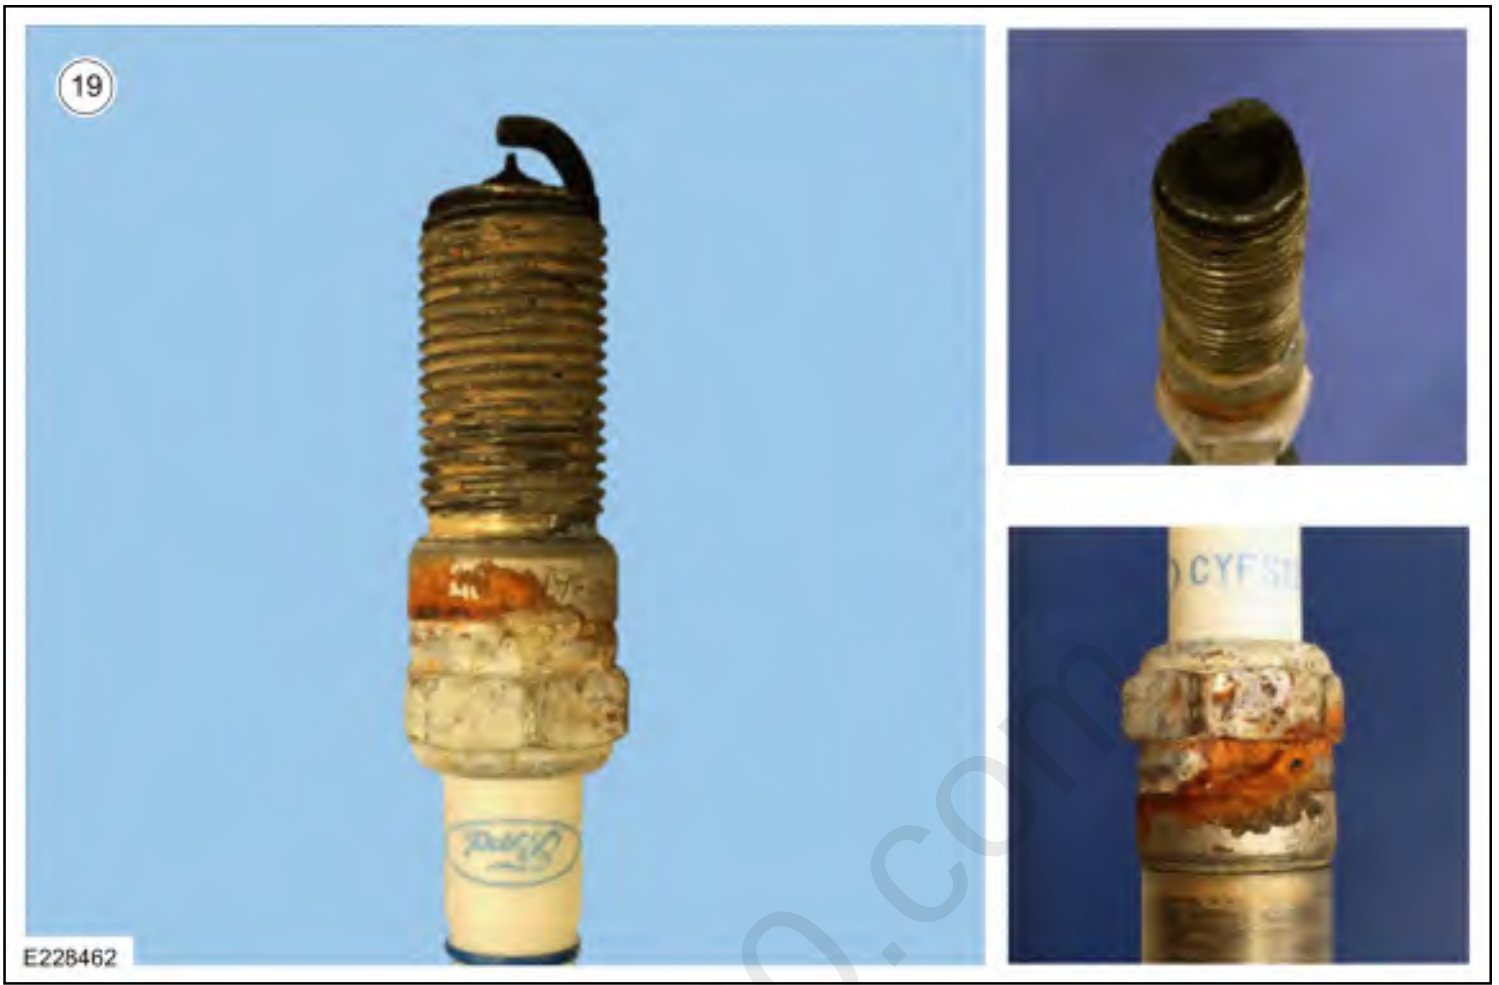
### Corrosion (Water Damage)

- Corrosion found on the wrench/threaded area can be a sign that the spark plug has experienced moisture and heat. Often this condition occurs when water has penetrated spark plug tube seals and entered the spark plug tube. Many times, this corroded spark plug also displays symptoms of misfire (as water provides a low resistance path from high voltage coil to ground) and the combustion chamber interface (center electrode and ground strap) will often be heavily carbon fouled.
- Check for the source of water intrusion and correct as necessary.
- Install new spark plugs.
- Install new ignition coil and boot assembly.
- Advise the customer to avoid direct water spray on the coil boots.
