## Removal

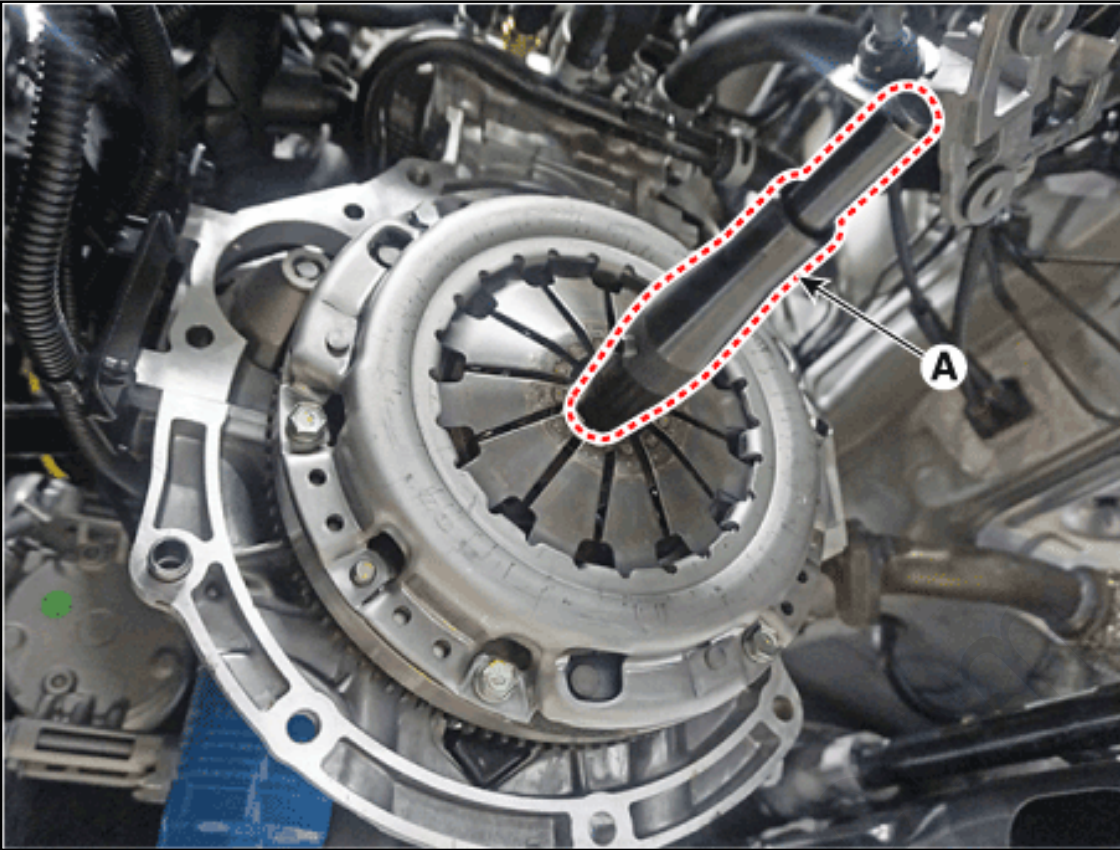
3. Install the clutch disc and the cover with SST(A : 09411-1P000).

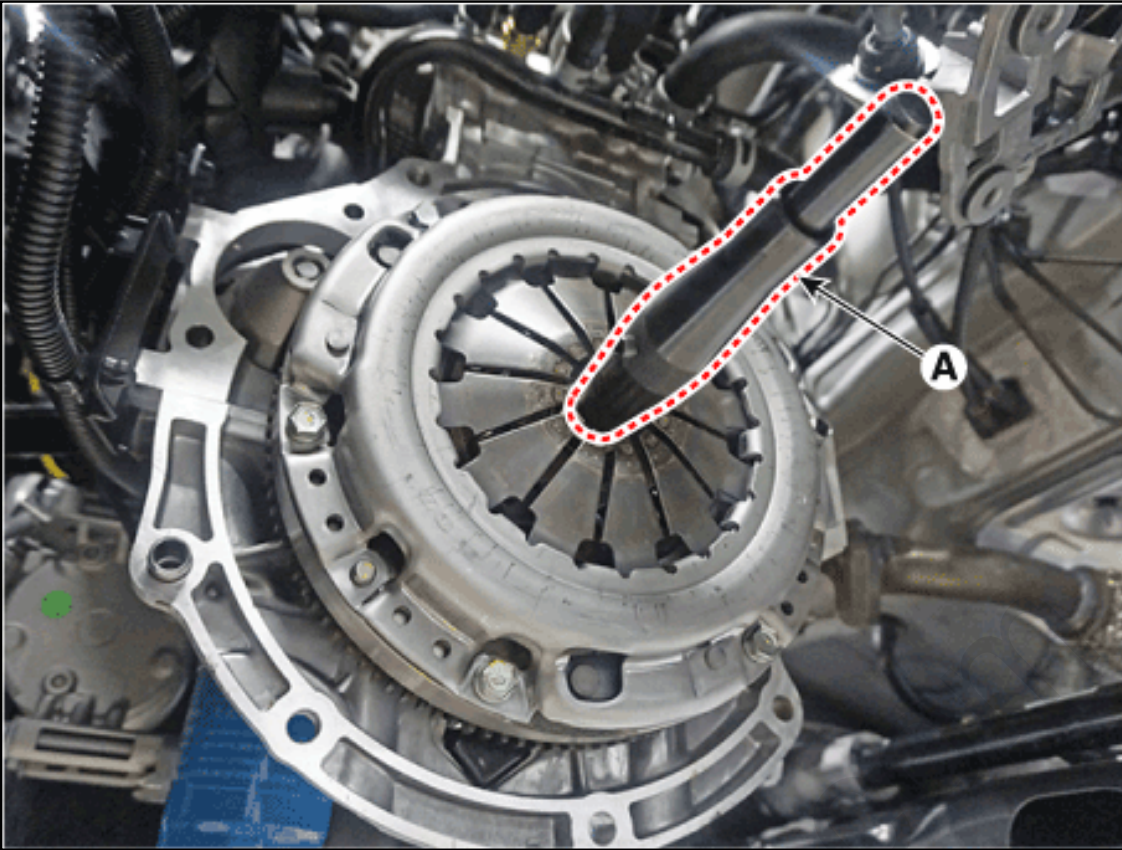
5. Remove the clutch disc guide SST (No.: 09411-1P000).
