# Transmission / Transaxle Cooling - TDV6 2.7L Diesel - Transmission Cooling

# Transmission / Transaxle Cooling - TDV6 2.7L Diesel - Transmission Fluid Cooler Tubes

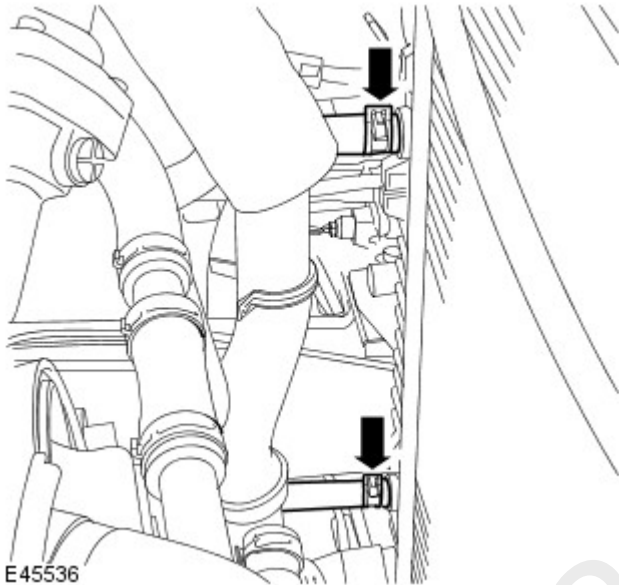
E45536

Disconnect the 2 transmission fluid cooler coolant hoses.

- Position a container to collect the fluid spillage.
- Release the 2 clips.

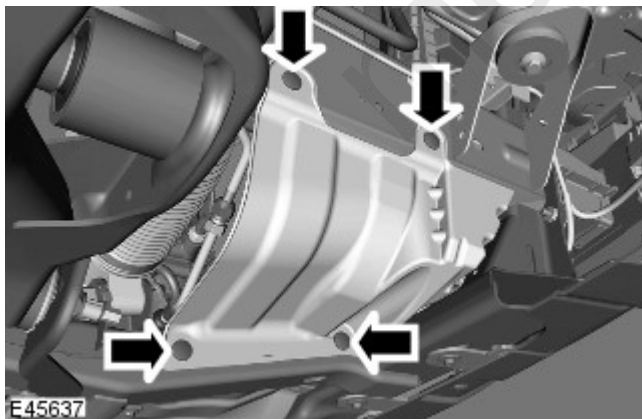
E45637

5. Remove the front LH splash shield.

- Remove the 4 clips.

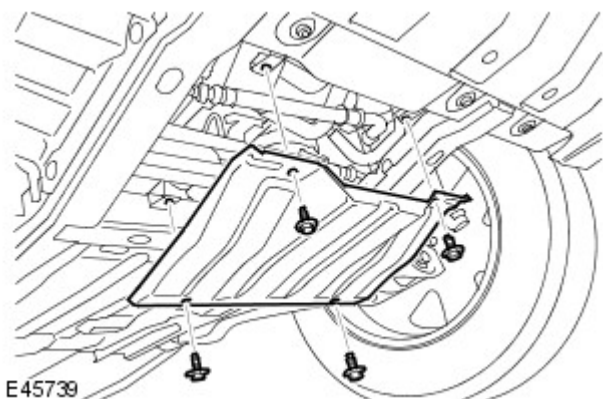
6. Remove the radiator access panel.

- Remove the 4 bolts.

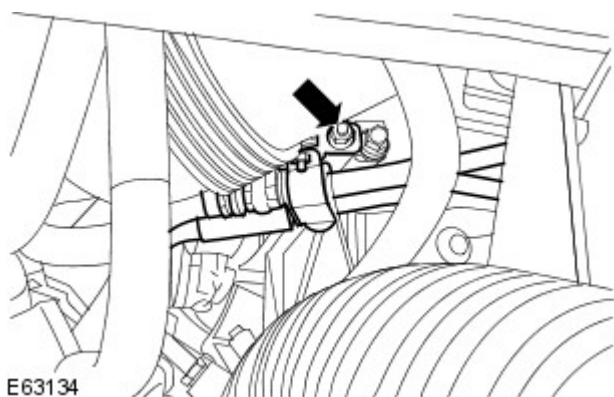
8. Release the transmission fluid cooler hoses bracket.

- Remove the bolt.

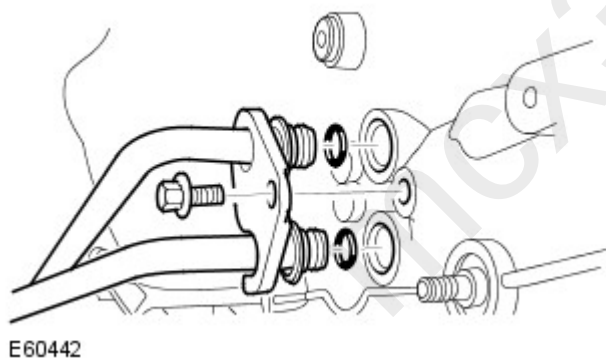
Remove the transmission fluid cooler hoses.

- Position a container to collect spillage.
- Remove the bolt.

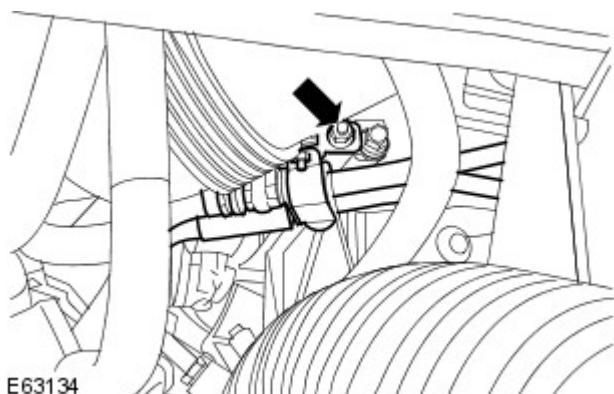
2. Install the transmission fluid cooler hoses.

- Tighten the bolt to 10 Nm.

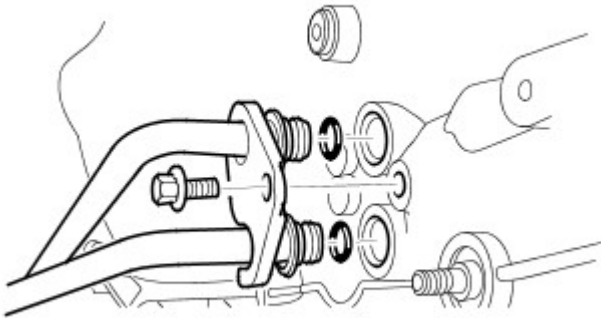
E60442

**3.** Connect the transmission fluid cooler hoses.

- Tighten the bolt to 10 Nm.
