PUBLISHED: 23-JUL-2020  
2020.0 DEFENDER (LE), 412-00

CLIMATE CONTROL SYSTEM – GENERAL INFORMATION

# CABIN COMFORT CLIMATE CONTROL SYSTEM (G2458955)

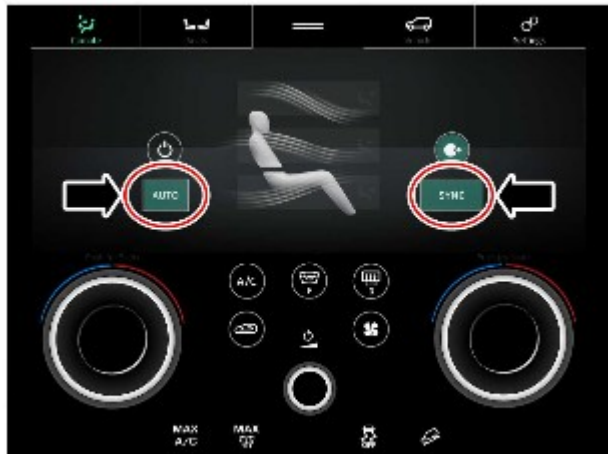
E252964

1. Make sure the vehicle is in a workshop environment and not in direct sunlight
2. Start the engine and run the vehicle at idle with all windows and doors closed for 30 minutes to allow the temperature to stabilize
3. Set the climate control to MANUAL and FOOT and FACE distribution

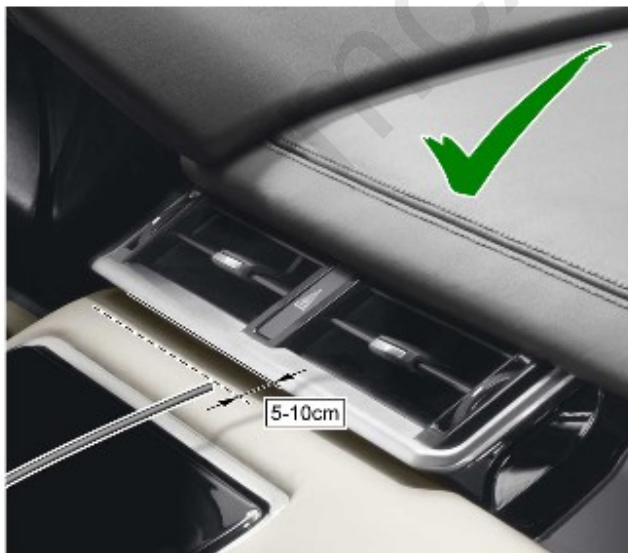
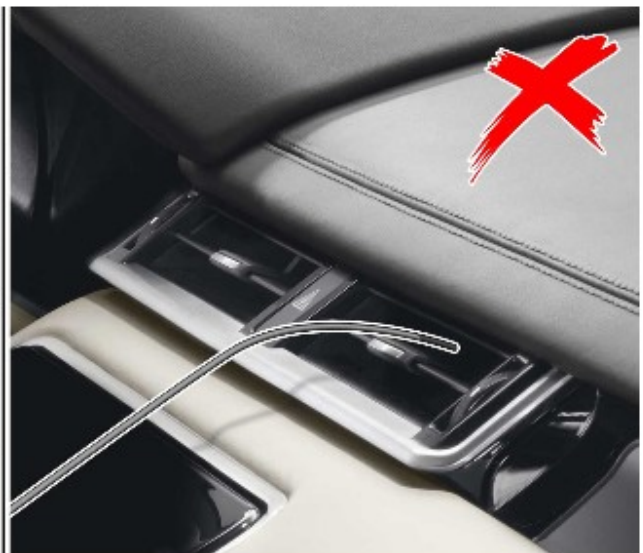
E252965

4. Confirm the driver and passenger temperatures are set to 22°C
5. Place the temperature sensor (Electronic Thermometer RA43230) directly in front and in the centre (not above or below), 5-10 cm away from the front centre vent and measure, make a note of the temperature
  1. Wait for 60 seconds

The temperature probe must be held directly in front and in the centre (not above or below) of the vent 5-10 cm away, incorrect positioning of the probe can cause up to a 4°C temperature difference

6. Place the temperature sensor (Electronic Thermometer RA43230) directly in front and in the centre (not above or below), 5-10 cm away from the rear centre face vent and measure, make a note of the temperature

7. If the temperature difference is between 10°C and 14°C refer to the symptom chart and continue with diagnostics
8. If the temperature difference is greater than 14°C, please raise a TA case for further guidance
