PUBLISHED: 10-SEP-2020  
2020.0 DEFENDER (LE), 501-10

# SEAT COVER INSPECTION (G2740477)

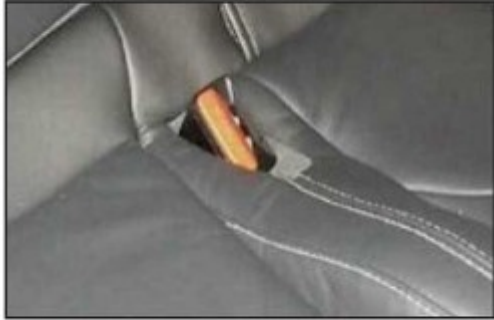
E269904

Examples of appearance showing the maximum allowable appearance. The outside of the seat cushion cannot be worse than the following image.

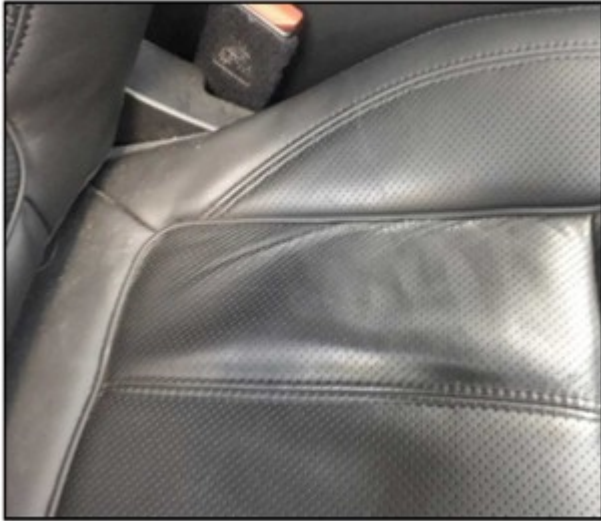
E243681

Creasing due to wear and tear

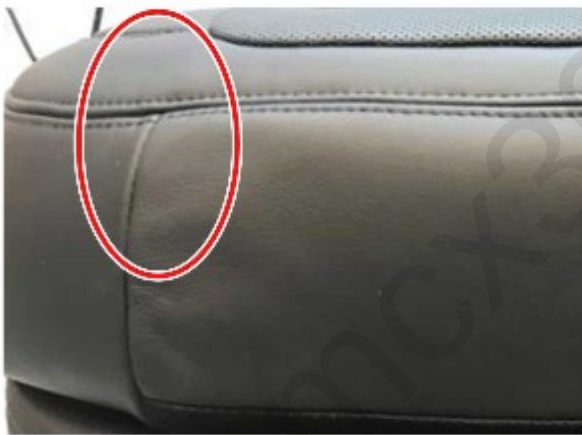
E239767

Uneven appearance on the front of the cushion cannot be worse than the following image.

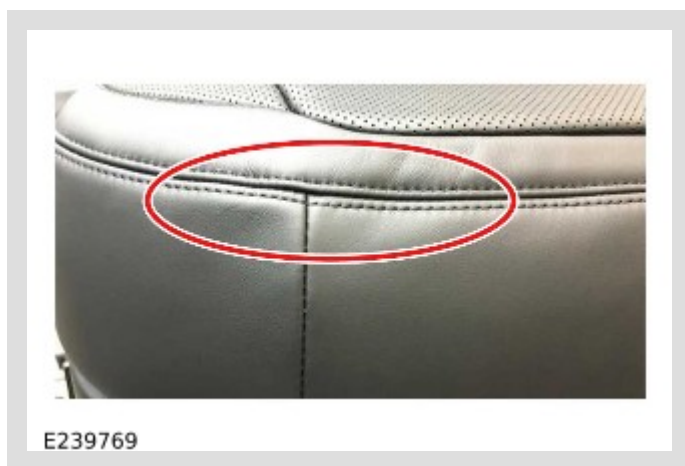
Creasing and seam movement around radius cannot be worse than the following image.

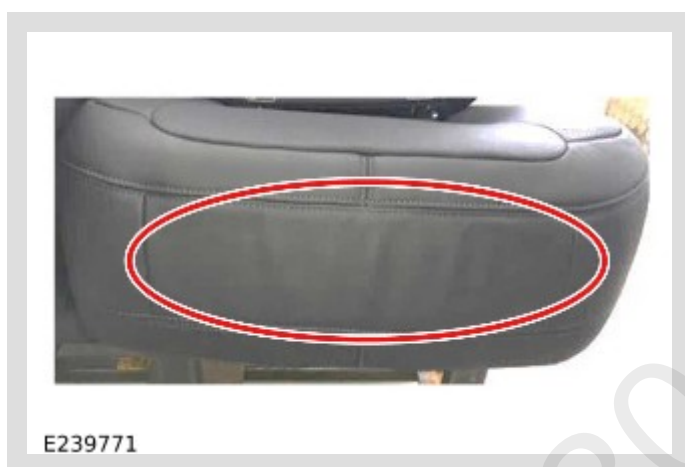
The creasing on the front of the cushion cannot be worse than the following image.

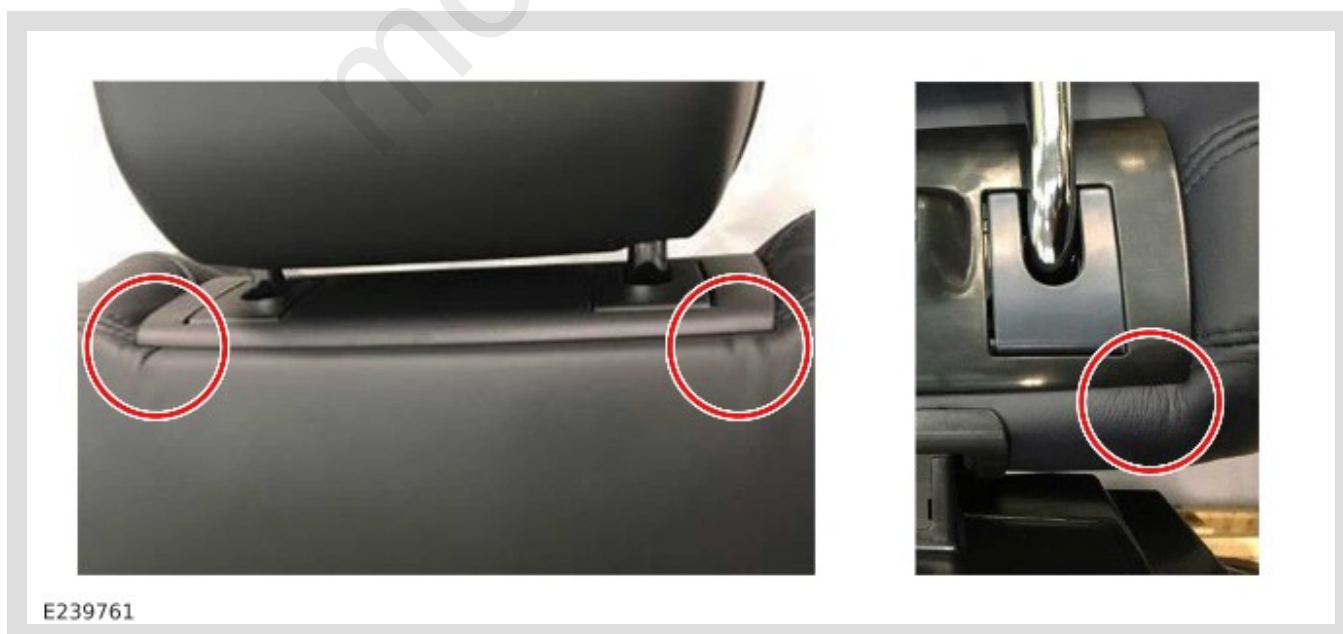
Backrest at the rear of the head restraint cannot be worse than the following images.

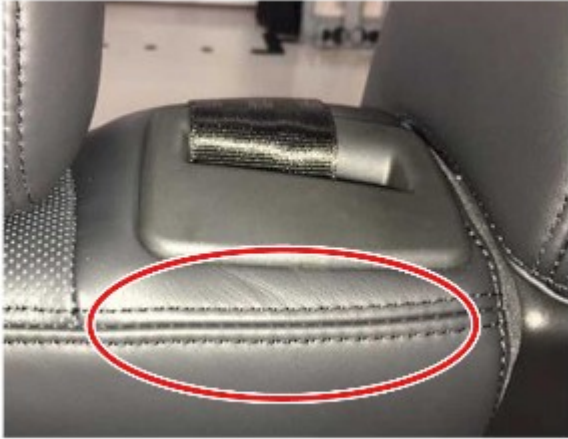
E239765

Creasing around the seatbelt stalk cannot be worse than the following image.

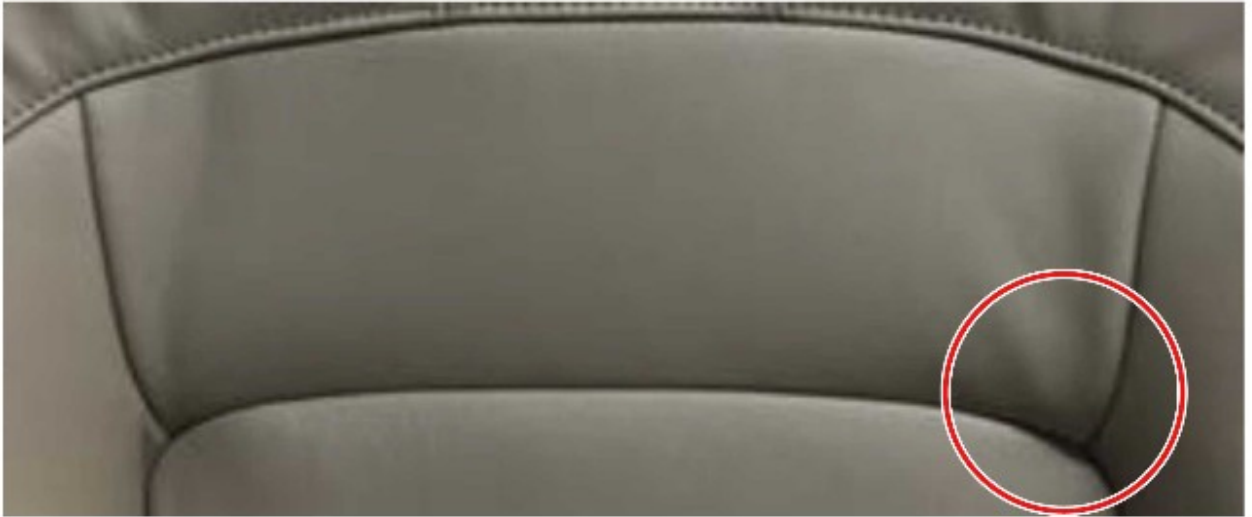
E239770

The centre back section on the seat backrest cannot be any worse than the following images.

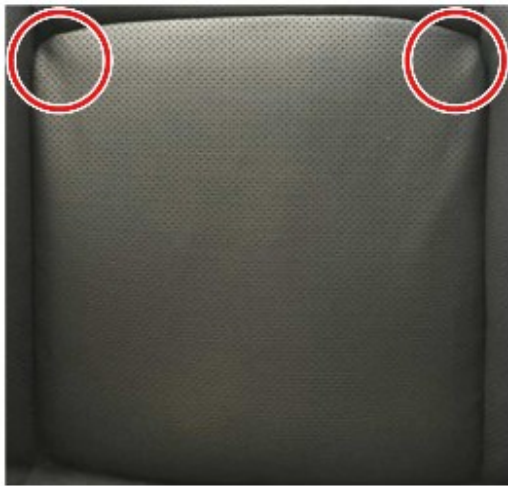
E239772

The square back section on the seat backrest cannot be worse than the following images.

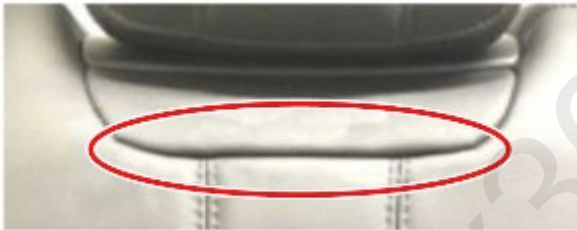
E239773

The front panel below the head restraint may appear to be wavy, it cannot be worse than the following image.

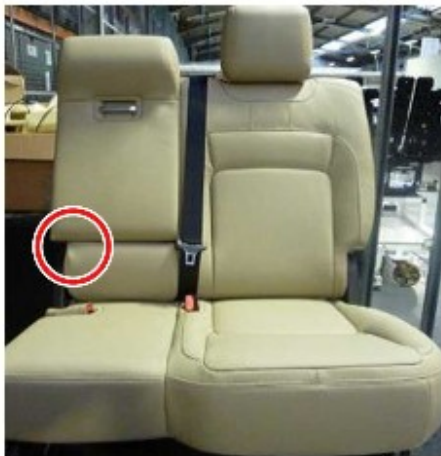
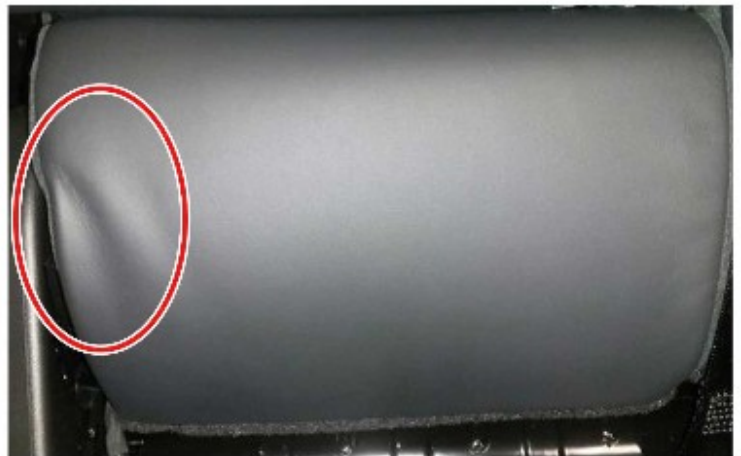
E239775

The area below the lower armrest cannot be worse than the following image.

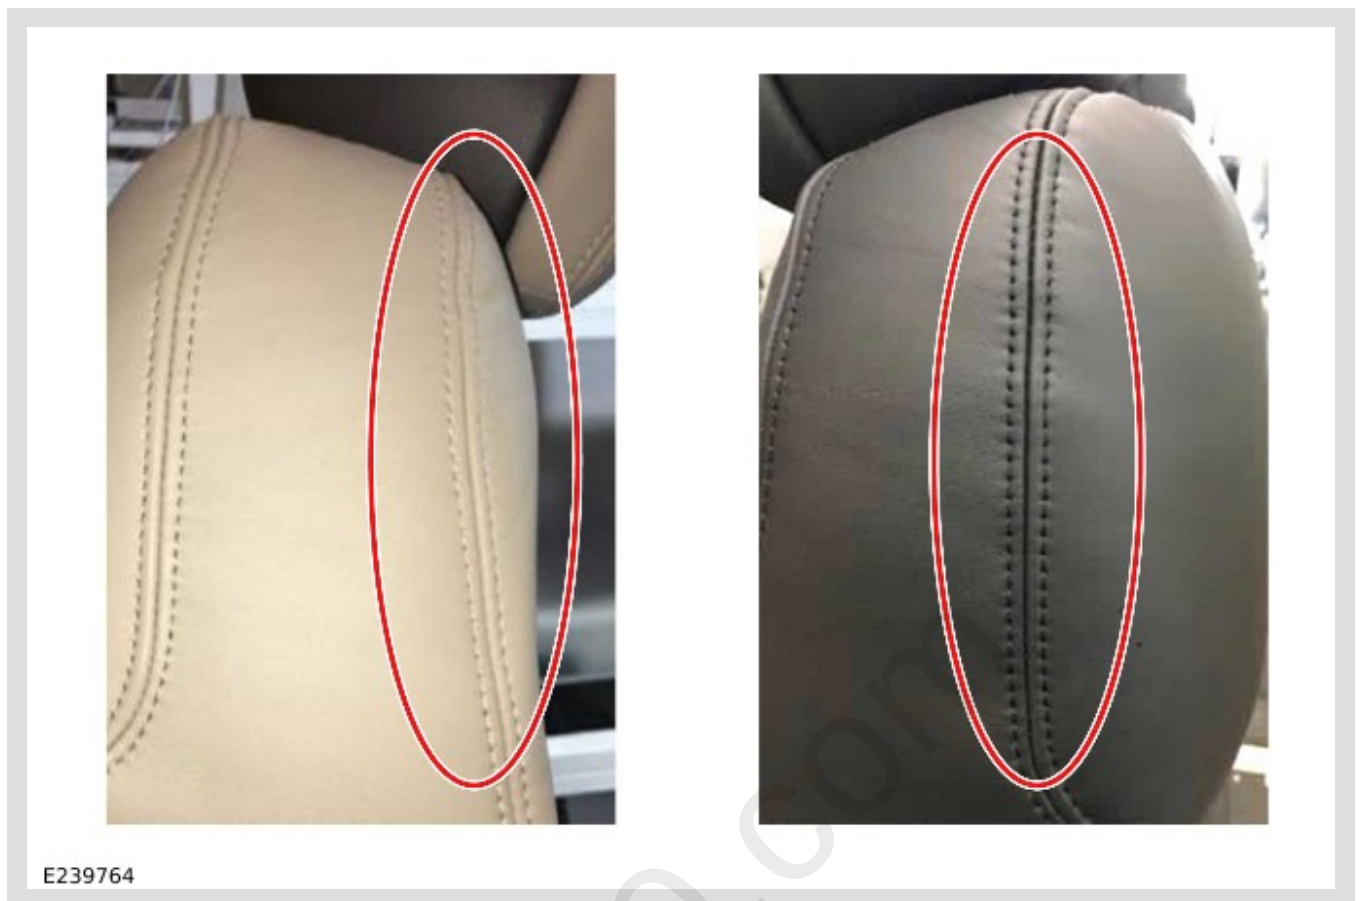
Backrest side (armrest side rear face) creasing sewing variation in radius cannot be worse than the following images.

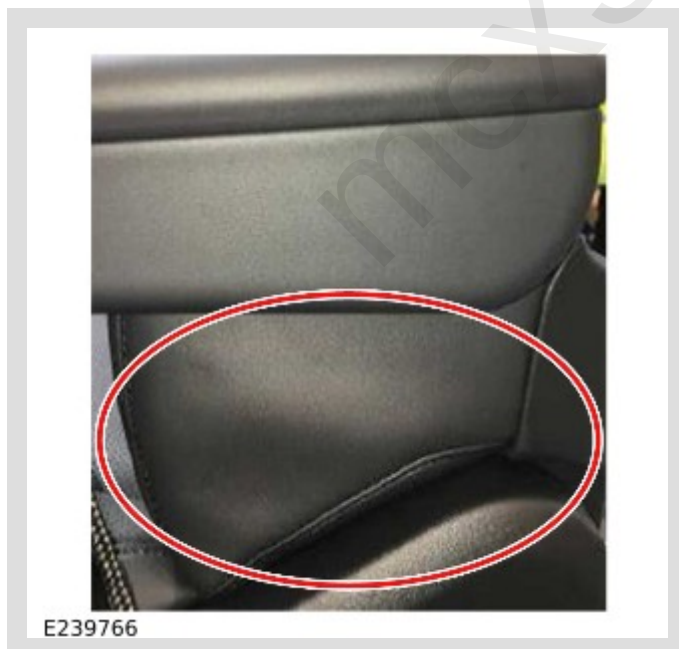
Creasing between the bottom of the seat and the armrest cannot be worse than the following image.

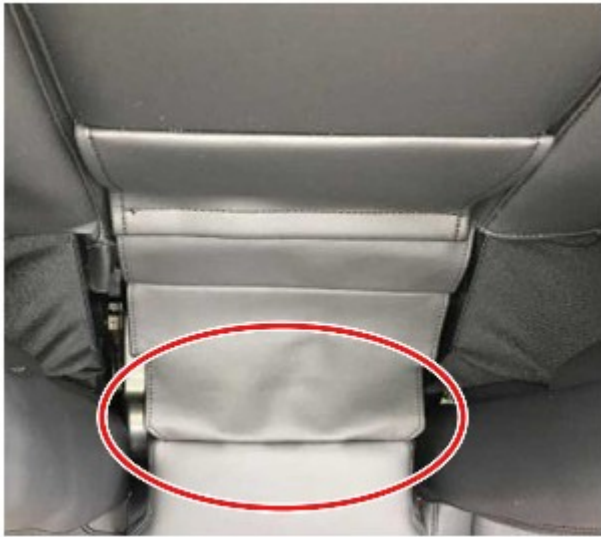
E239776

Creasing armrest gap is not a defect due to the folding operation of the armrest.

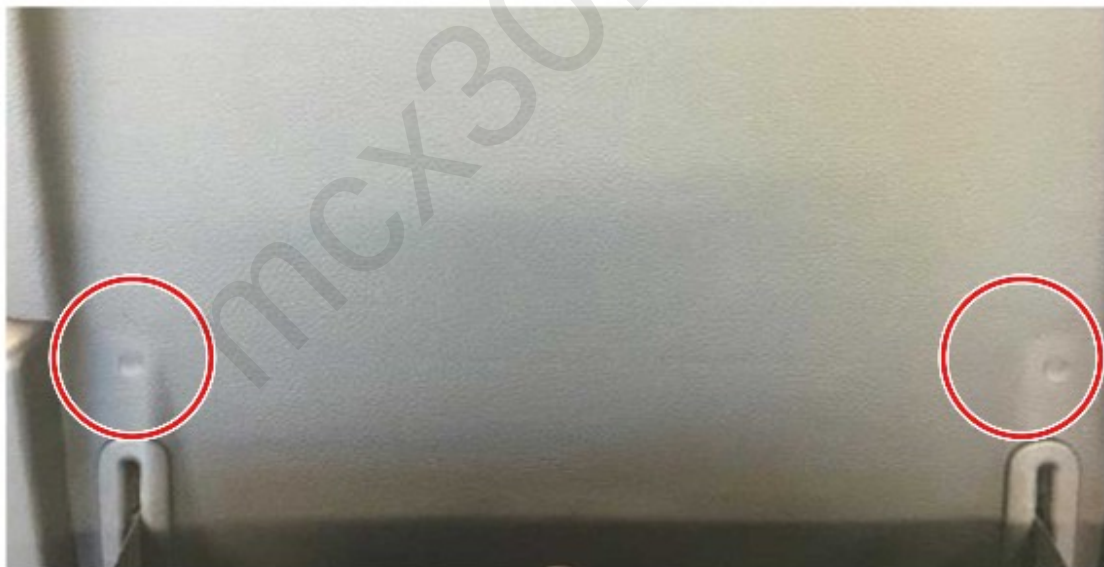
E239774

Permanent mark from the map pocket stops (if equipped) cannot be worse than the image below.

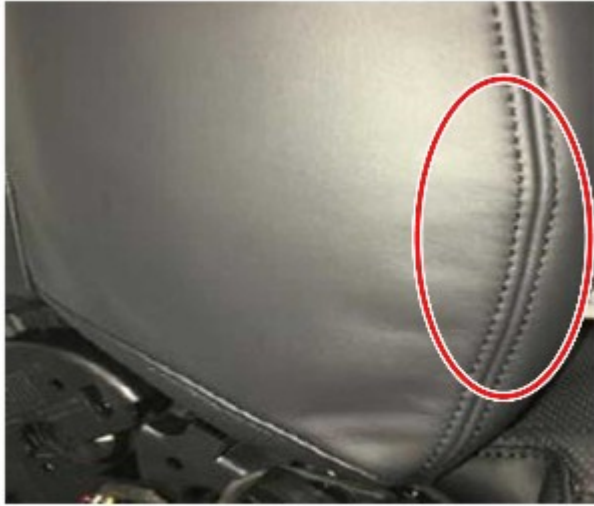
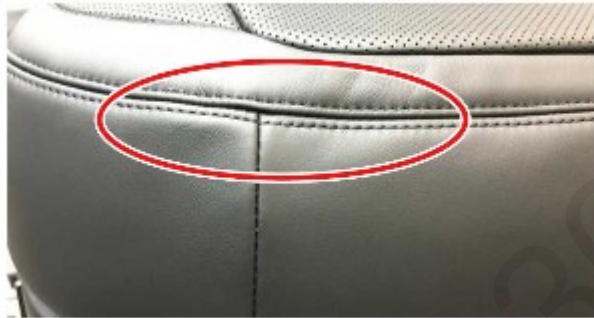
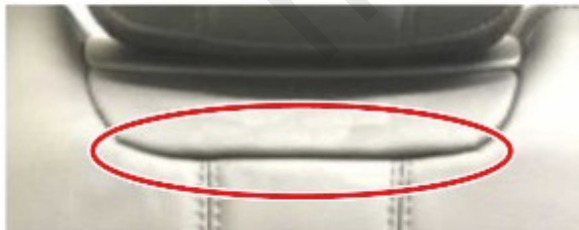
Waviness appearance on the bottom corner of the seat bolster cannot be worse than the following images.

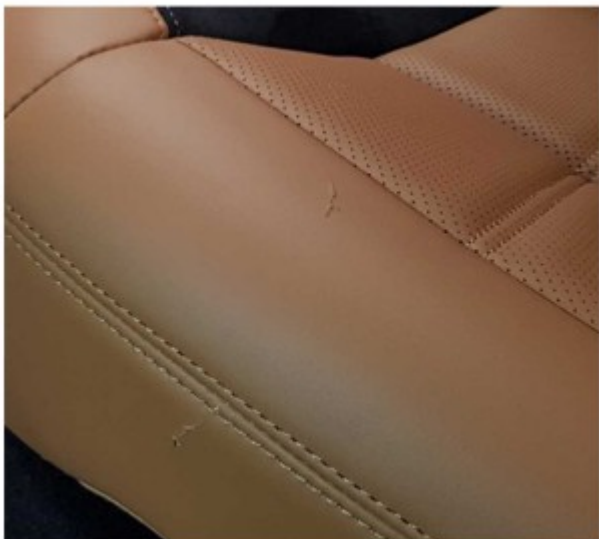
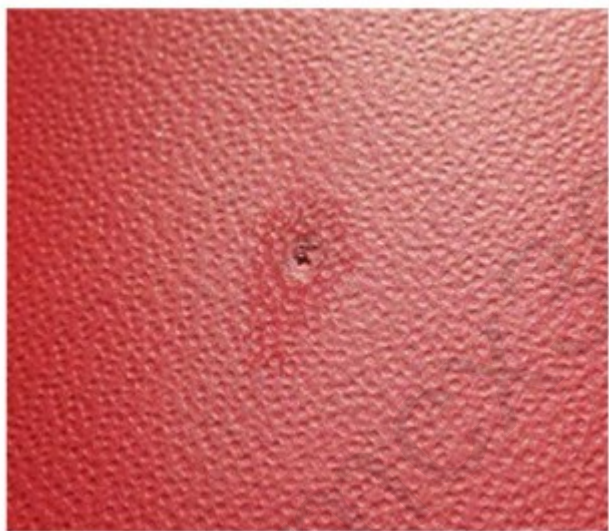
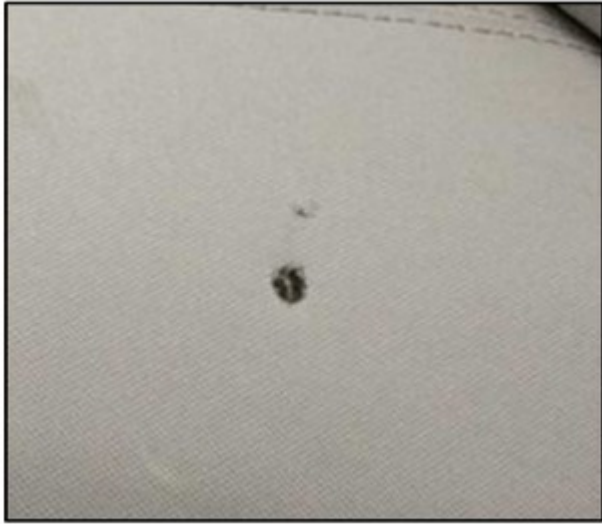
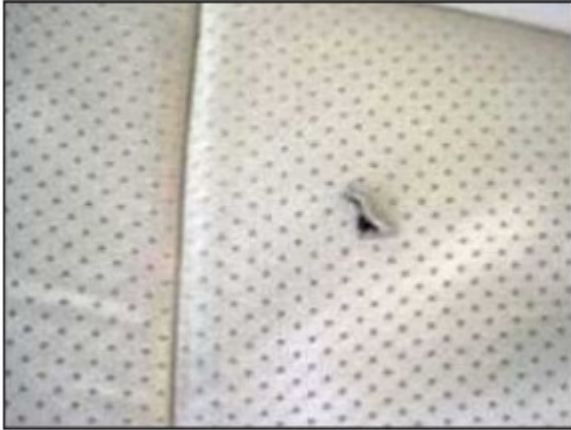
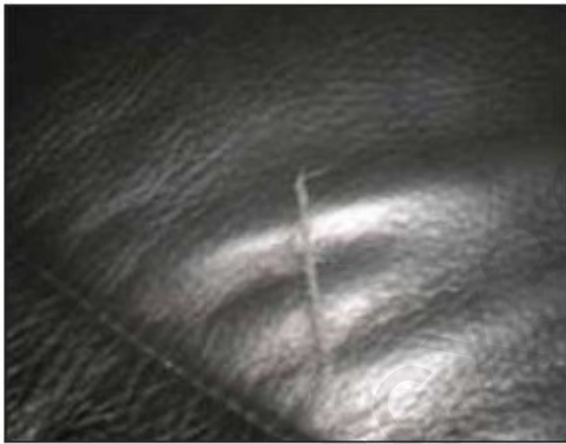
The examples below show damage such as cuts, tears and puncture holes. These types of damage would not be accepted under the terms of the Jaguar Land Rover warranty agreement

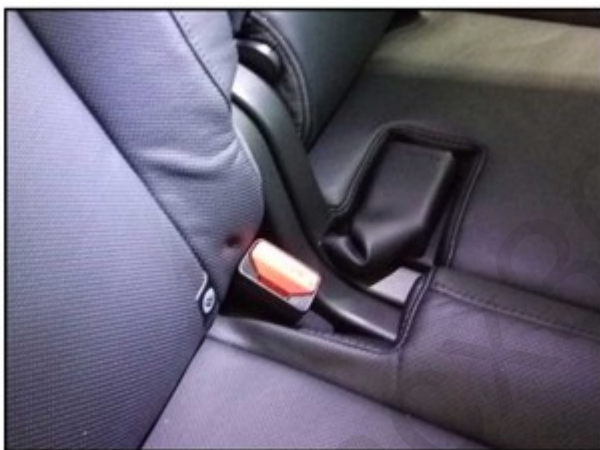
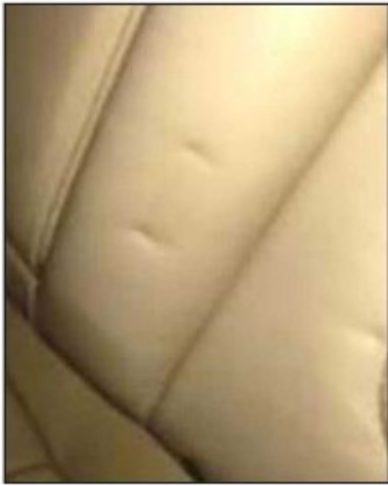
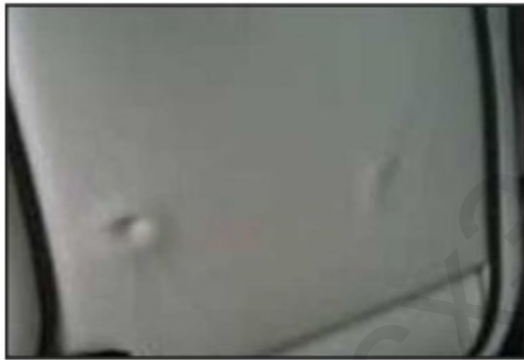
The examples below show damage such as scratches, scrapes, snags and indentation marks. These types of damage would not be accepted under the terms of the Jaguar Land Rover warranty agreement

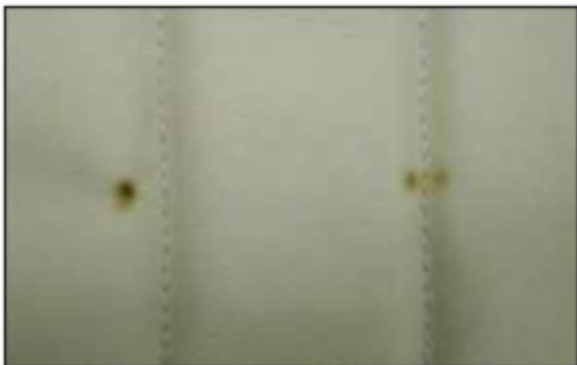
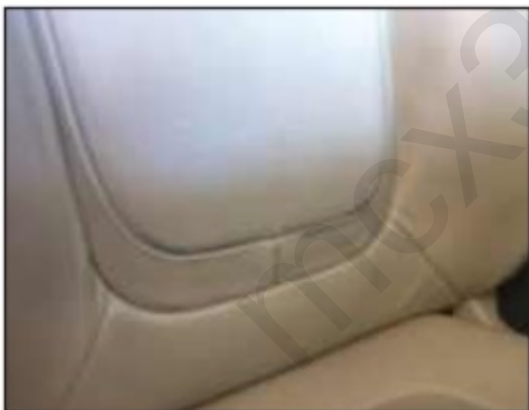
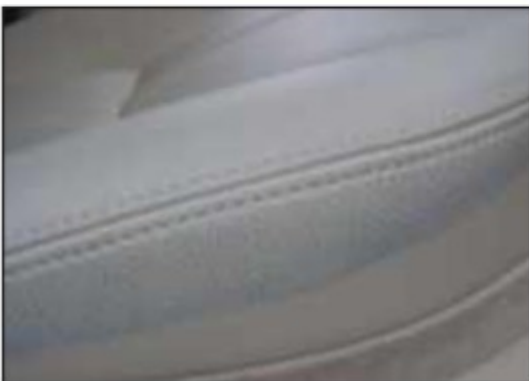
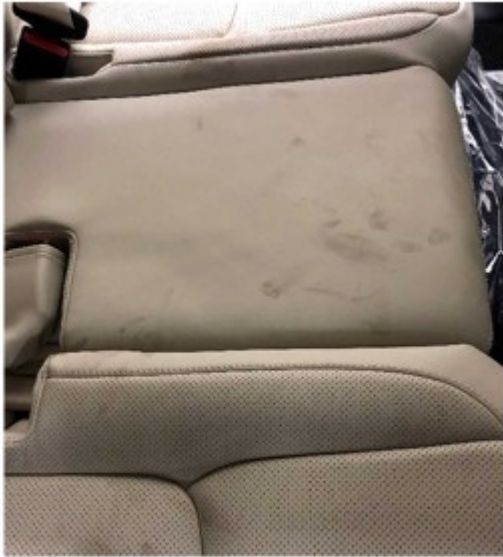
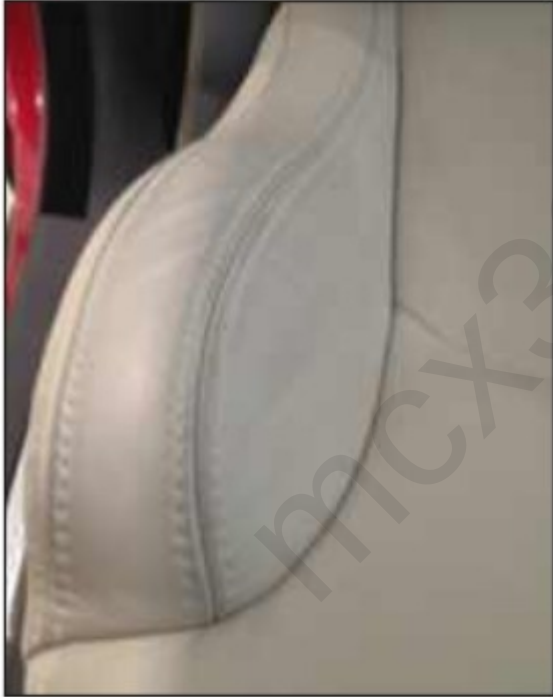
The examples below show damage such as pen marks, soiling, stains, incorrect cleaning and visual surface burns. These types of damage would not be accepted under the terms of the Jaguar Land Rover warranty agreement.

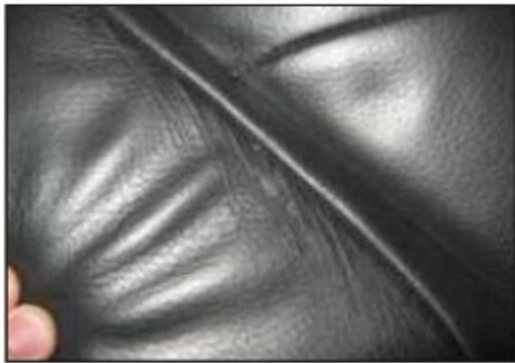
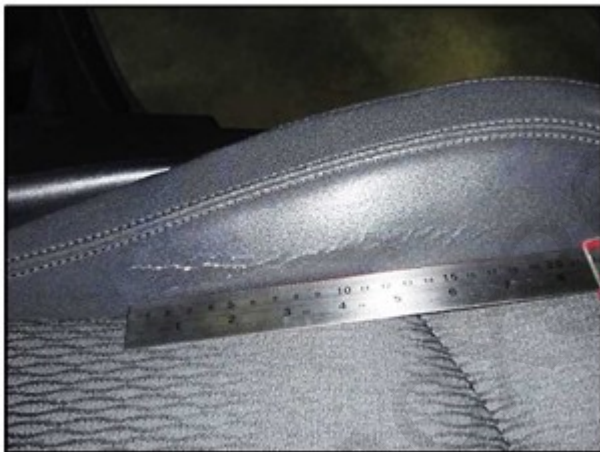
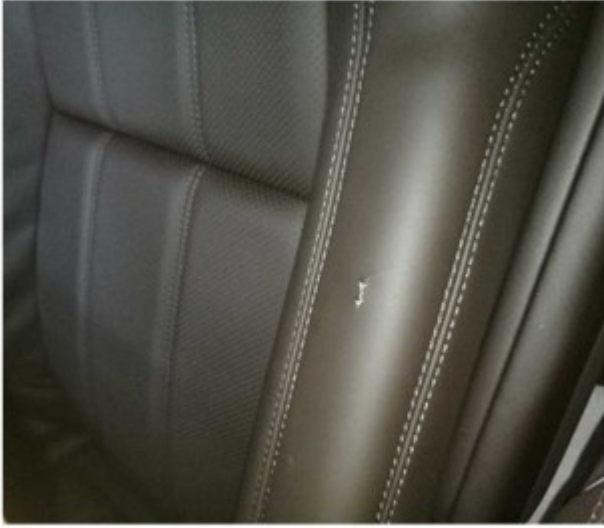
The examples below show damage such as Leather cracking/splitting. These types of damage would not be accepted under the terms of the Jaguar Land Rover warranty agreement
