PUBLISHED: 09-JAN-2020  
2020.0 DEFENDER (LE), 501-14

HANDLES, LOCKS, LATCHES AND ENTRY SYSTEMS

# TAILGATE STRIKER ADJUSTMENT (G2424898)

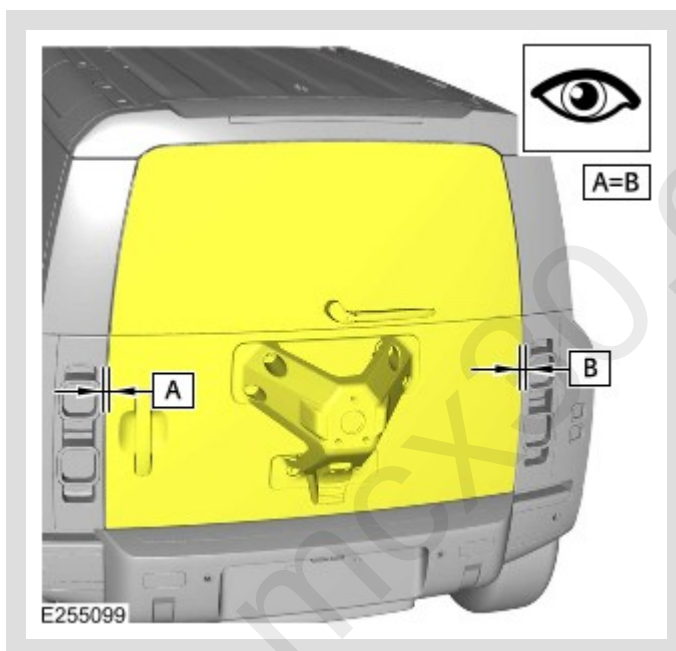
1.

Check the tailgate flush on both side. If incorrect, follow the adjust procedure below.

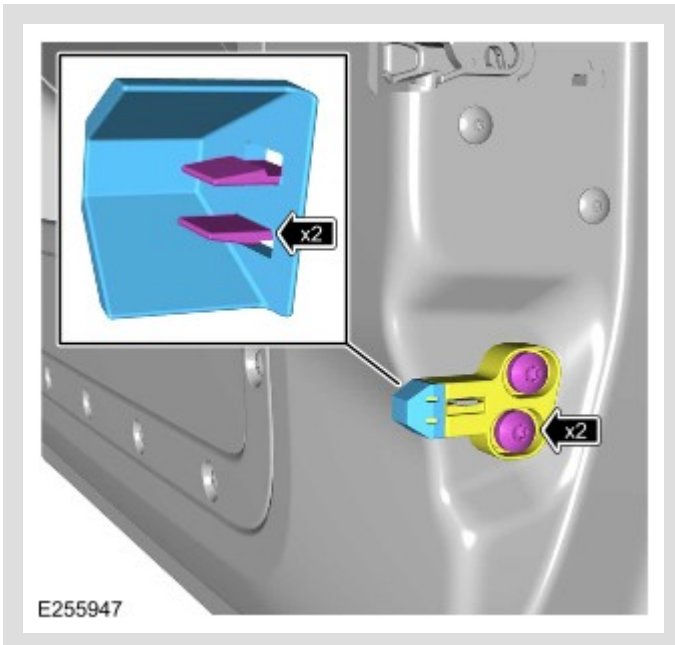
1.

- Remove the plastic cover from the wedge.
- Loose but not fully remove the 2 bolts.

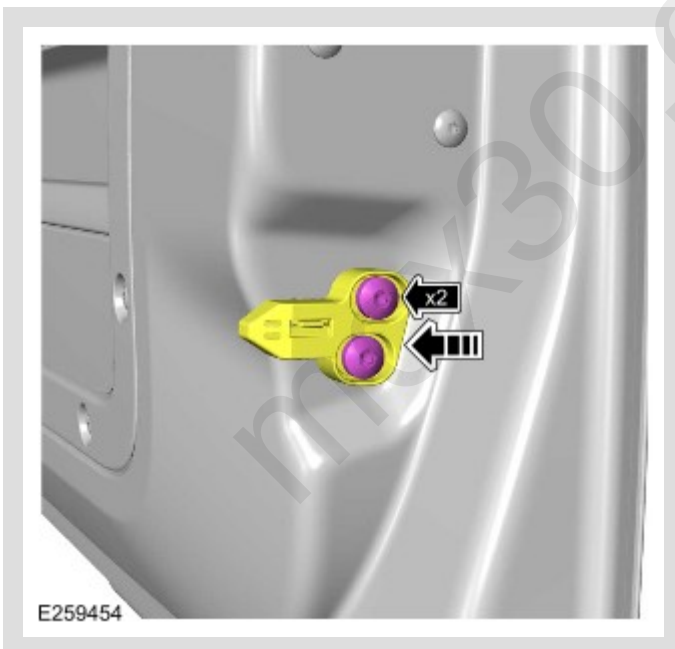
1. Tighten the 2 bolts.  
*Torque: 2Nm*
2. Loose the 2 bolts with quarter of a turn.
3. Push the wedge towards the vehicle to the outermost position.

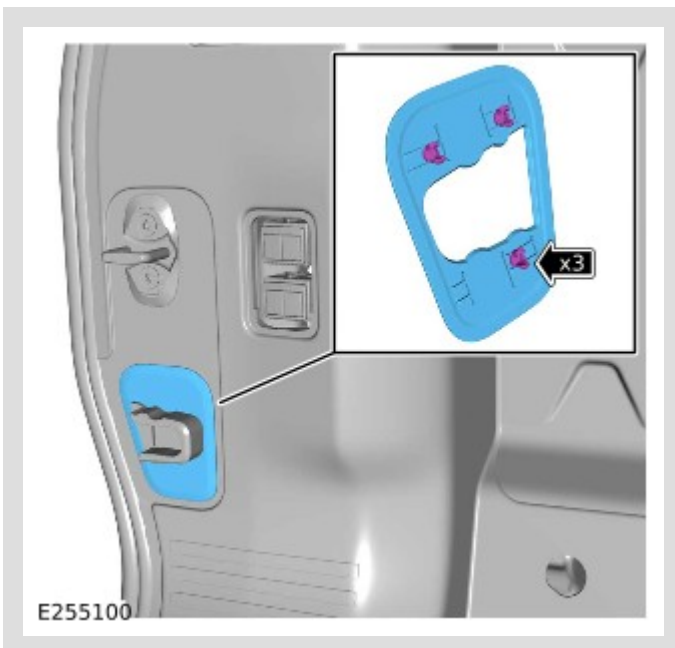
3.

- Release the 3 clips.
- Remove the access panel.

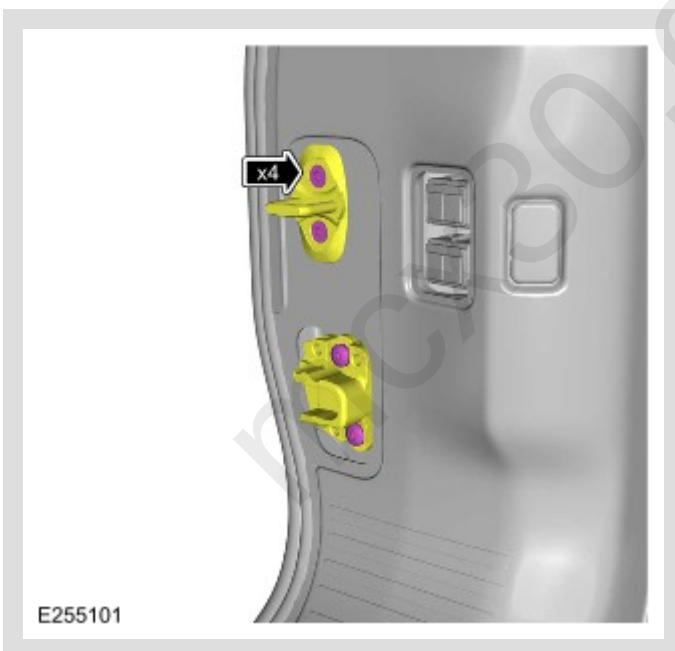
4.

- Loose but not fully remove tailgate striker 2 bolts.
- Loose but not fully remove the wedging guide 2 bolts.

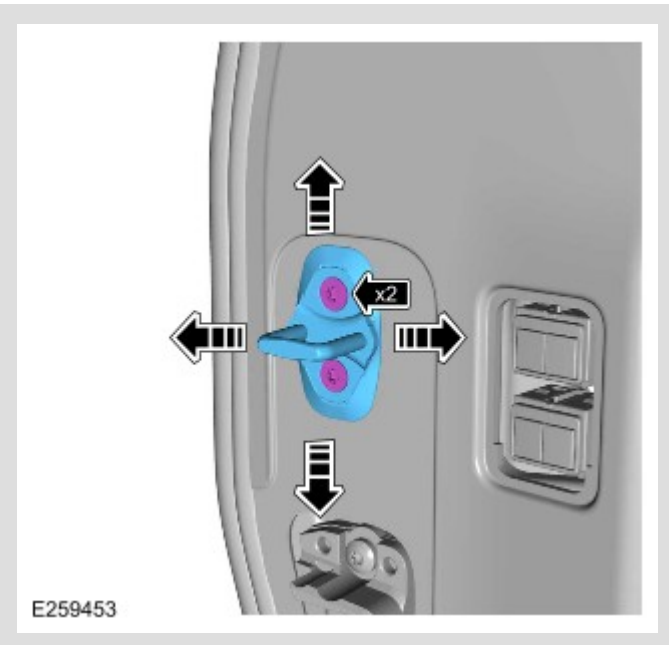
5.

Adjust the tailgate striker as illustrated.

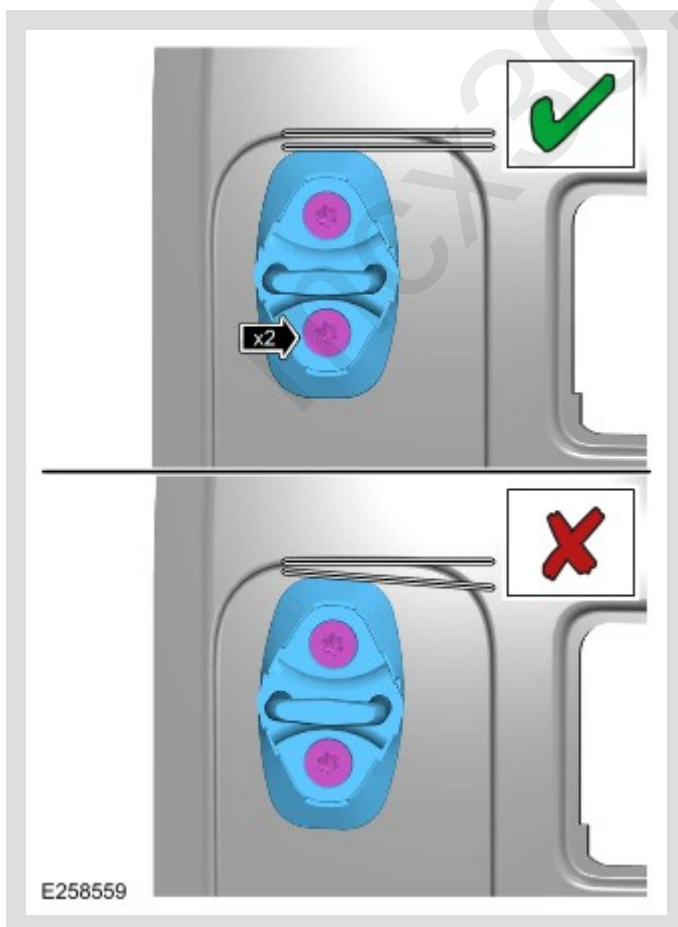
6.

Make sure the tailgate striker installed parallel.

Tighten the 2 bolts.

*Torque: 24Nm*

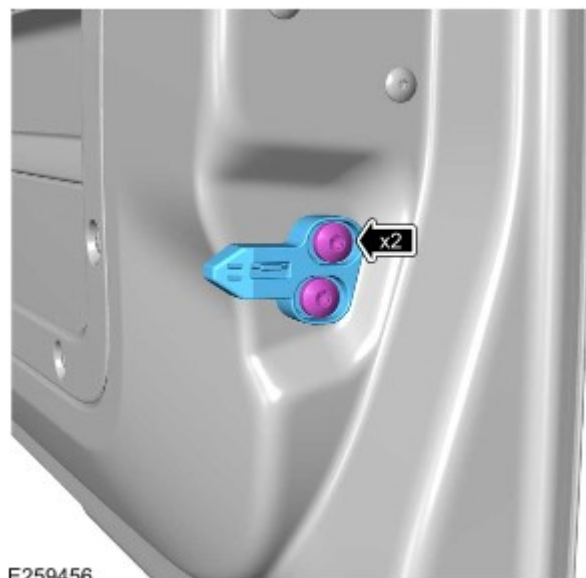
7.

1. Close the tailgate carefully with the closing motor.
2. Open the tailgate.
3. Tighten the 2 bolts.  
*Torque: 24Nm*

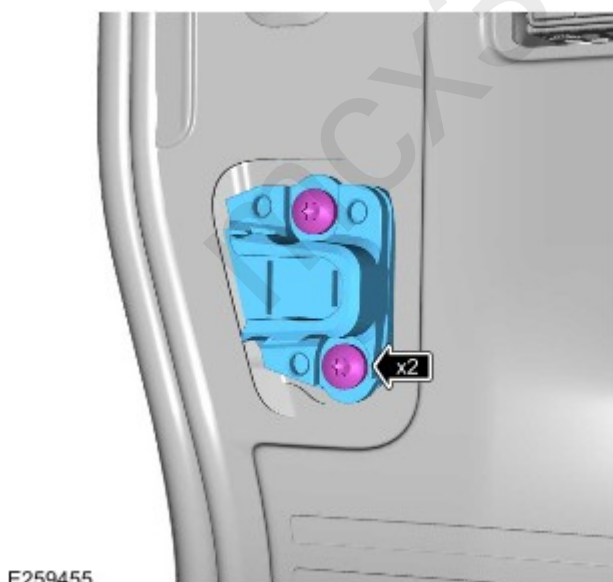
8.

Tighten the 2 bolts.  
*Torque: 24Nm*

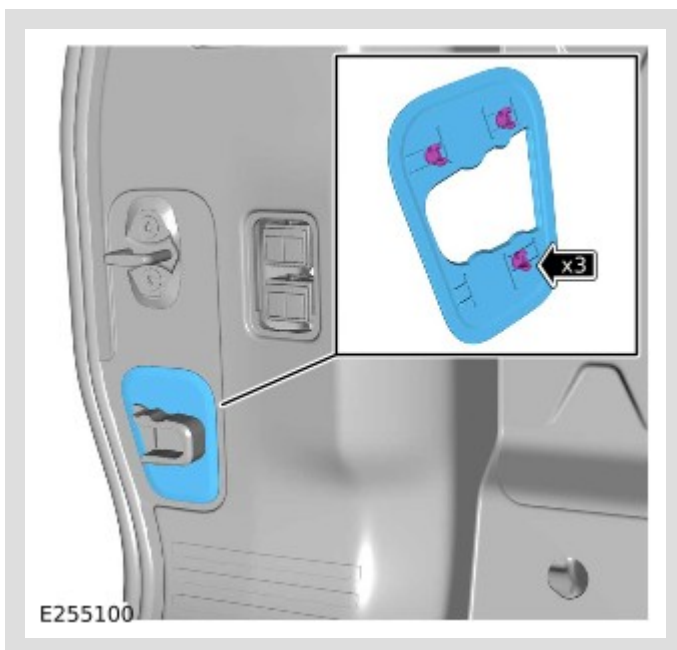
9.

Install the access panel.

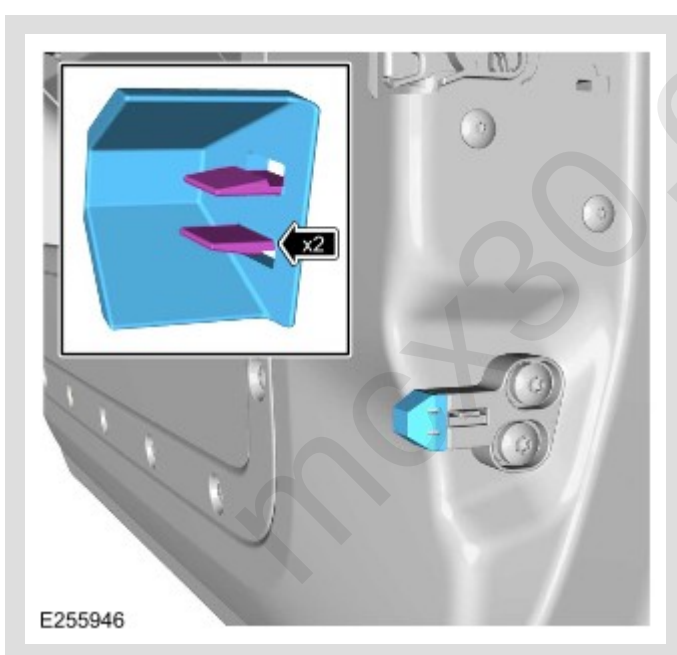
10.

Install the plastic cover to the wedge.
