PUBLISHED: 07-OCT-2019  
2020.0 DEFENDER (LE), 501-30

REAR END SHEET METAL REPAIRS

## TAILGATE OPENING PANEL LEFT SIDE - 110 (G2413838)

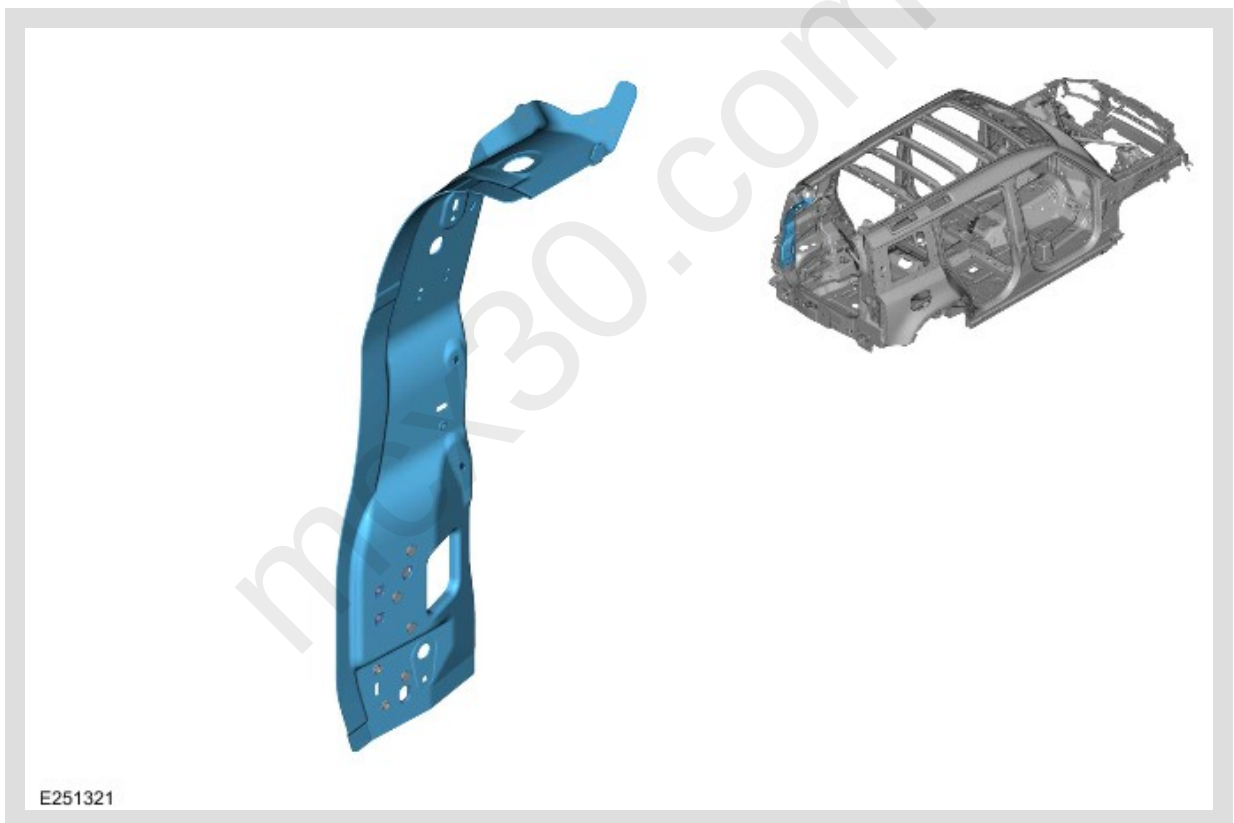
1.

The tailgate opening panel left side is serviced as indicated.

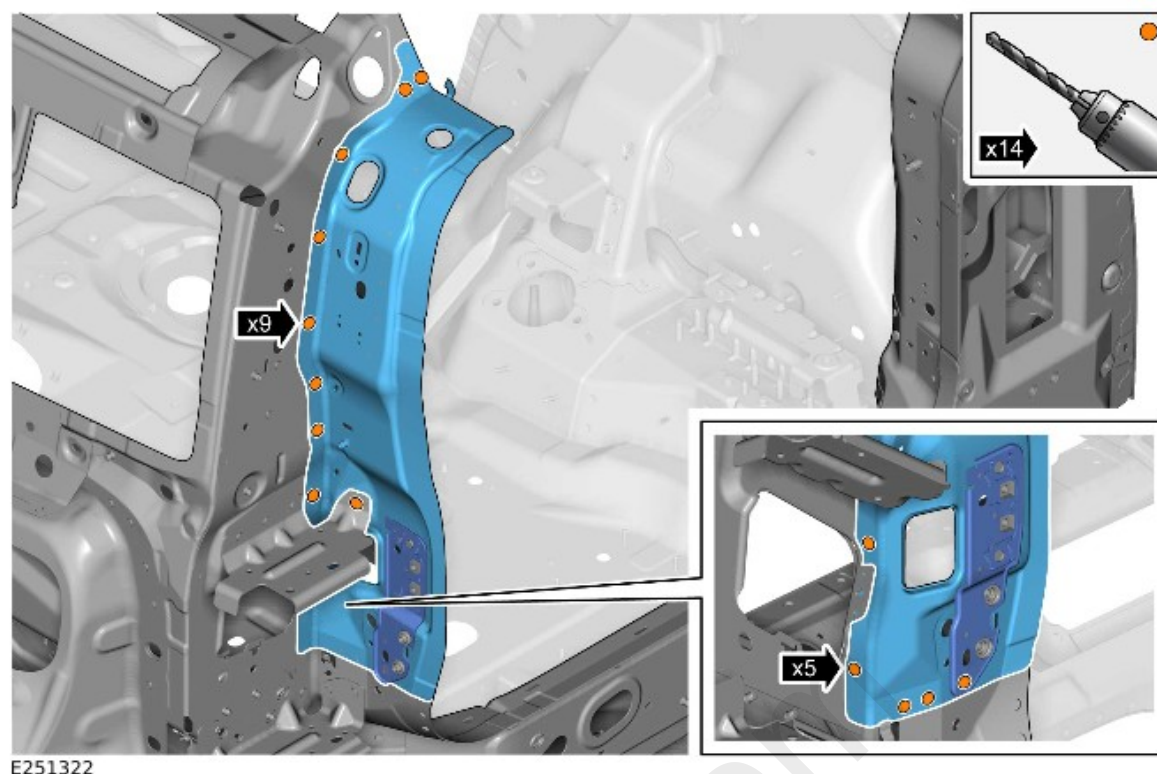
8.

Remove the self piercing rivets as indicated.

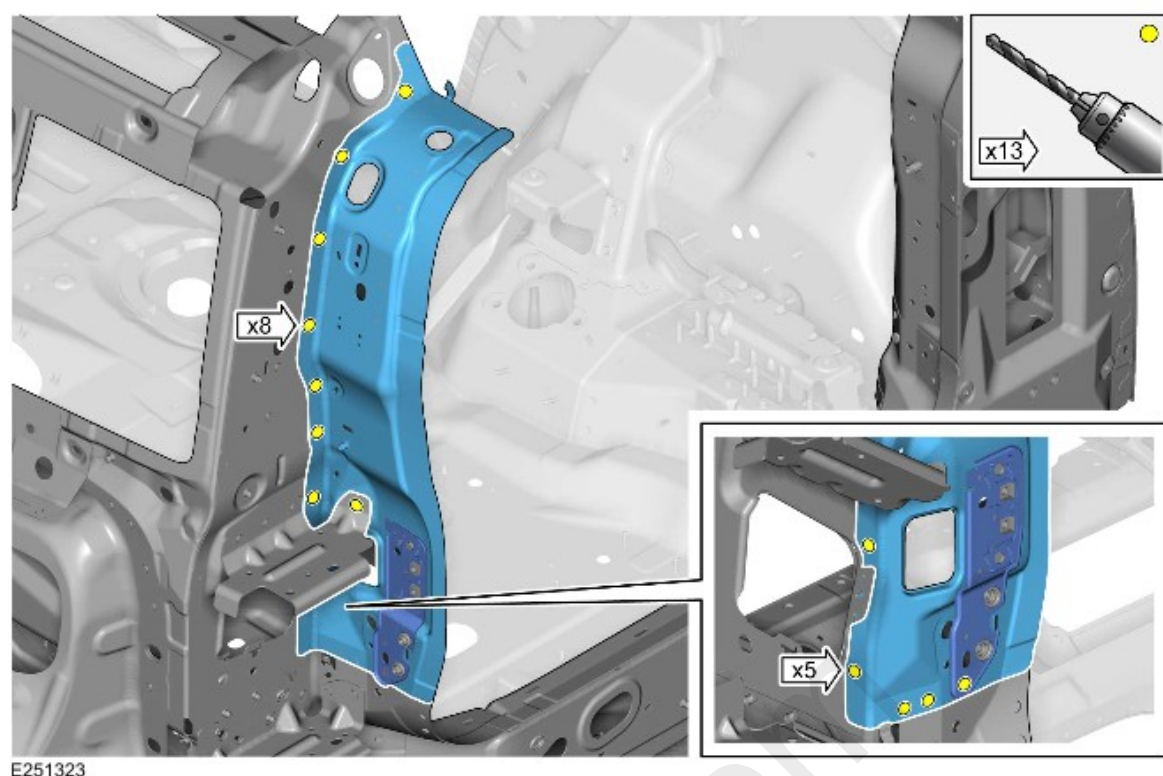
Drill holes where the Breakstem Fasteners (BSFs) are to be installed as indicated.

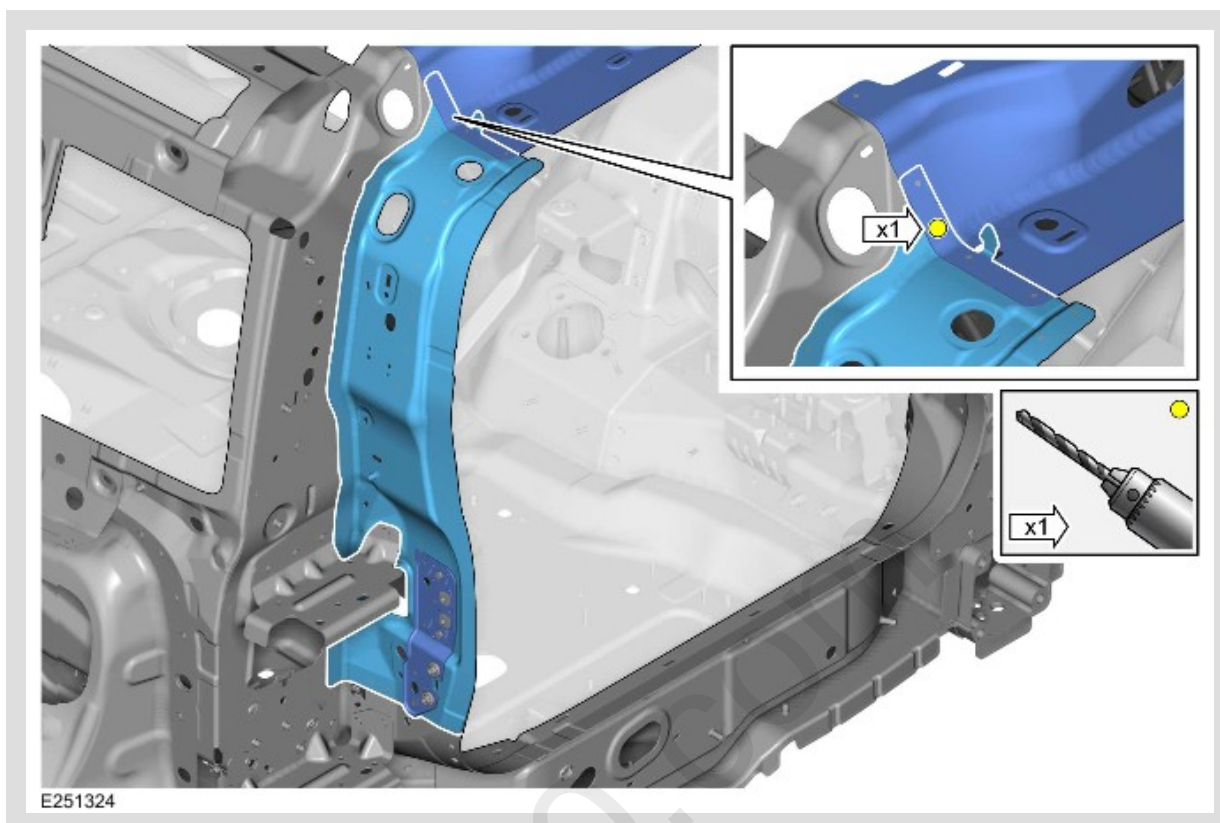
5.

When installing the tailgate opening panel left side in conjunction with the rear header panel lower.

Drill a hole where the BSF is to be installed as indicated.

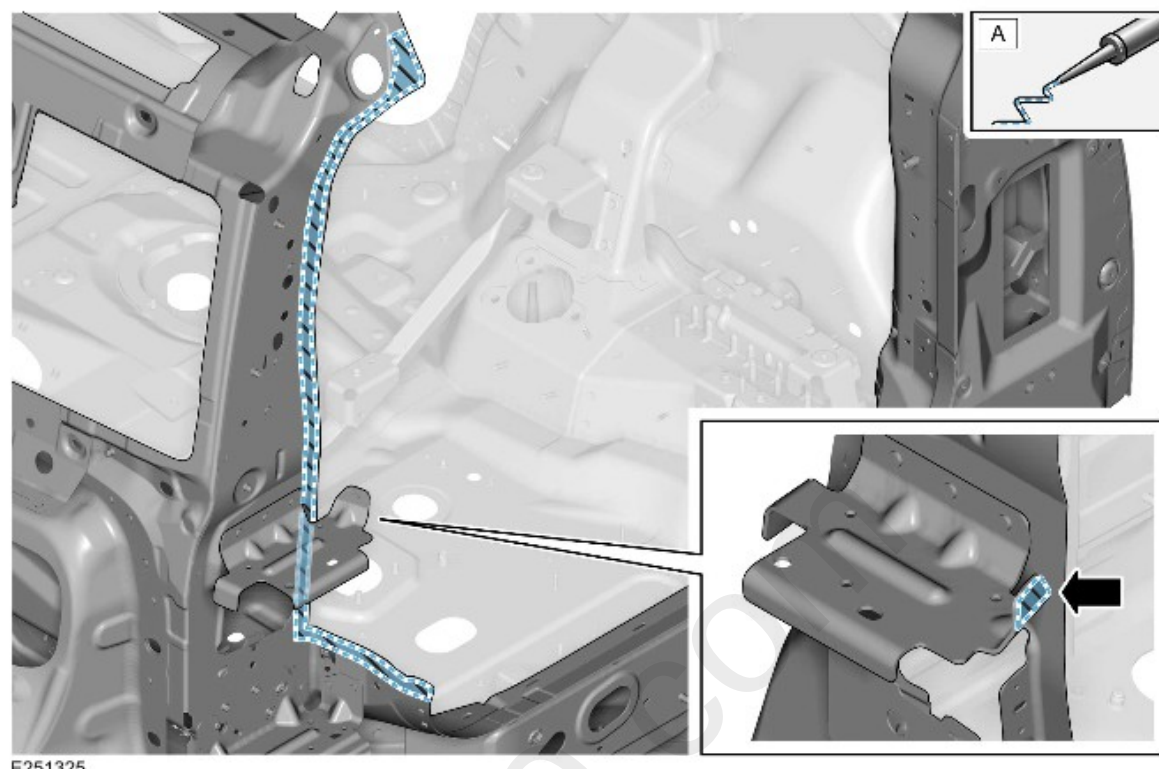
9.

Make sure a continuous bead of adhesive surrounds fixing holes.

Apply a 5 mm zig zag bead of the Jaguar Land Rover (JLR) recommended bonding material as indicated.

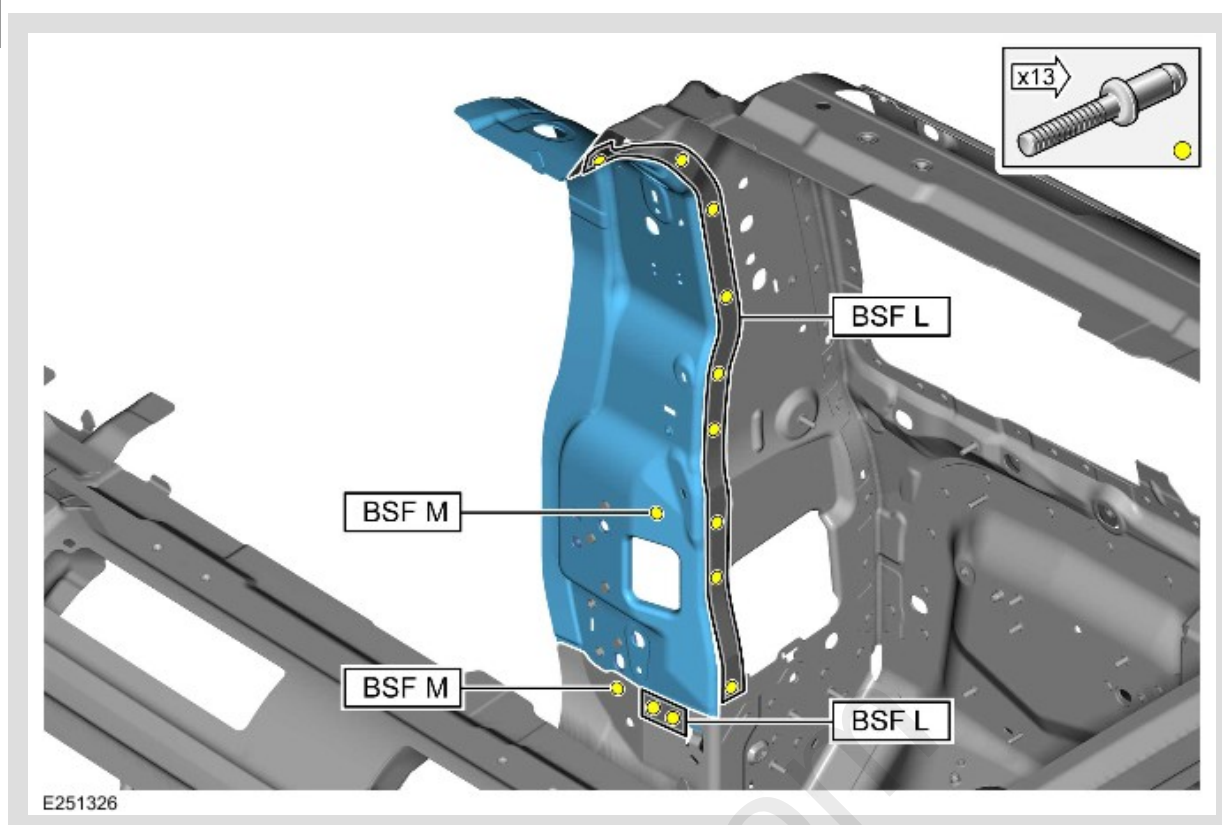
Install the BSFs as indicated.

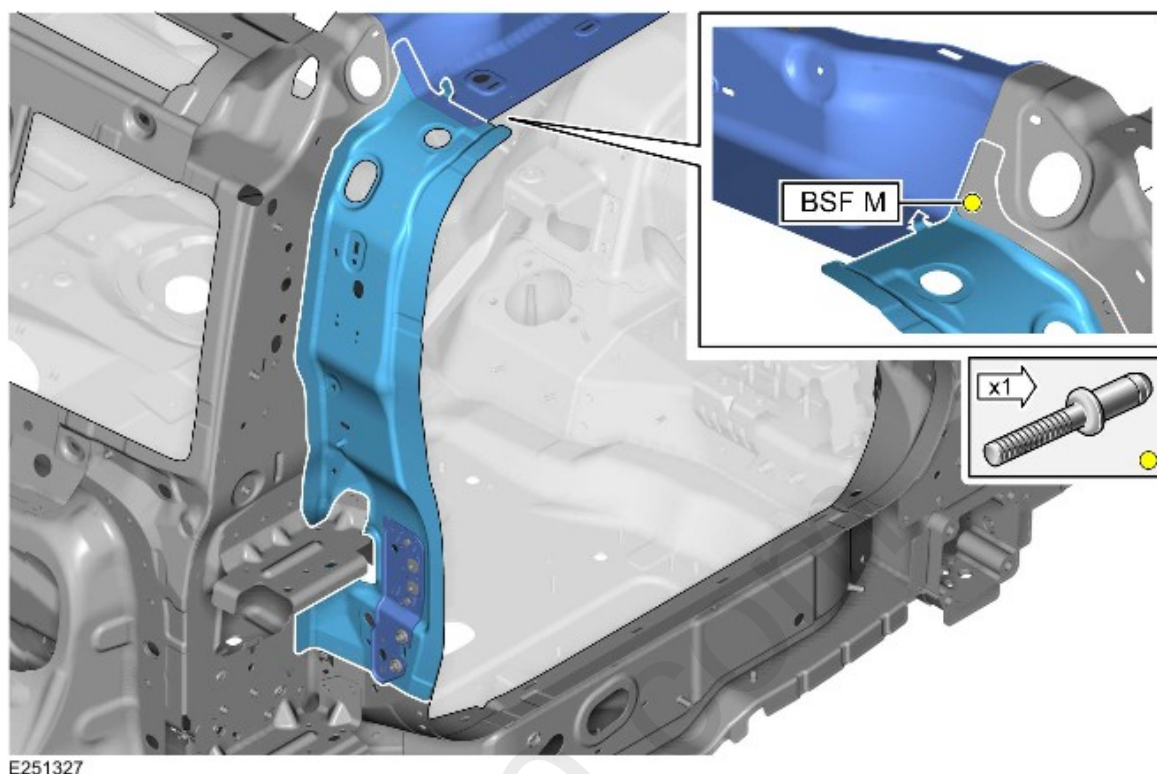
12.

When installing the tailgate opening panel left side in conjunction with the rear header panel lower.

Install the BSF as indicated.
