PUBLISHED: 12-FEB-2020  
2020.0 DEFENDER (LE), 501-30

REAR END SHEET METAL REPAIRS

## TAILGATE REINFORCEMENT LEFT SIDE - 90 (G2452702)

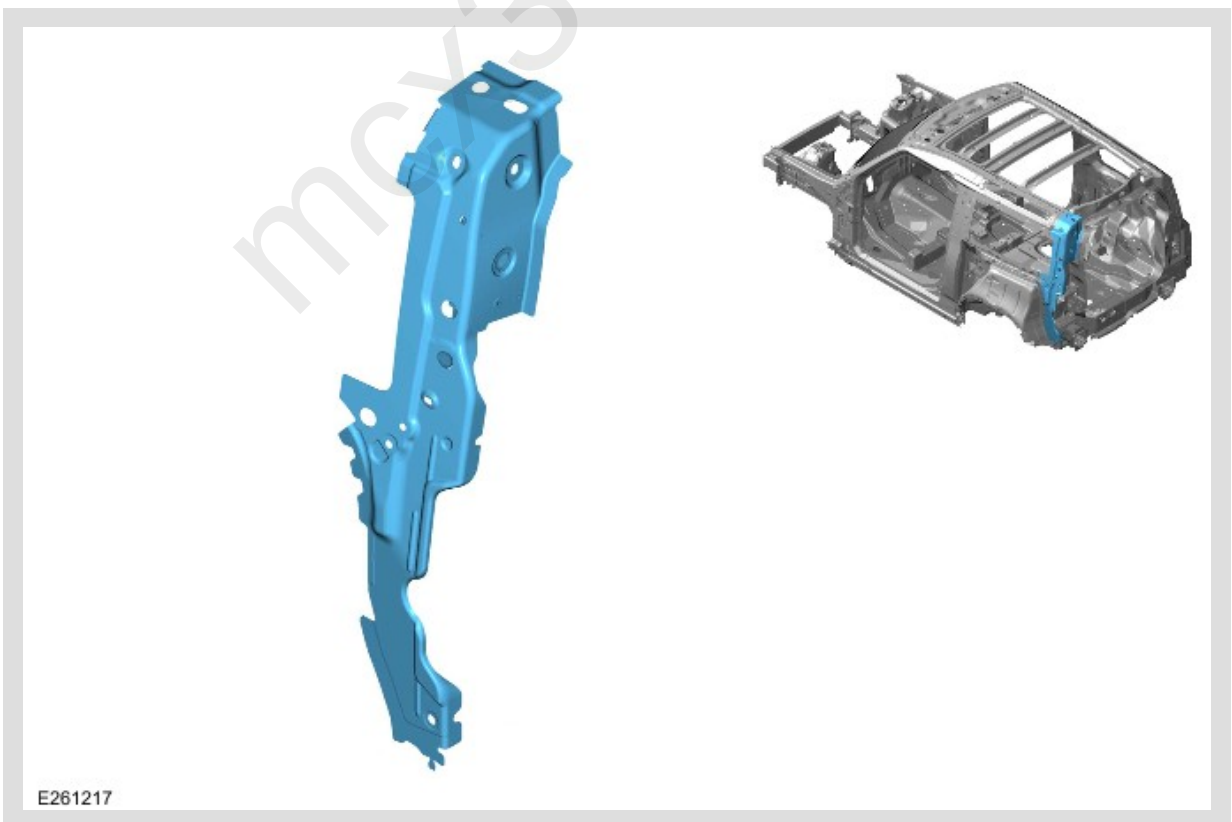
1.

The tailgate reinforcement left side is serviced as indicated.

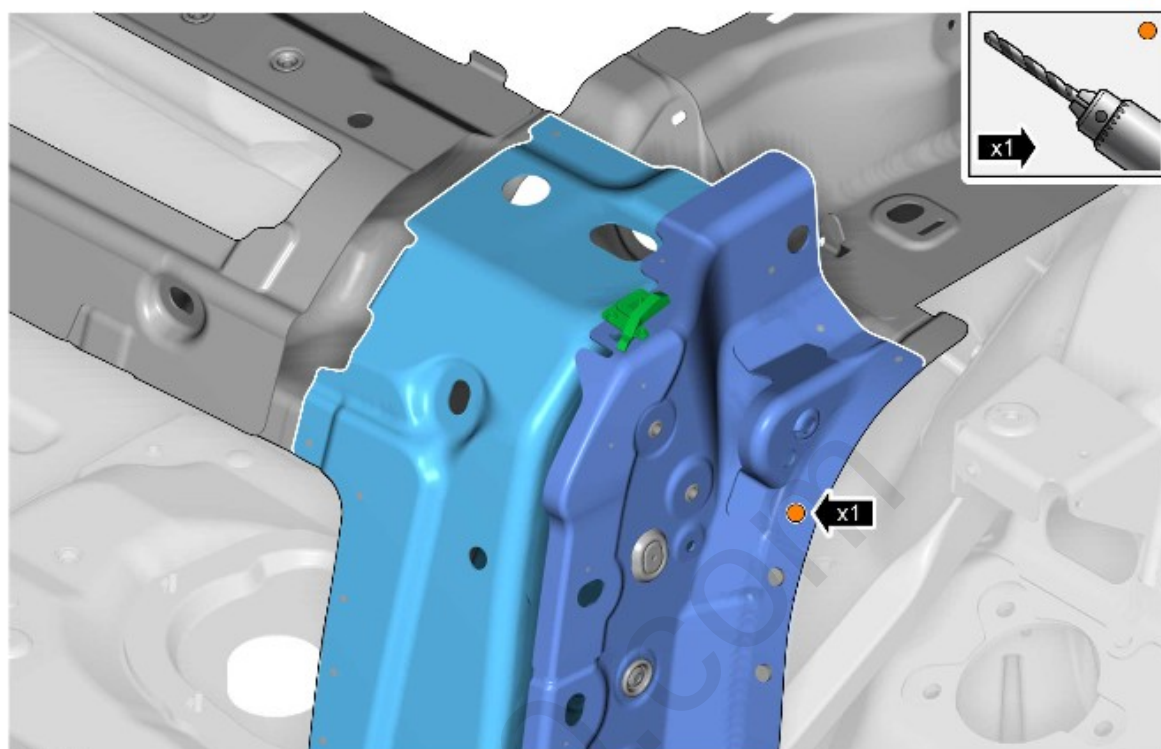
E250284

When installing the tailgate reinforcement left side in conjunction with the outer tail lamp outer panel left side.

Remove the Self Piercing Rivet (SPR) as indicated.

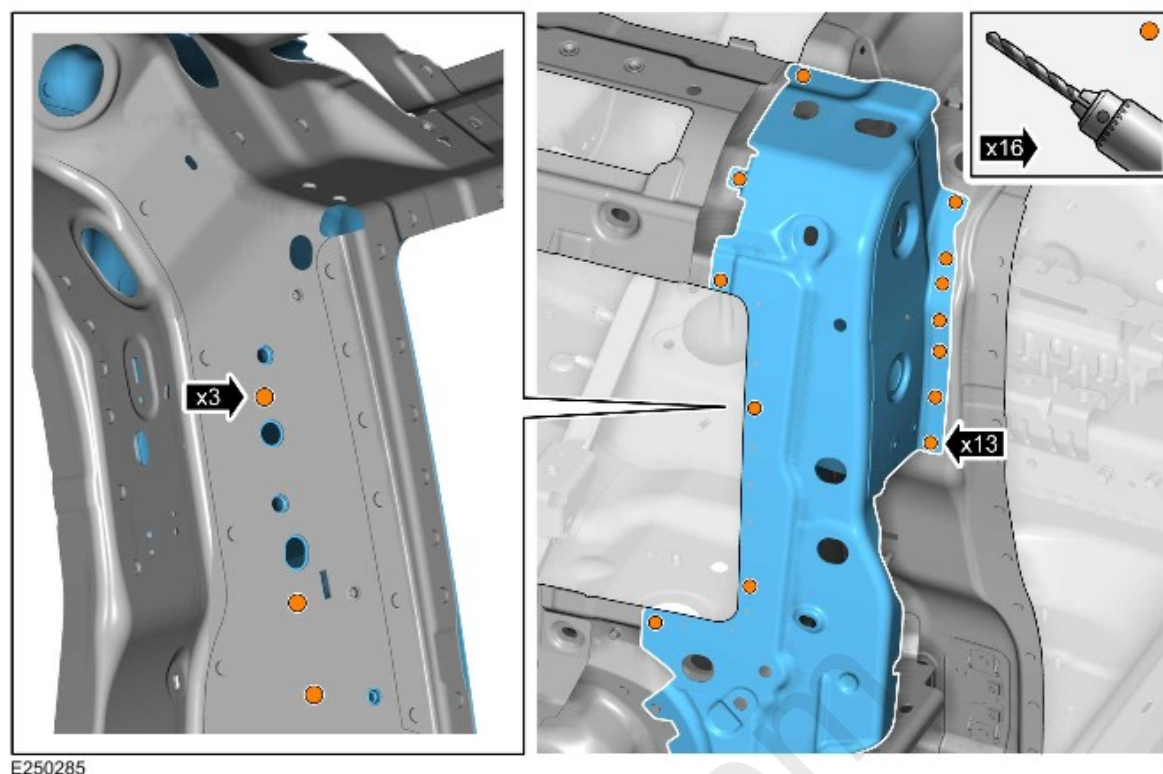
12.

Remove the SPRs as indicated.

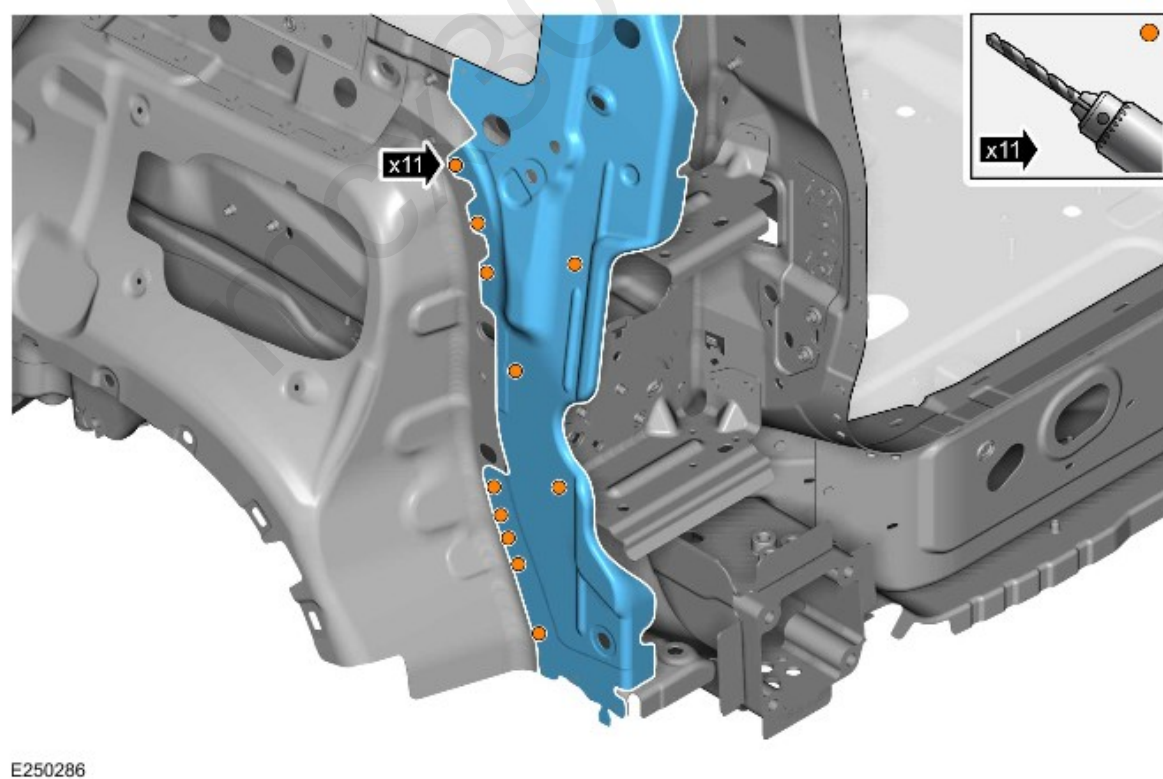
13.

Remove the SPRs as indicated.

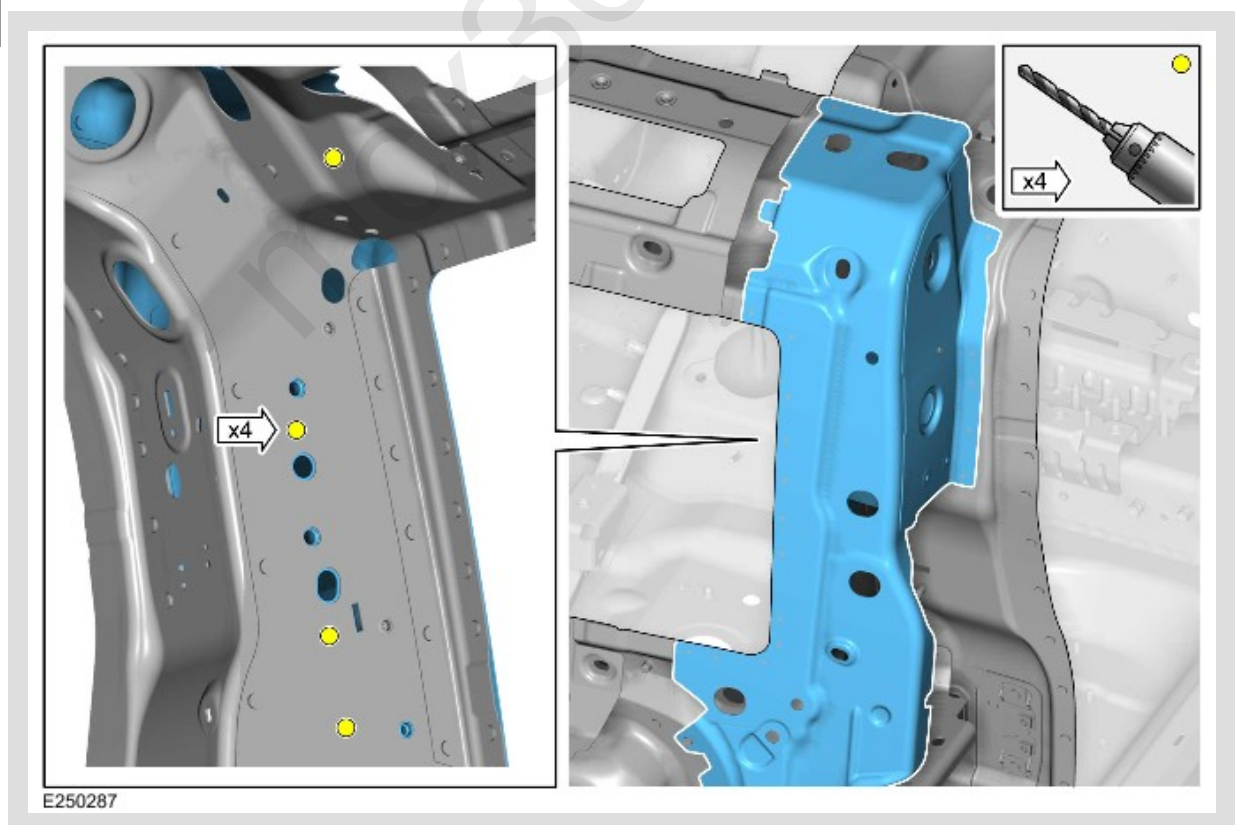
4.

Drill holes where the Breakstem Fasteners (BSFs) are to be installed as indicated.

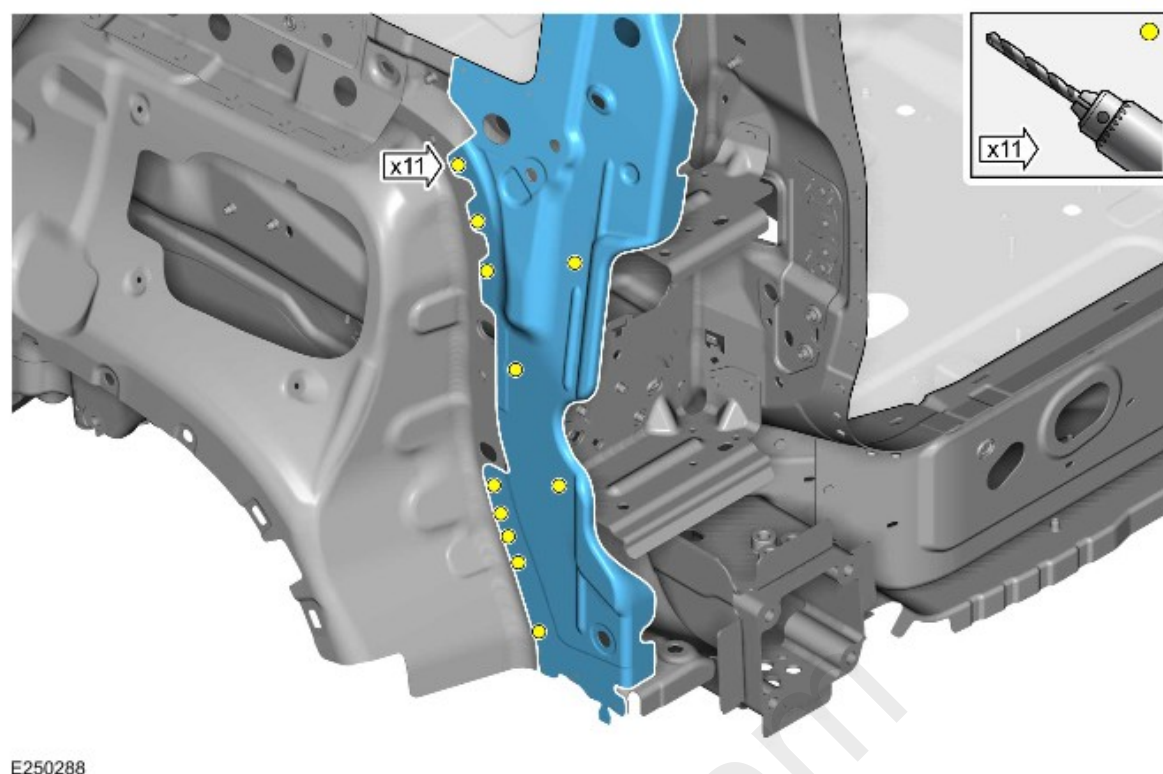
5.

Drill holes where the BSFs are to be installed as indicated.

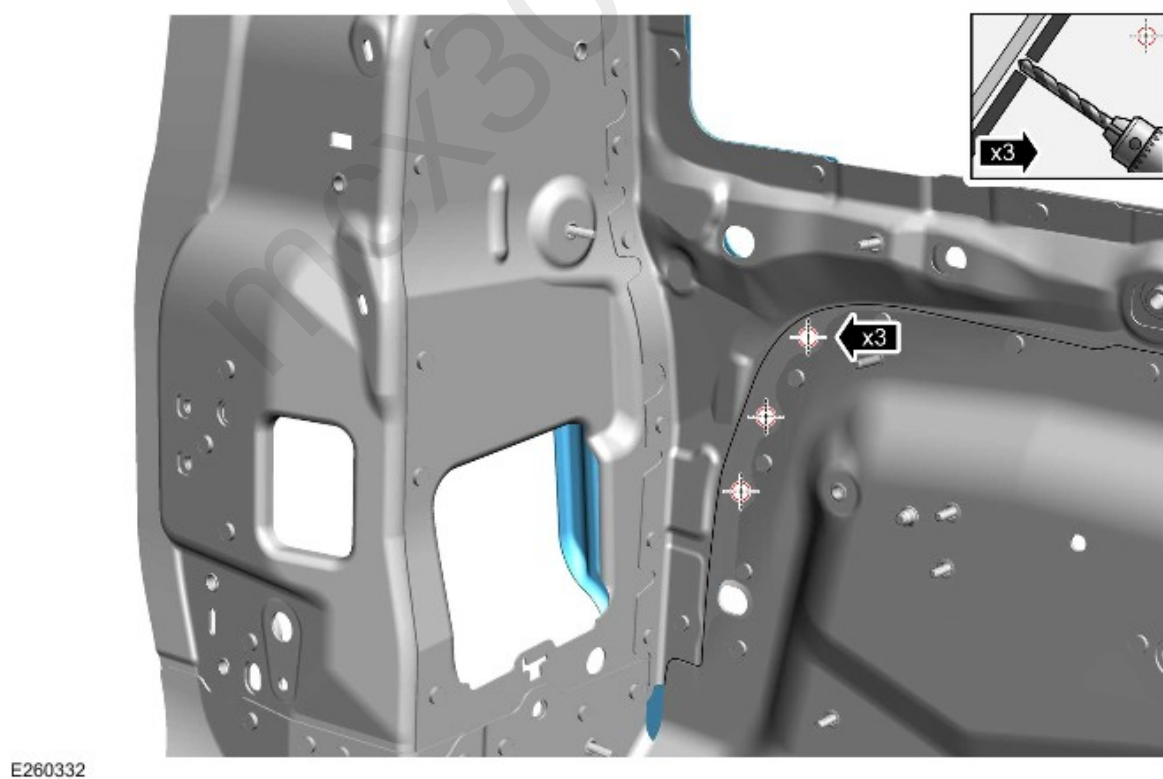
6.

Drill 12 mm clearance holes for BSF access as indicated.

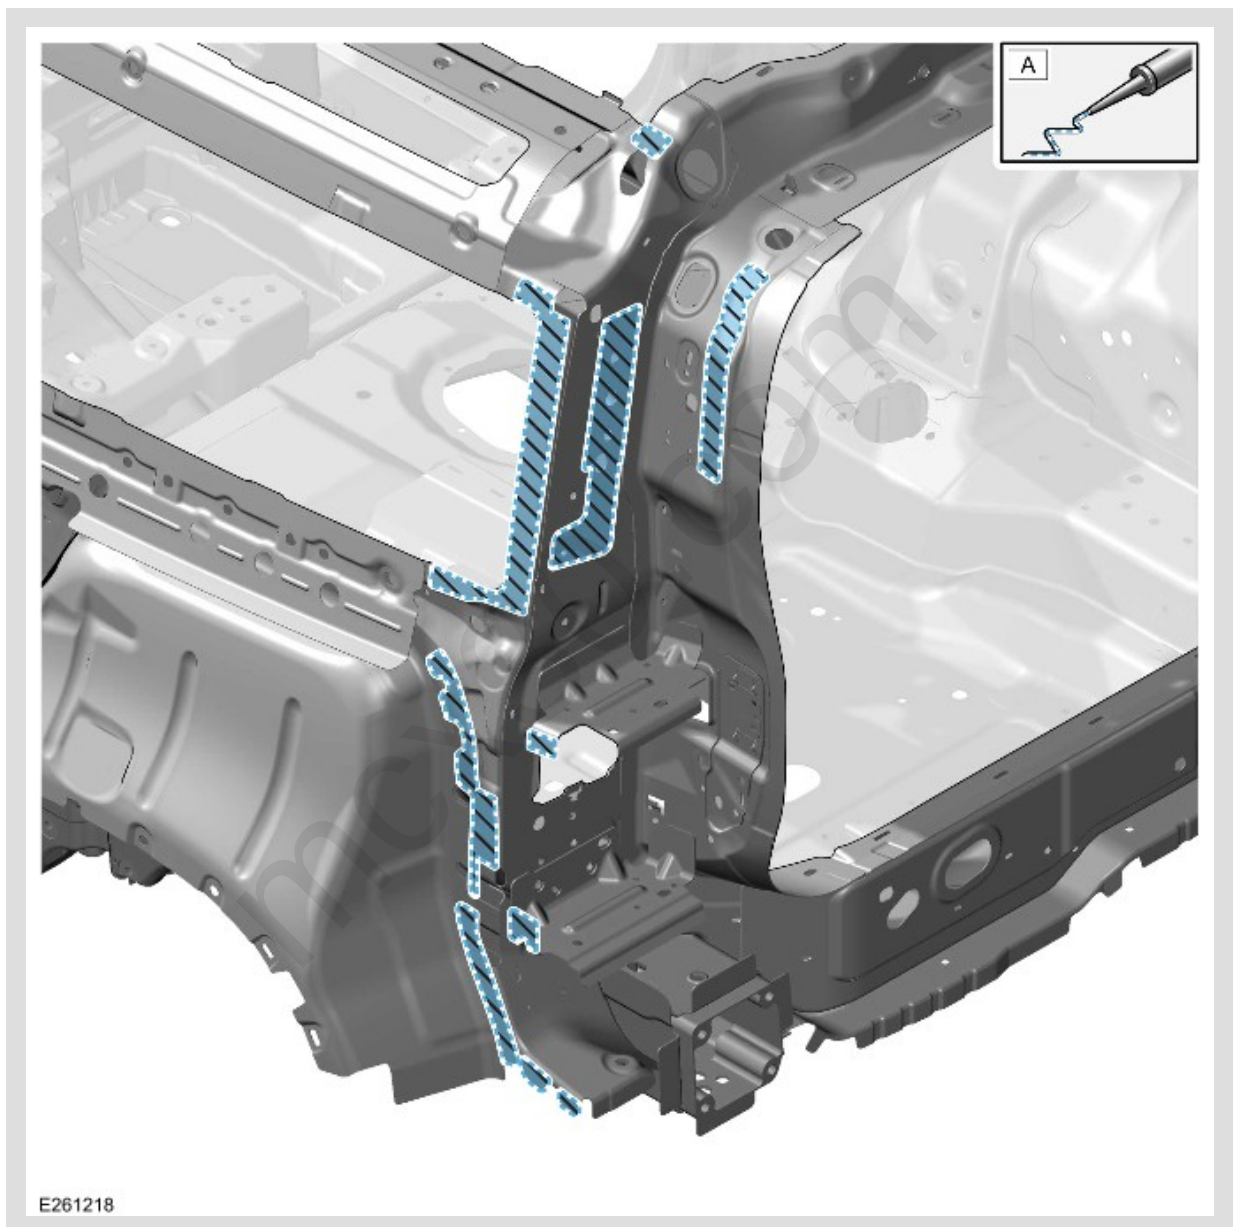
Make sure a continuous bead of adhesive surrounds the fixing holes.

Apply a 5 mm zig zag bead of the JLR recommended bonding material as indicated.

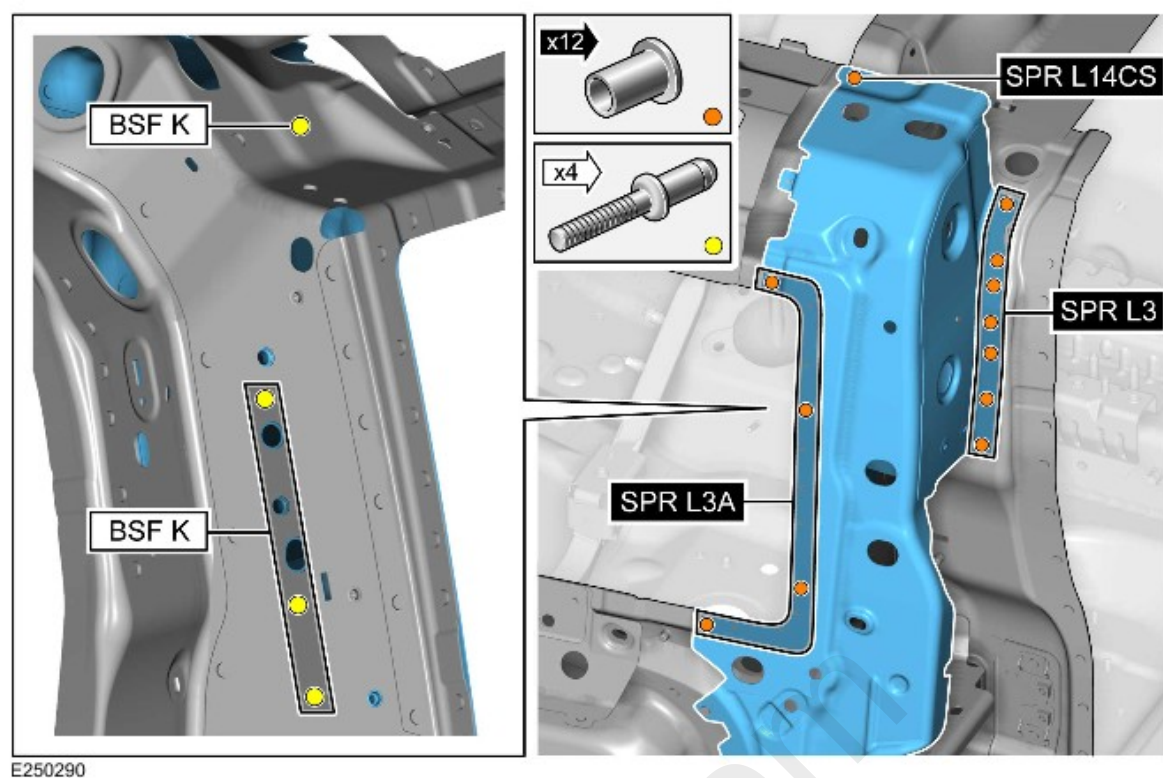
12.

Install the BSFs and Self Piercing Rivets (SPRs) as indicated.

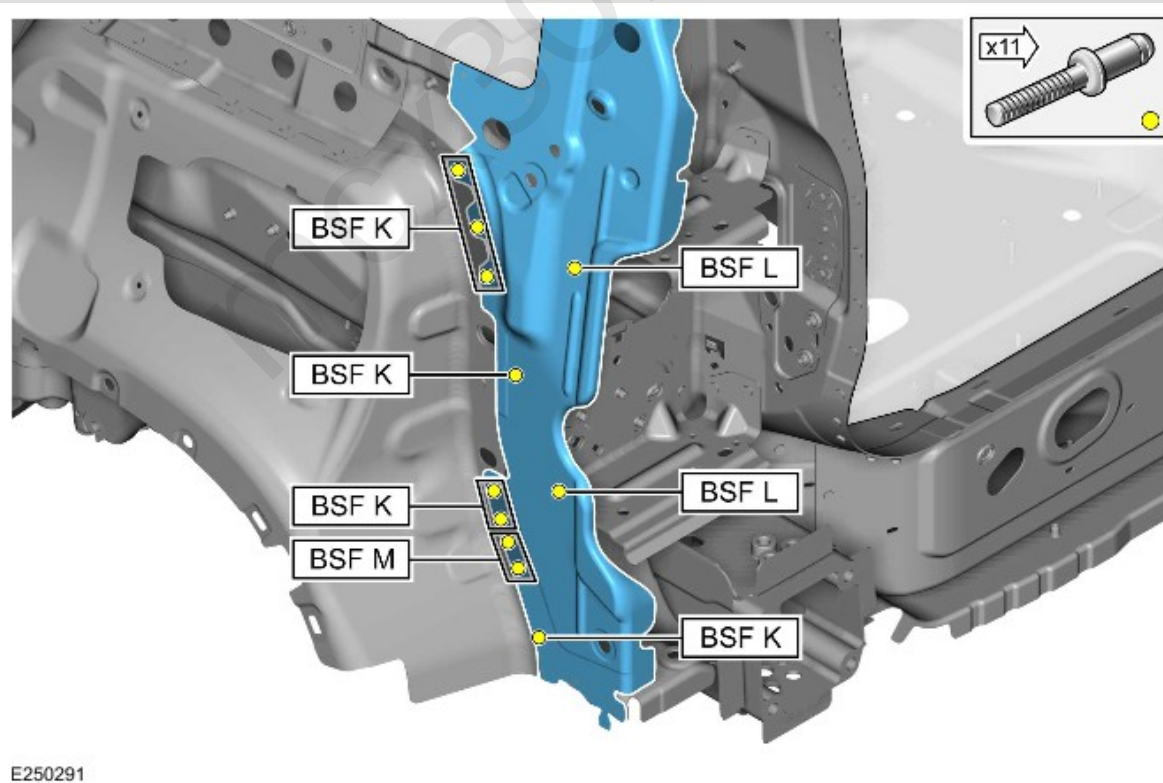
13.

Install the BSFs as indicated.

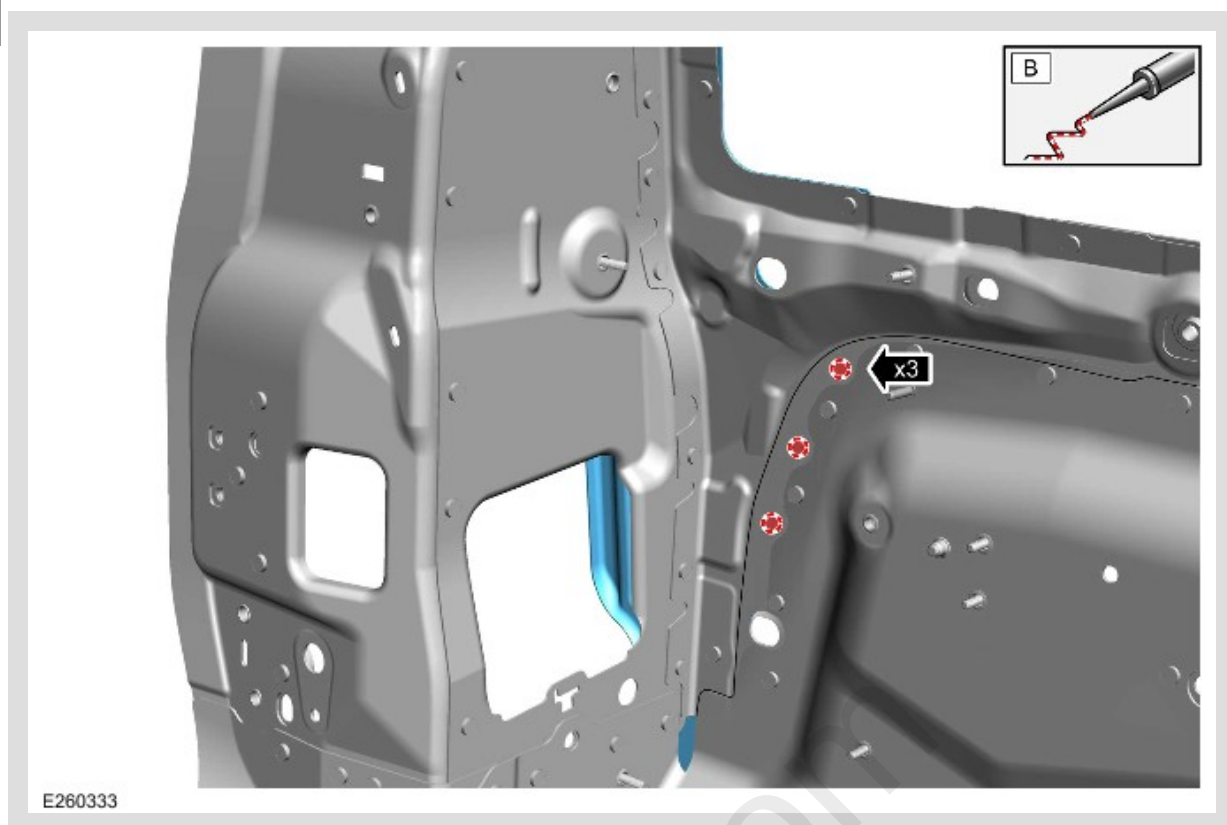
Apply a JLR recommended sealant to the BSF clearance holes as indicated.

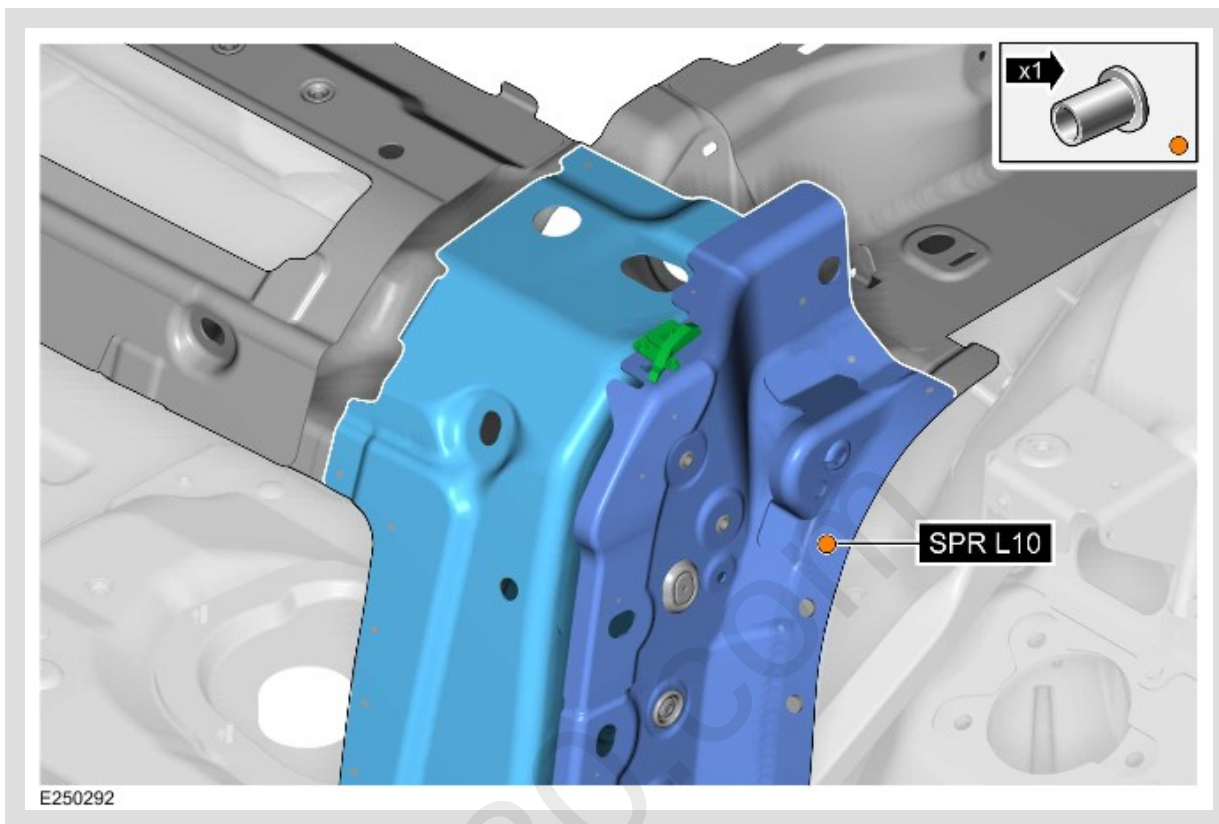
15.

When installing the tailgate reinforcement left side in conjunction with the outer tail lamp outer panel left side.

Install the SPR as indicated.
