# 2022 CHEVROLET CORVETTE SERVICE MANUAL

## Front Floor Console Applique Replacement - Left Side

### Removal Procedure

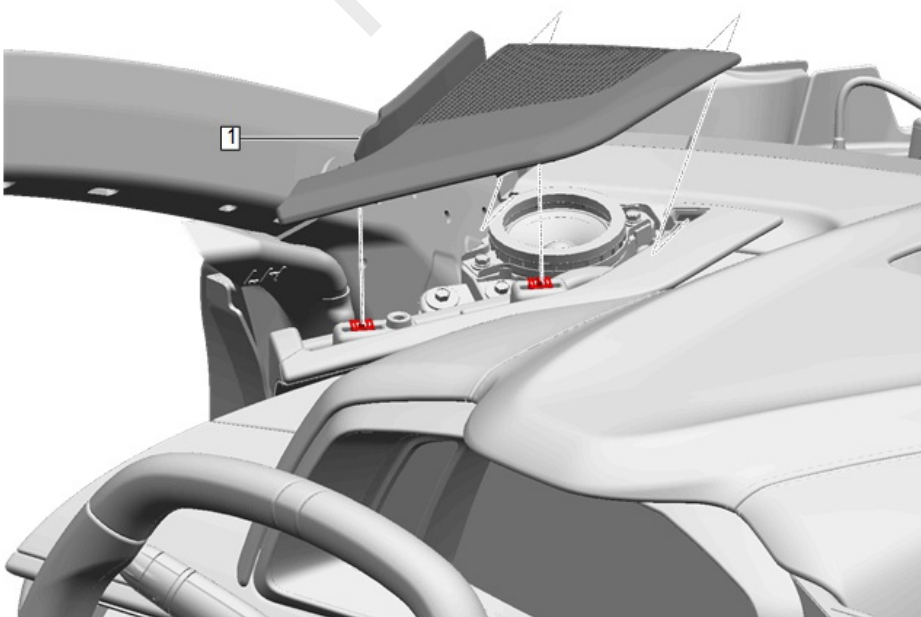
5. Remove the left instrument panel trim pad radio speaker opening cover (1).Instrument Panel Trim Pad Radio Speaker Opening Cover Replacement

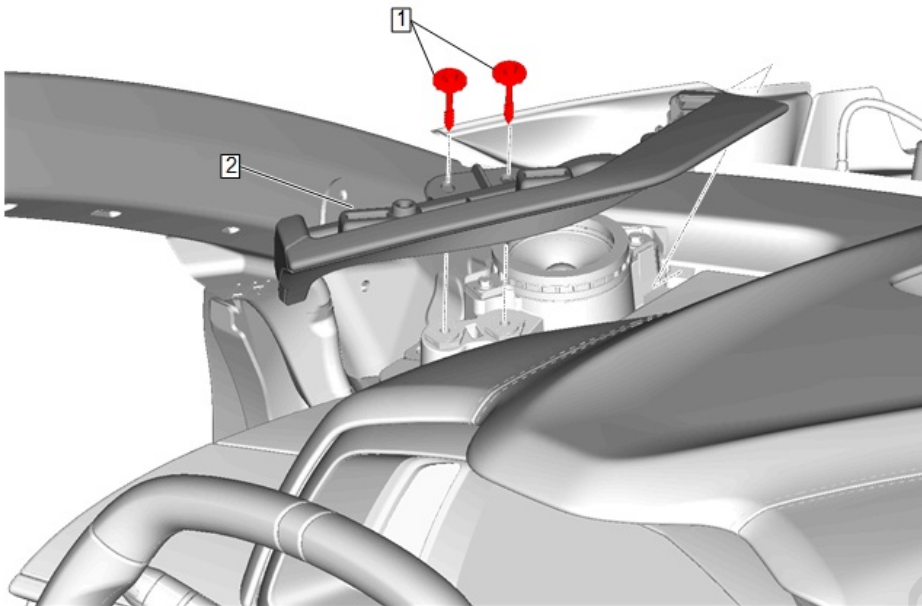
7. Remove the left radio front speaker grille molding (2).Radio Front Speaker Grille Molding Replacement

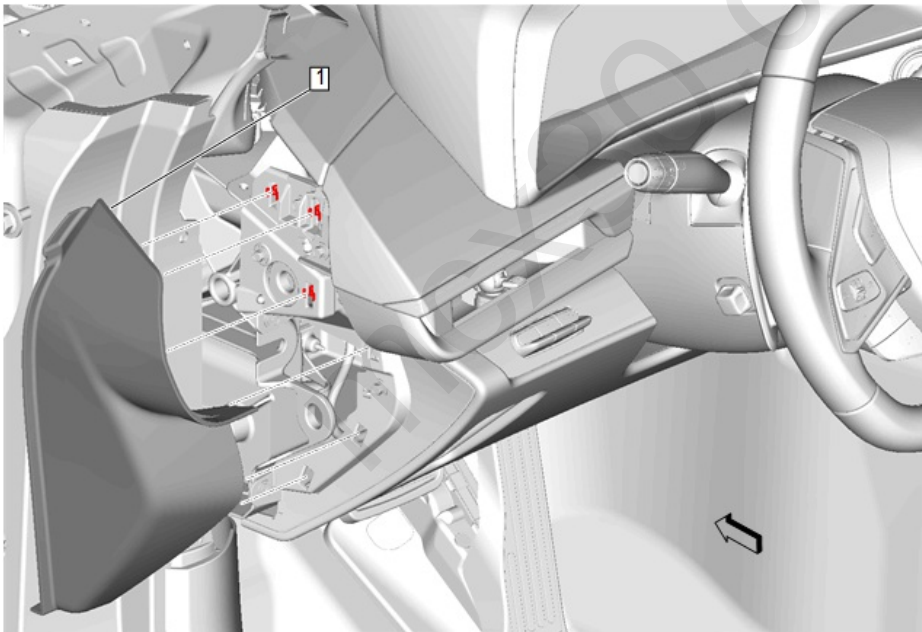
9. Remove the left instrument panel outer trim cover (1).Instrument Panel Outer Trim Cover Replacement

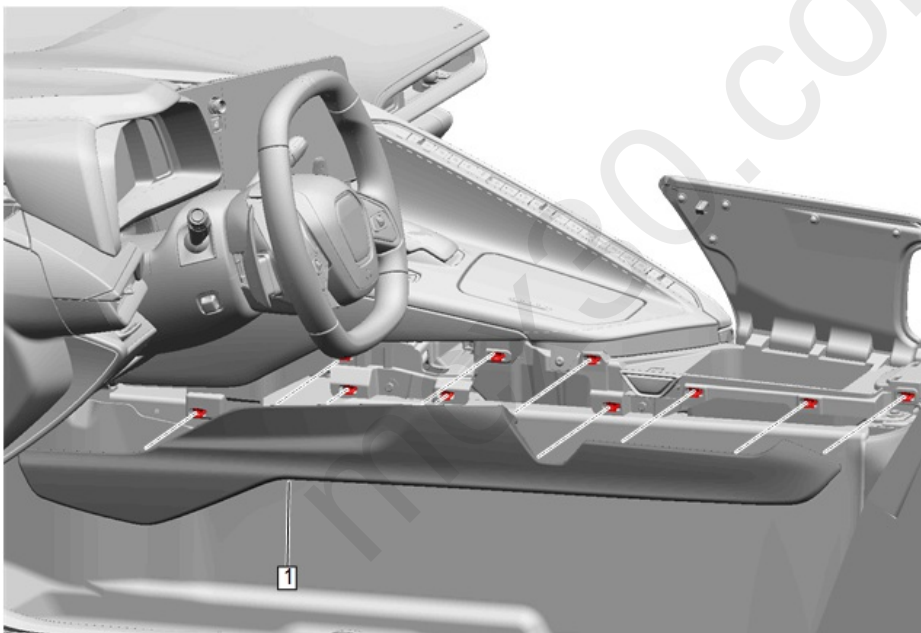
13. Front Floor Rear Console Side Trim Panel - Left Side (1) >> Remove - Front Floor Rear Console Side Trim Panel Replacement - Left Side

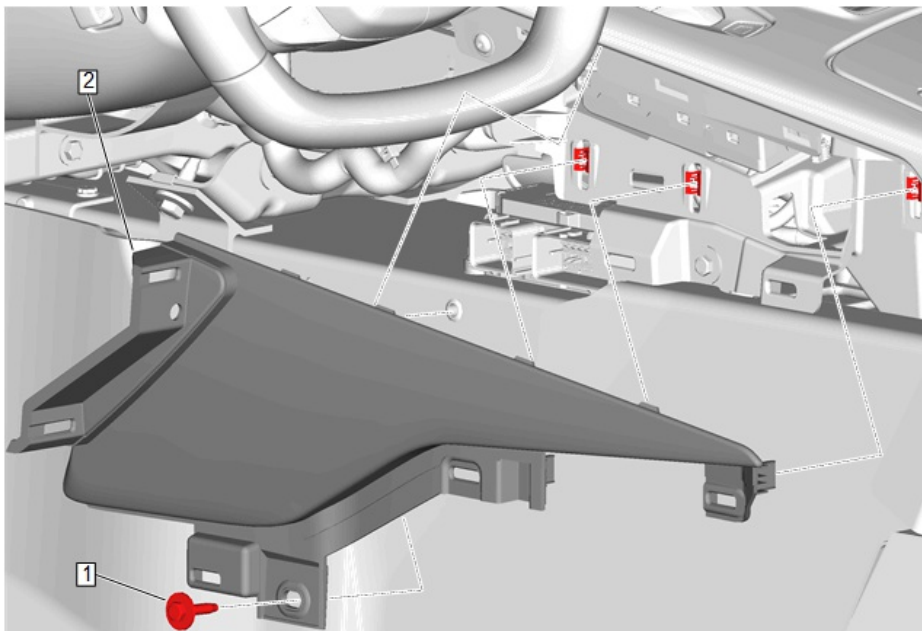
14. [Click here for full size](#)
15. Front Floor Console Applique Bolt (1) >>> Remove
16. Front Floor Console Applique - Left Side (2) >>> Remove

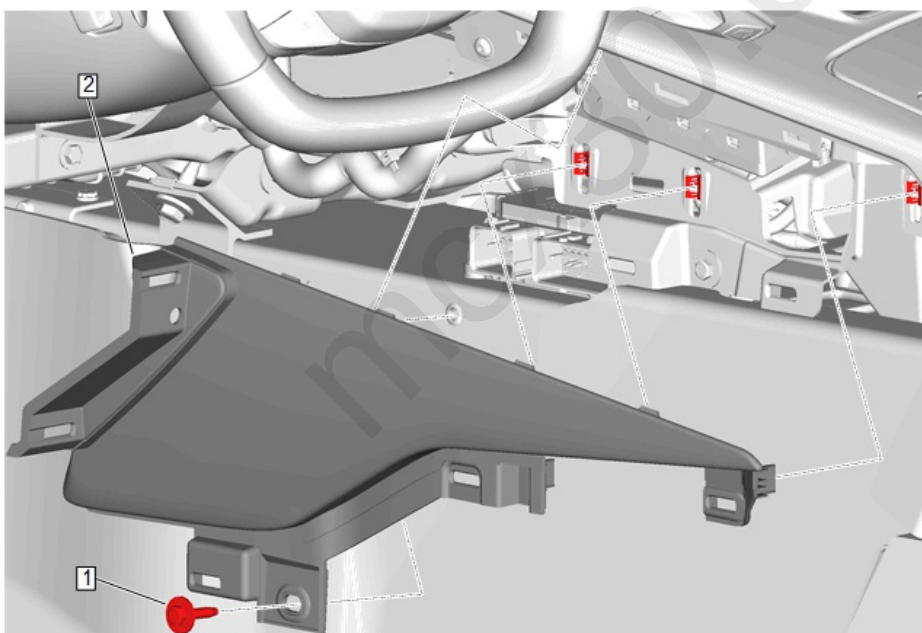
1. [Click here for full size](#)
2. Front Floor Console Applique - Left Side (2) >>> Install
3. Caution:  
Refer to Fastener Caution.
4. Front Floor Console Applique Bolt (1) >>> Install and tighten 7>N-m (62 lb in)

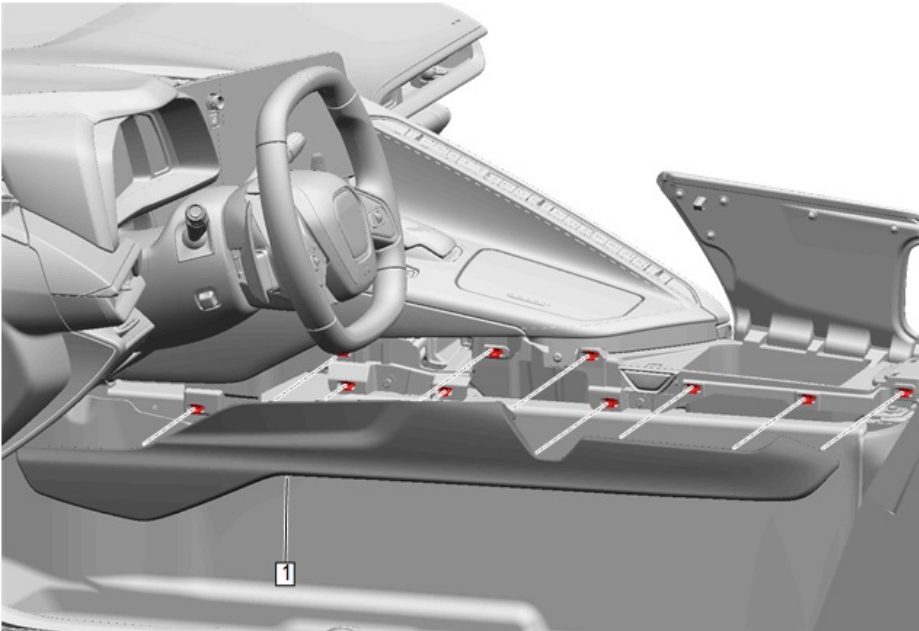
6. Front Floor Rear Console Side Trim Panel - Left Side (1) >> Install - Front Floor Rear Console Side Trim Panel Replacement - Left Side

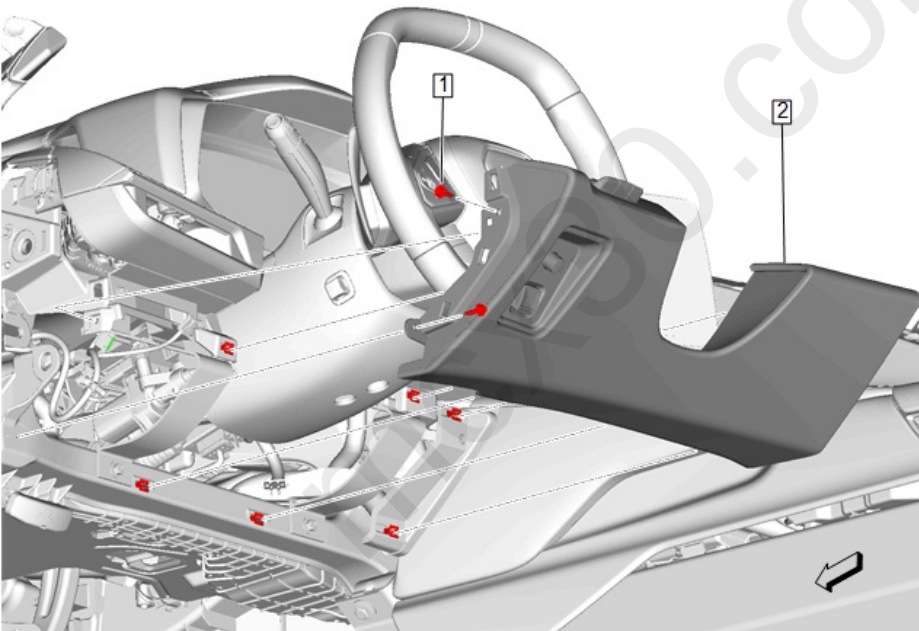
8. Instrument Panel Knee Bolster (2) >> Install - Instrument Panel Knee Bolster Replacement

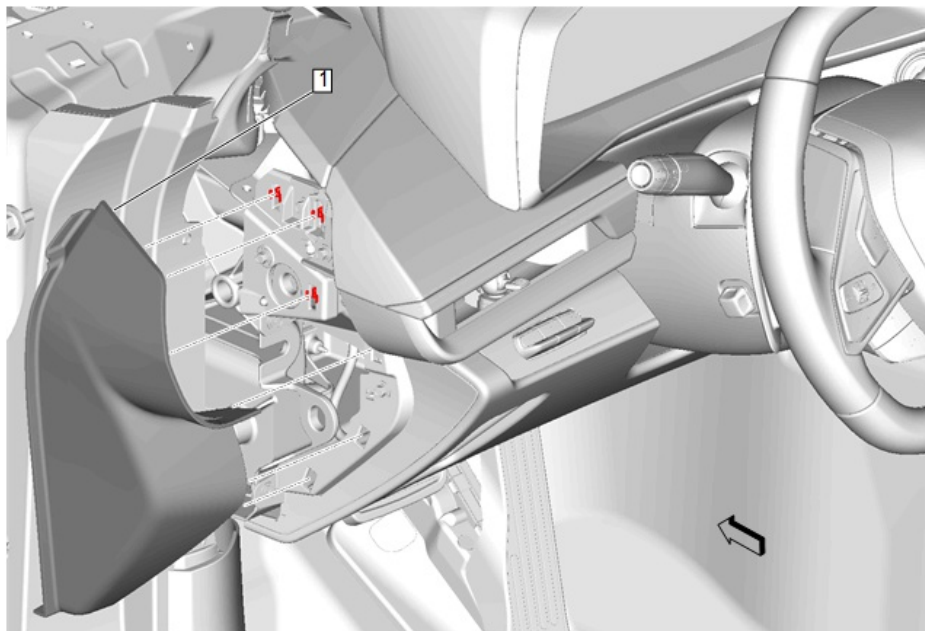
10. Install the left instrument panel outer trim cover (1).Instrument Panel Outer Trim Cover Replacement

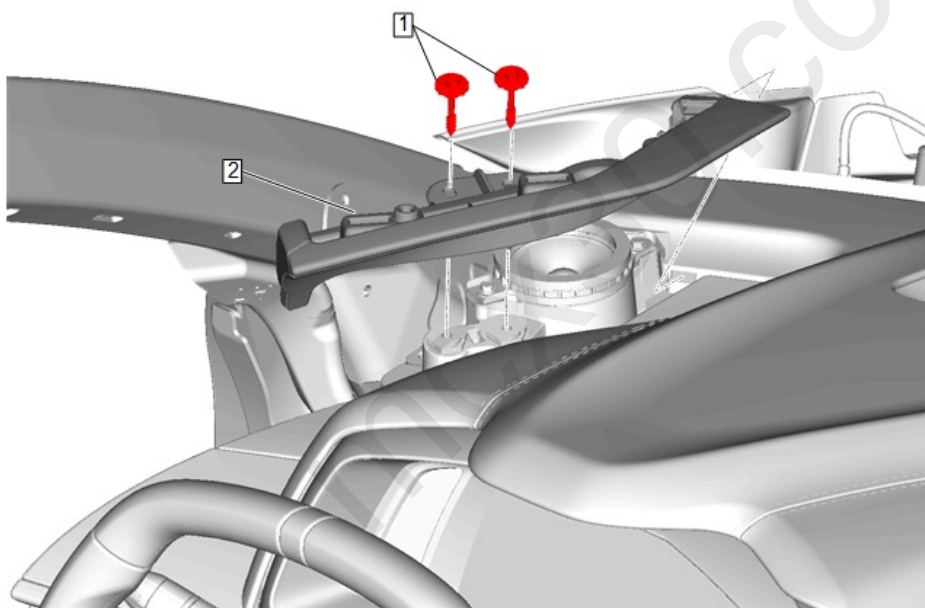
12. Install the left radio front speaker grille molding (2).Radio Front Speaker Grille Molding Replacement

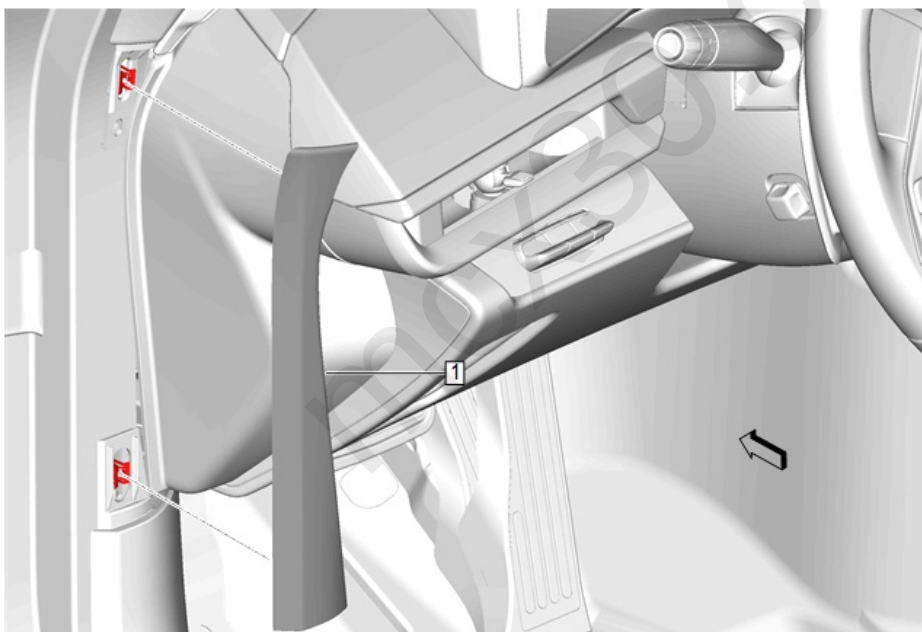
16. [Click here for full size](#)
17. Install the left body hinge pillar garnish molding (1).Body Hinge Pillar Garnish Molding Replacement
