# 2022 CHEVROLET CORVETTE SERVICE MANUAL

**Front Floor Rear Console Side Trim Panel Replacement - Left Side**

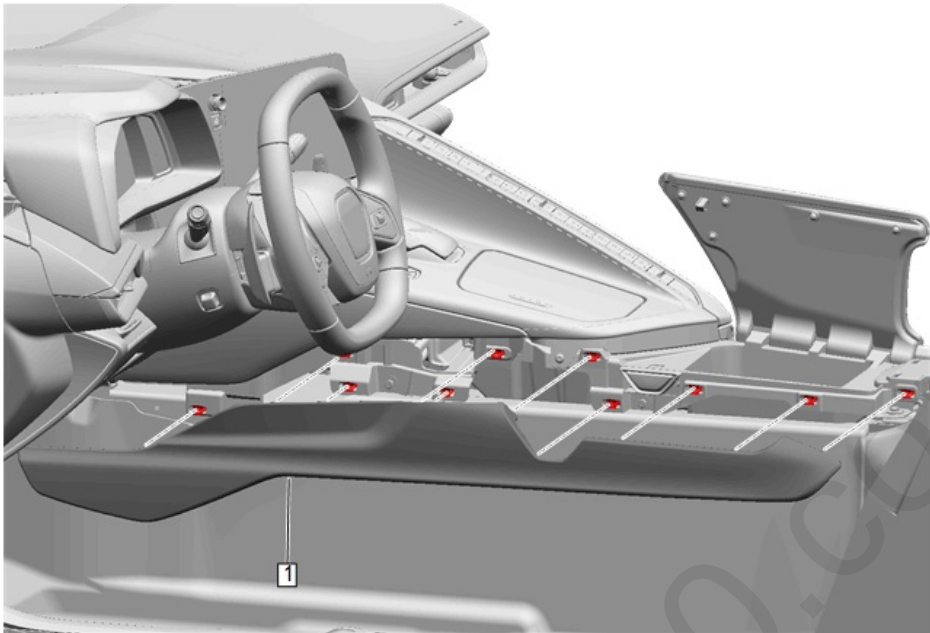
| Callout | Component Name |
|---|---|
| 1 | <p>Front Floor Rear Console Side Trim Panel - Left Side</p> <p>Note:</p> <p>Use care not to bend or deform the panel when removing.</p> <p>Procedure</p> <ol style="list-style-type: none"><li>1. Open the armrest cover.</li><li>2. Starting at the front and working your way back, disengage the retainers using a flat-bladed plastic tool.</li></ol> |
