# 2022 CHEVROLET CORVETTE SERVICE MANUAL

## Instrument Panel Compartment Replacement

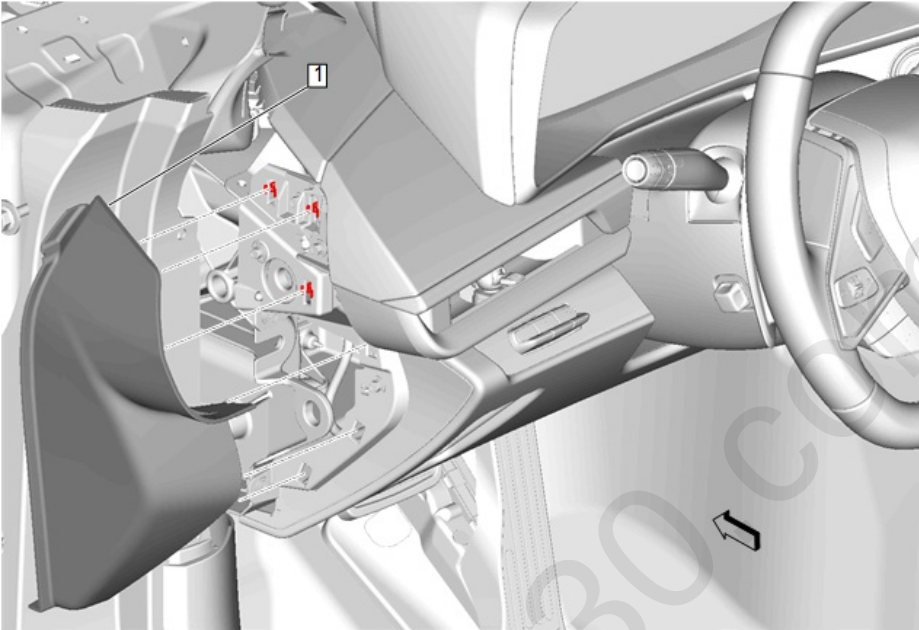
1. [Click here for full size](#)
2. Remove the right instrument panel outer trim cover (1).Instrument Panel Outer Trim Cover Replacement

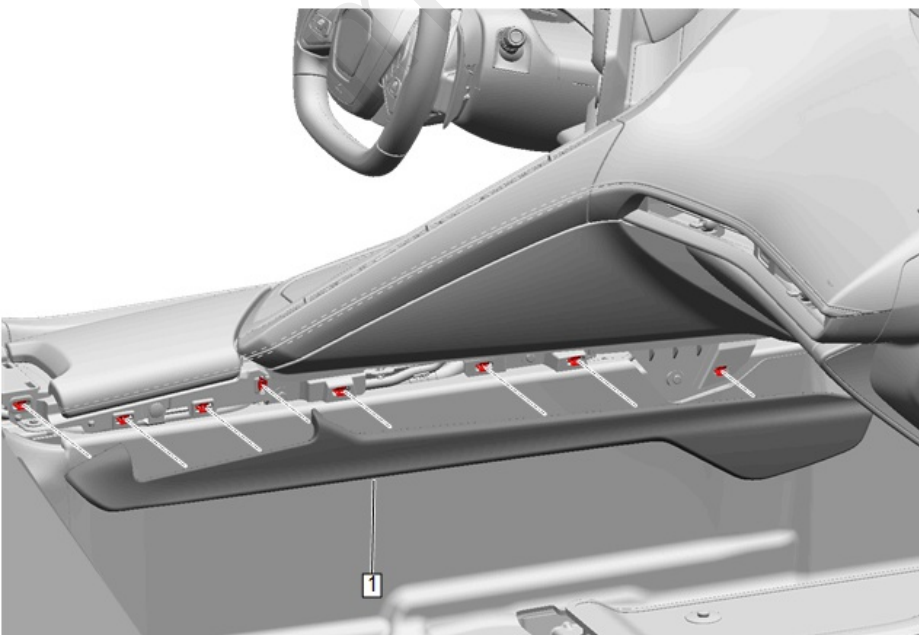
3. [Click here for full size](#)
4. Front Floor Rear Console Side Trim Panel - Right Side (1) >> Remove - Front Floor Rear Console Side Trim Panel Replacement - Right

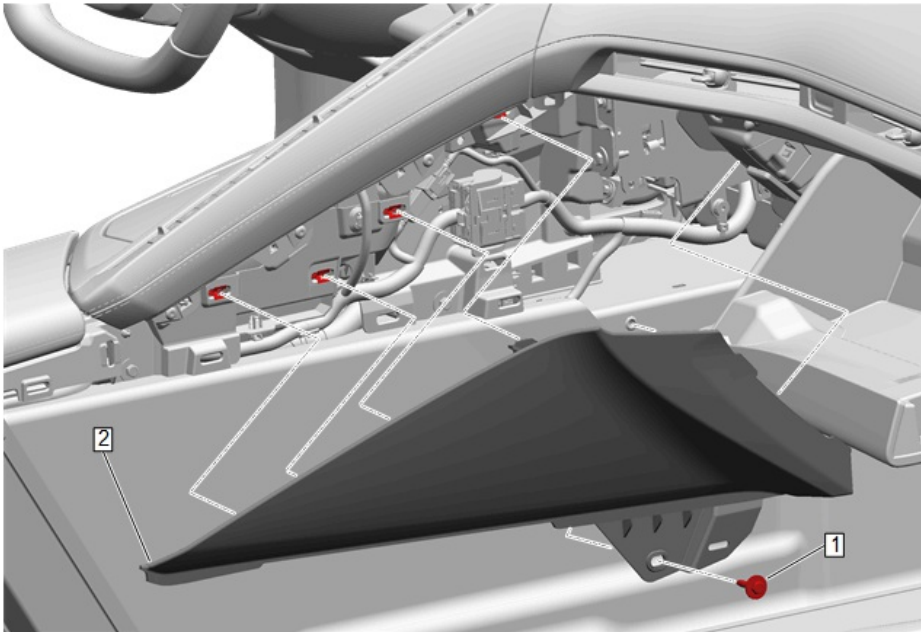
5. [Click here for full size](#)
6. Front Floor Console Extension Panel (2) >> Remove - Front Floor Console Extension Panel Replacement
7. In the event that the door is inoperable, manually release the latch. Refer to Opening the Instrument Panel Compartment Door without Electrical Power.

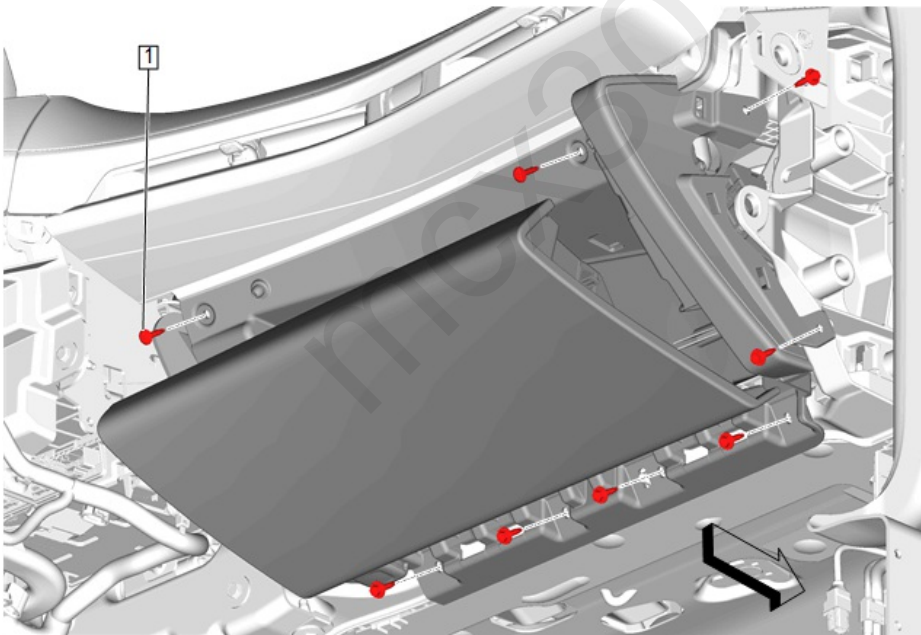
8. [Click here for full size](#)
9. Instrument Panel Compartment Bolt (1) >> Remove [8x]

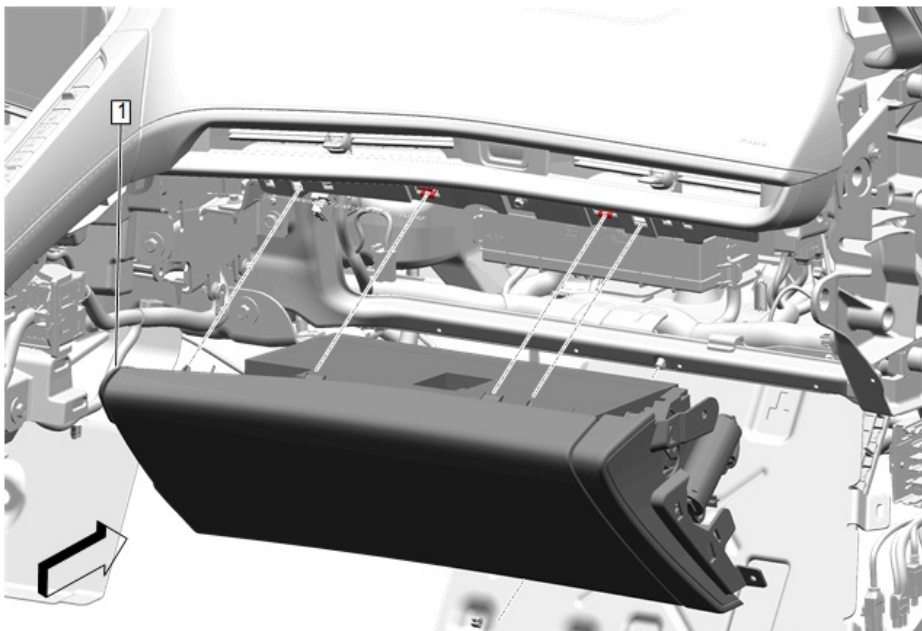
10. [Click here for full size](#)
11. Note:  
Use a plastic trim tool if necessary.
12. Instrument Panel Compartment (1) >> Remove
13. Disconnect the electrical connectors.
14. Transfer components as necessary.

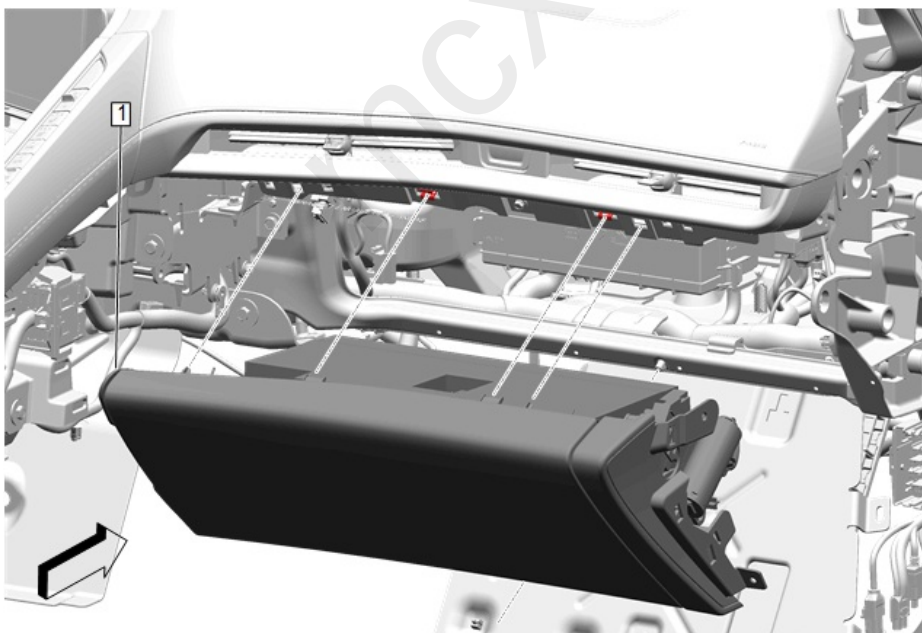
2. [Click here for full size](#)
3. Instrument Panel Compartment (1) >> Install

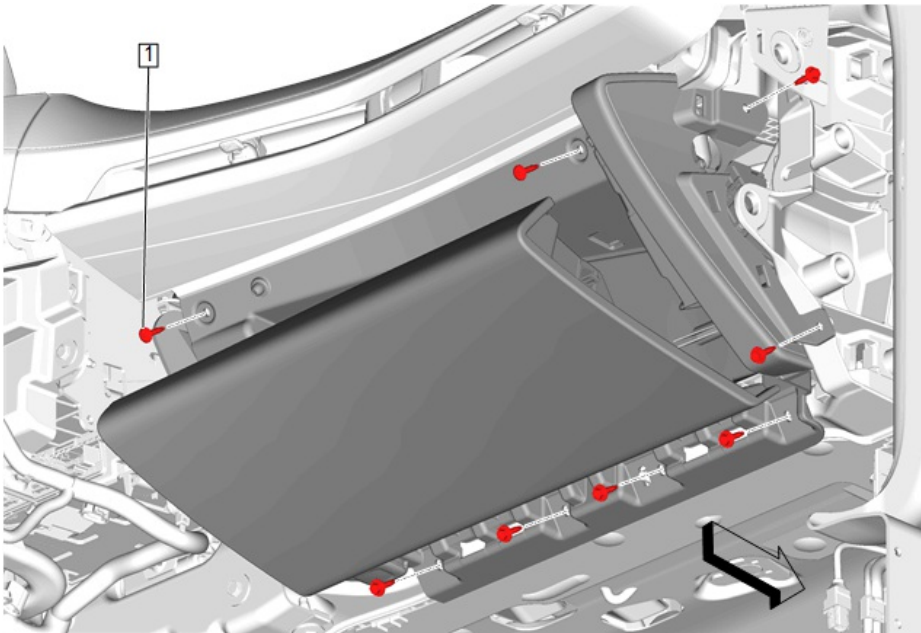
4. [Click here for full size](#)
5. Caution:  
Refer to Fastener Caution.
6. Instrument Panel Compartment Bolt (1) >> Install and tighten [8x]2.5N-m (22 lb in)

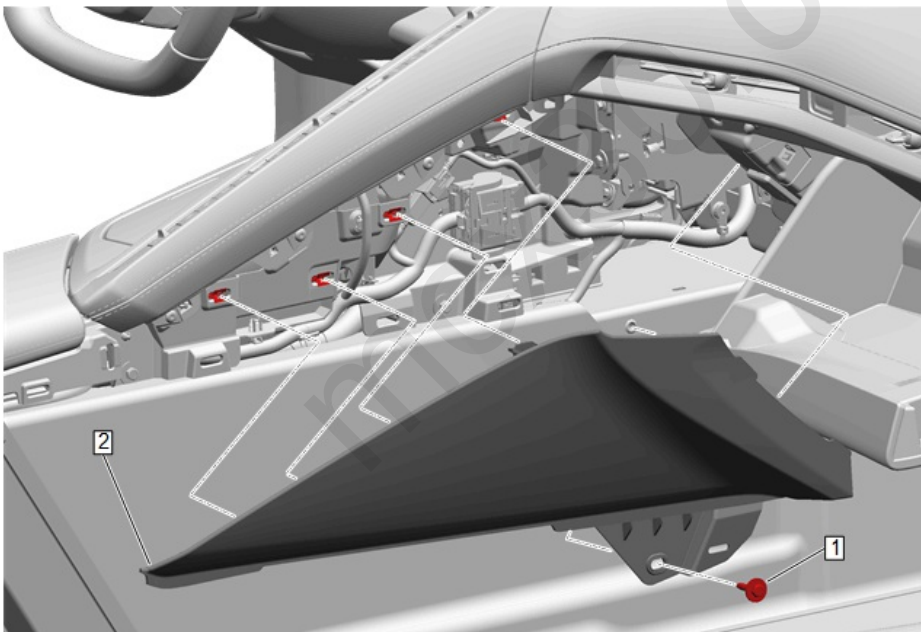
7. [Click here for full size](#)
8. Front Floor Console Extension Panel (2) >> Install - Front Floor Console Extension Panel Replacement

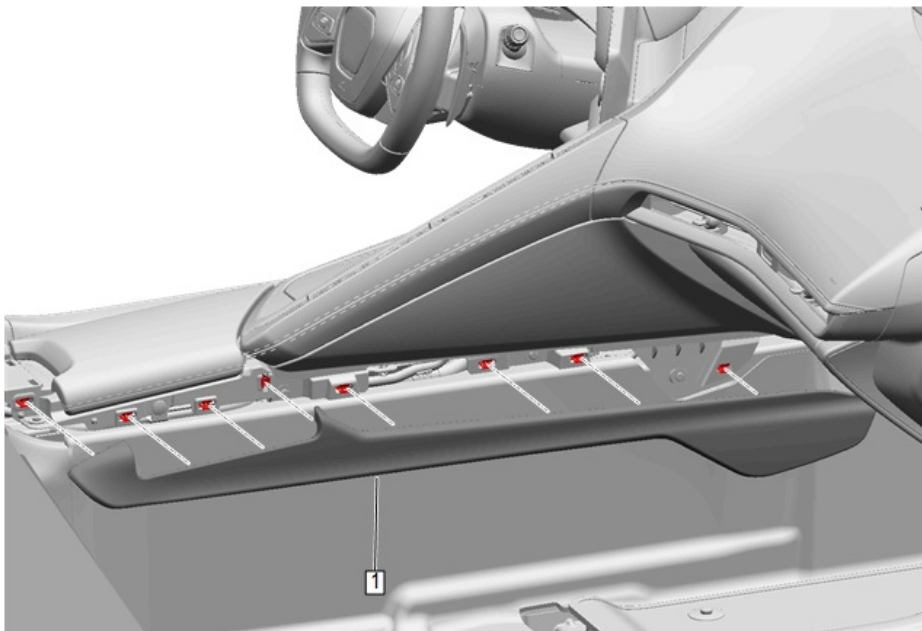
10. Front Floor Rear Console Side Trim Panel - Right Side (1) >> Install - Front Floor Rear Console Side Trim Panel Replacement - Right Side

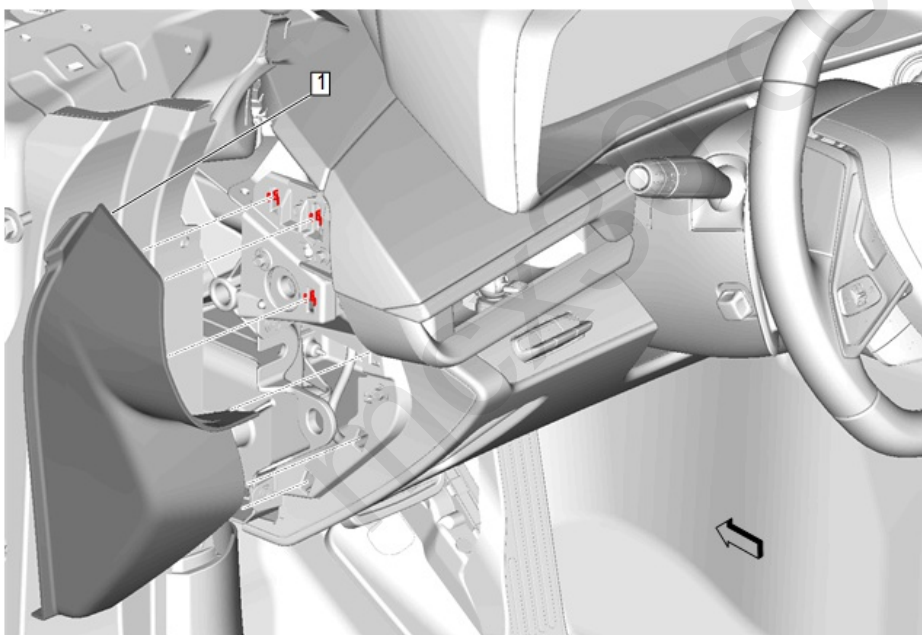
12. Install the right instrument panel outer trim cover (1).Instrument Panel Outer Trim Cover Replacement
