# 2022 CHEVROLET CORVETTE SERVICE MANUAL

## Instrument Panel Switch Trim Plate Replacement

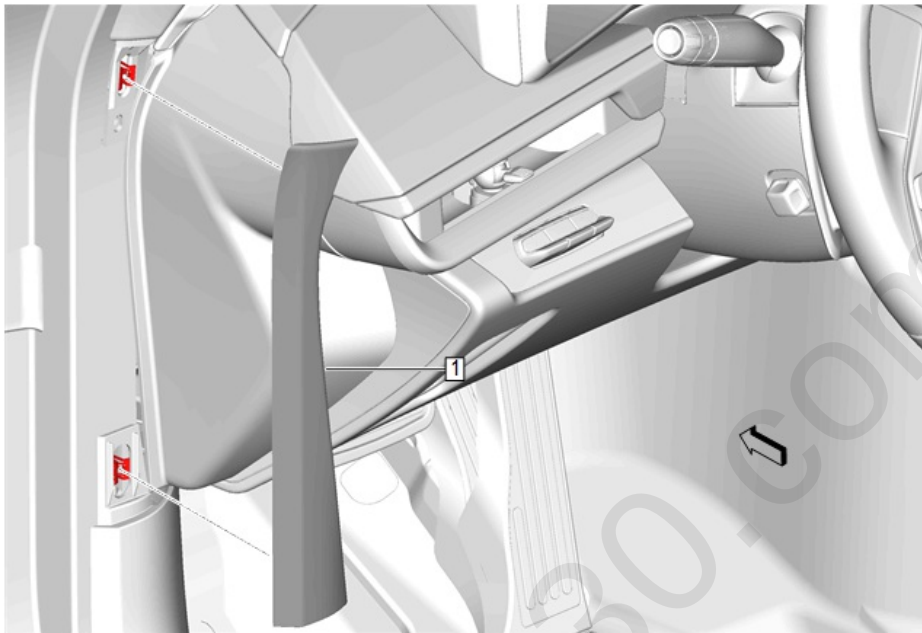
1. [Click here for full size](#)
2. Remove the left body hinge pillar garnish molding (1).Body Hinge Pillar Garnish Molding Replacement

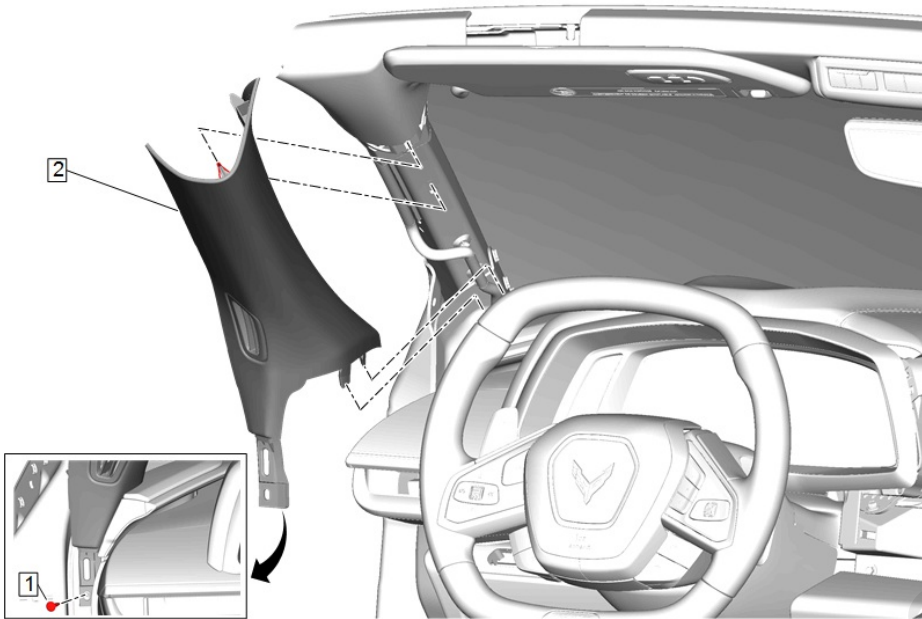
4. Remove the left windshield garnish molding (2). Windshield Garnish Molding Replacement

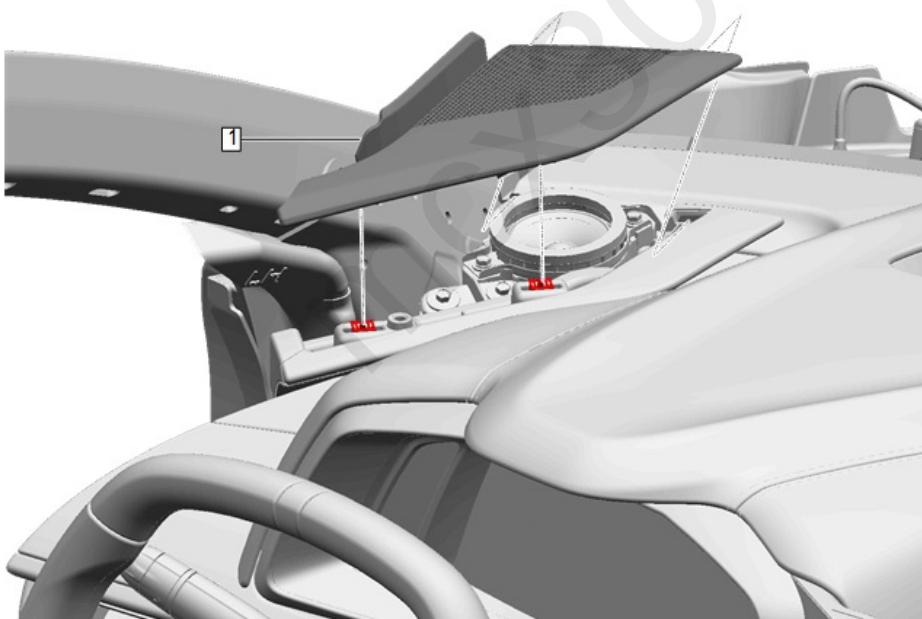
6. Remove the left instrument panel trim pad radio speaker opening cover (1). Instrument Panel Trim Pad Radio Speaker Opening Cover Replacement

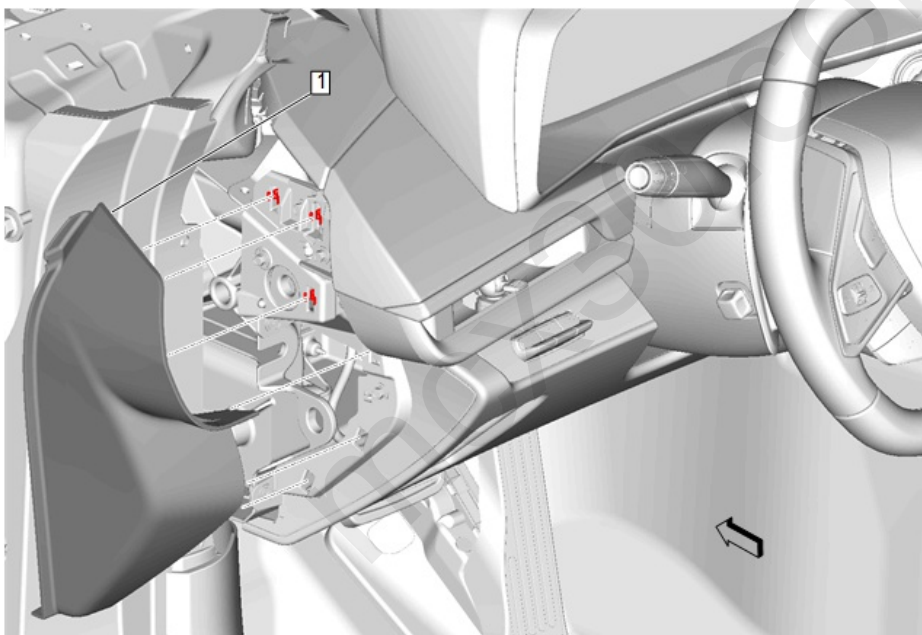
10. Remove the left instrument panel outer trim cover (1).Instrument Panel Outer Trim Cover Replacement

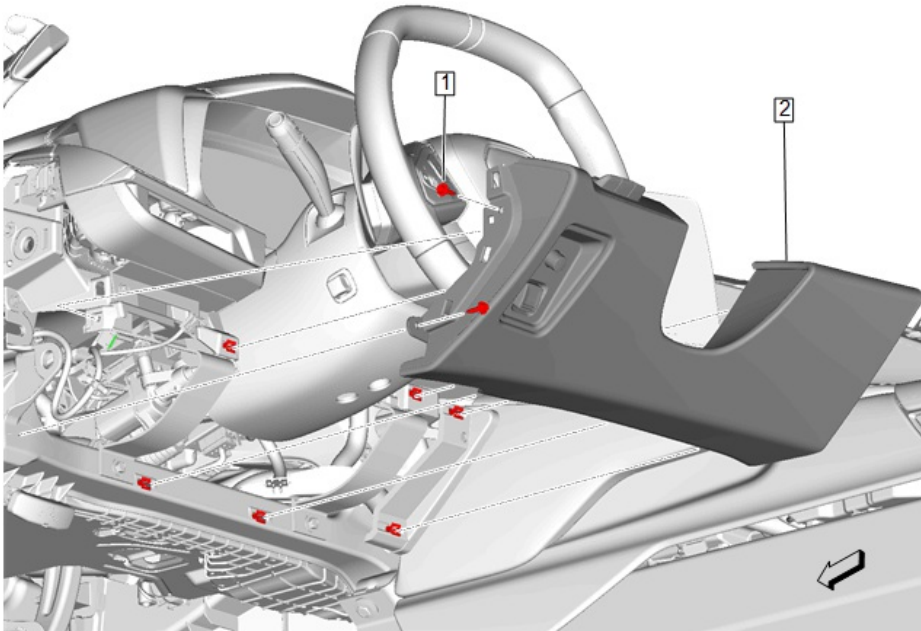
12. Instrument Panel Knee Bolster (2) >> Remove - Instrument Panel Knee Bolster Replacement

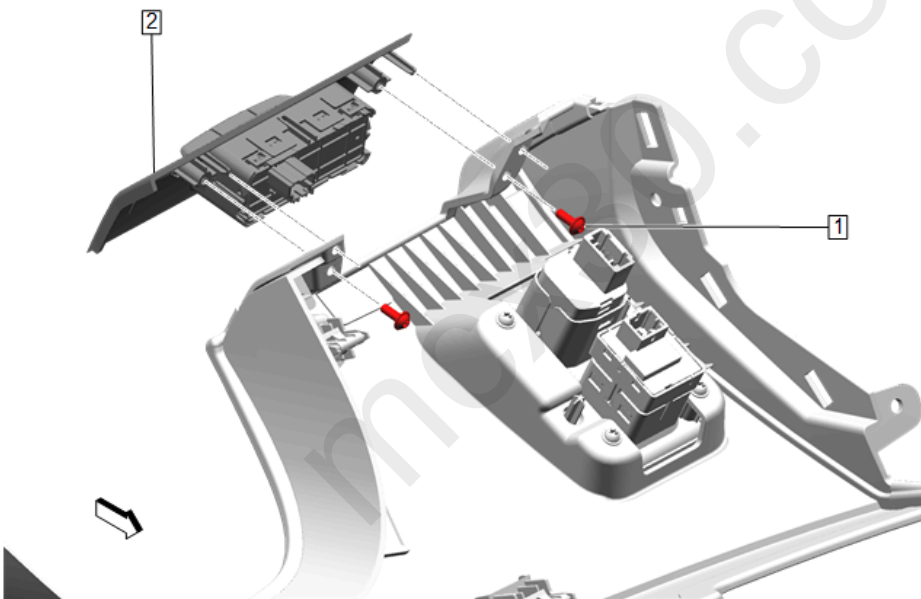
14. Instrument Panel Knee Bolster Bolt (1) >> Remove [2x]

15. Instrument Panel Switch Trim Plate (2) >> Remove

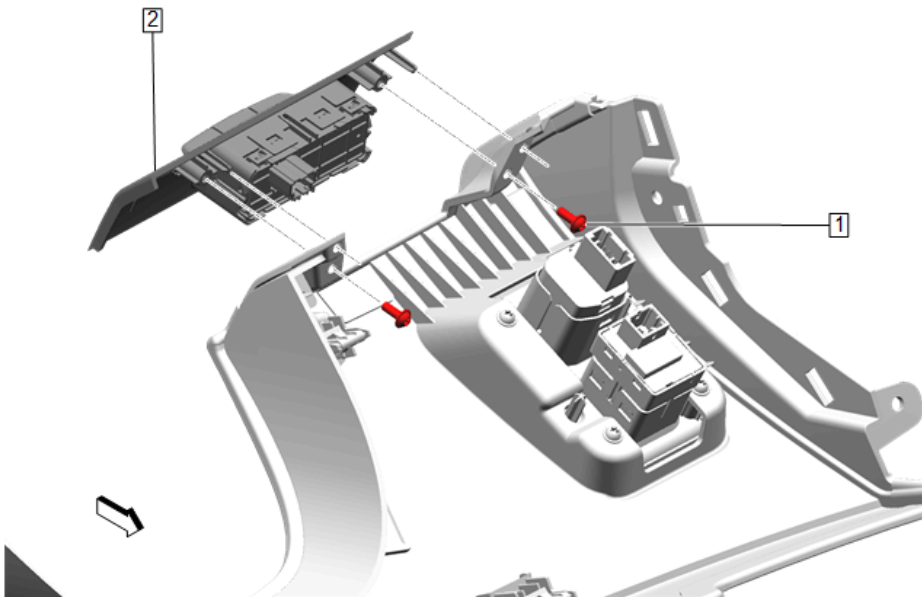
1. [Click here for full size](#)
2. Instrument Panel Switch Trim Plate (2) >> Install
3. Caution:  
Refer to Fastener Caution.
4. Instrument Panel Knee Bolster Bolt (1) >> Install and tighten [2x]2.5N-m (22 lb in)

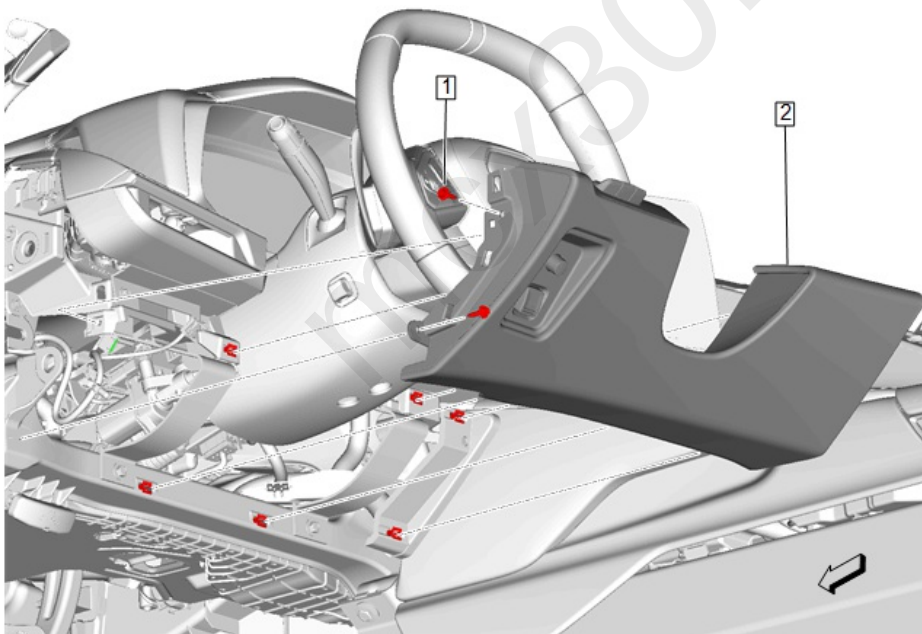
5. [Click here for full size](#)
6. Instrument Panel Knee Bolster (2) >> Install - Instrument Panel Knee Bolster Replacement

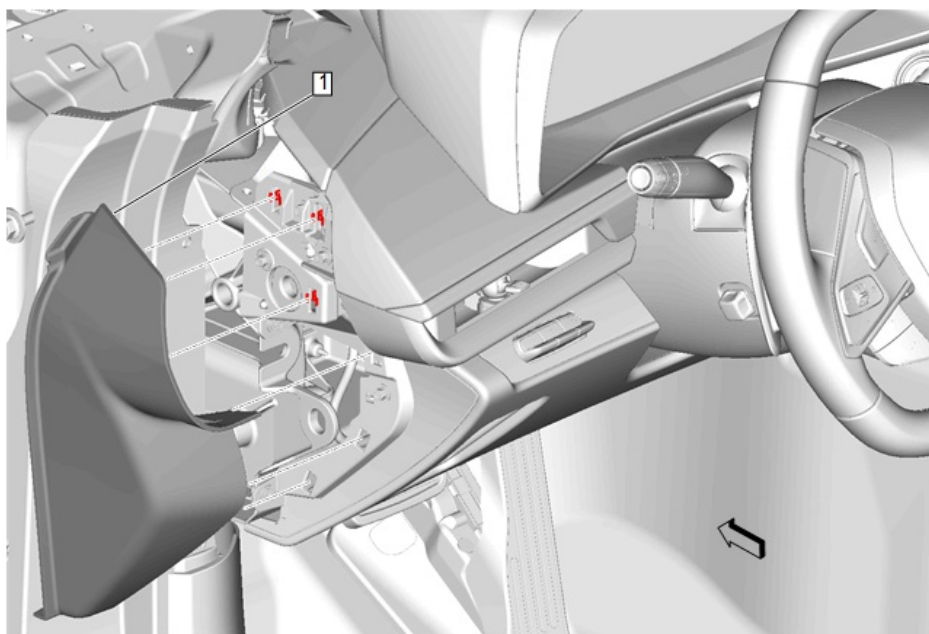
8. Install the left instrument panel outer trim cover (1).Instrument Panel Outer Trim Cover Replacement

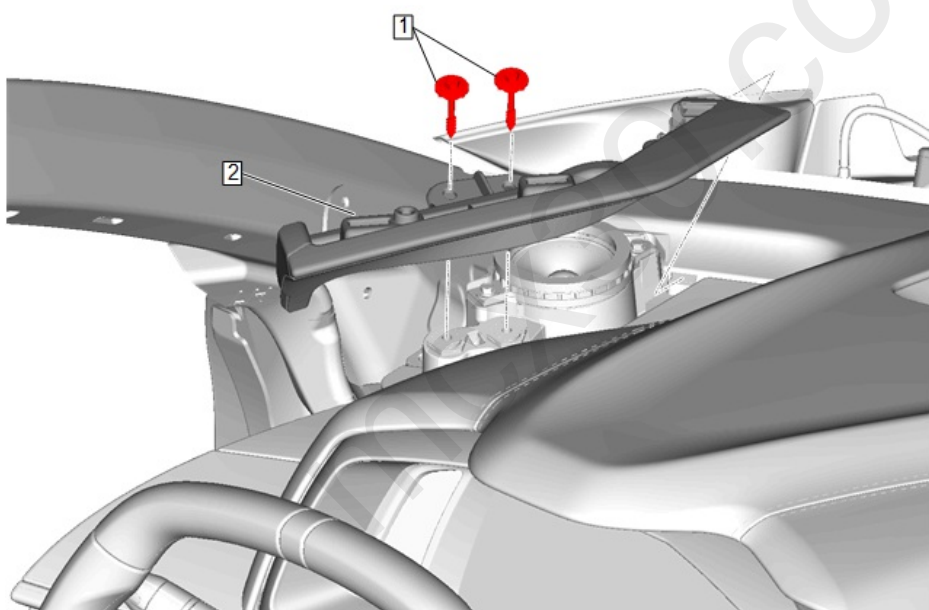
10. Install the left radio front speaker grille molding (2).Radio Front Speaker Grille Molding Replacement
