# 2022 CHEVROLET CORVETTE SERVICE MANUAL

## Instrument Panel Upper Trim Panel Cover Replacement

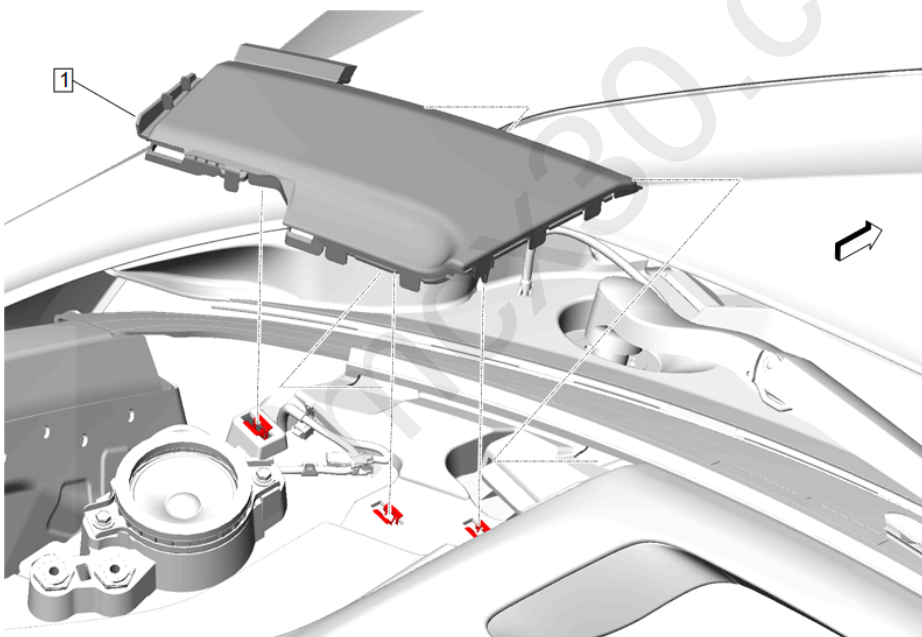
10. Release the retainer clips with a suitable trim tool and pull the instrument upper trim panel cover (1) rearward to remove.

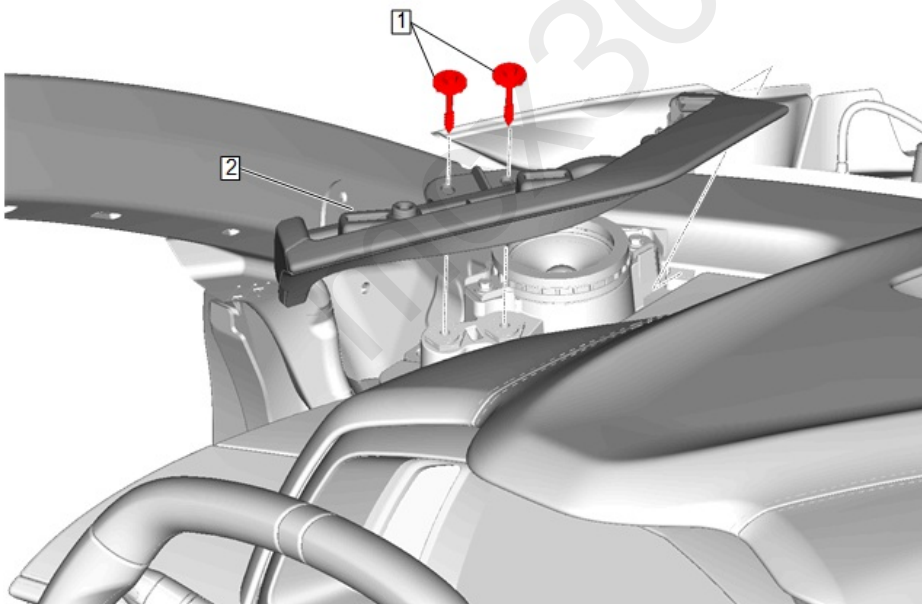
3.  
Click here for full size
4. Radio Front Speaker Grille Molding (2) >> Remove - Radio Front Speaker Grille Molding Replacement

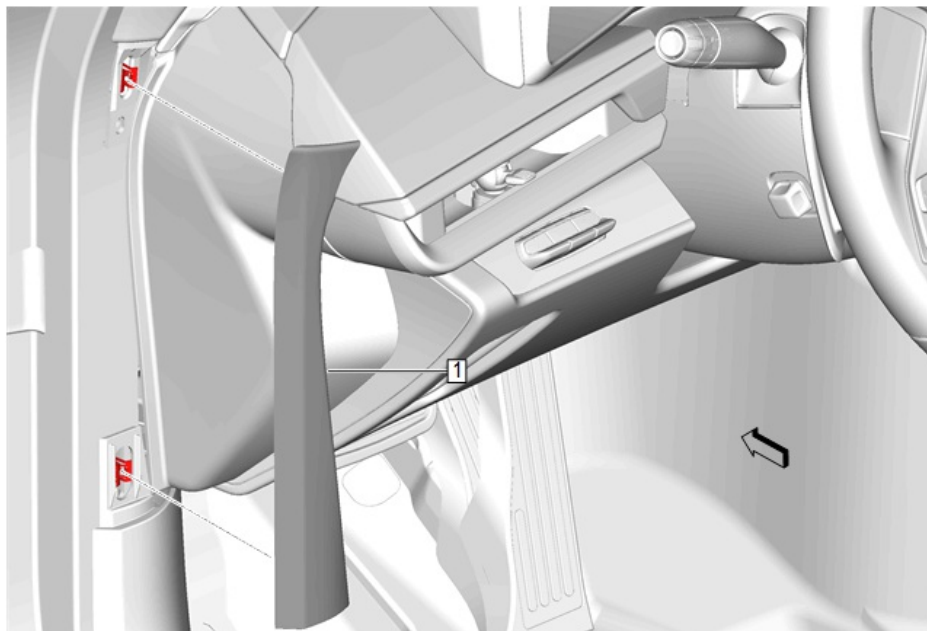
10. Install the left body hinge pillar garnish molding (1).Body Hinge Pillar Garnish Molding Replacement
