# 2022 CHEVROLET CORVETTE SERVICE MANUAL

## Radio Front Center Speaker Grille Replacement

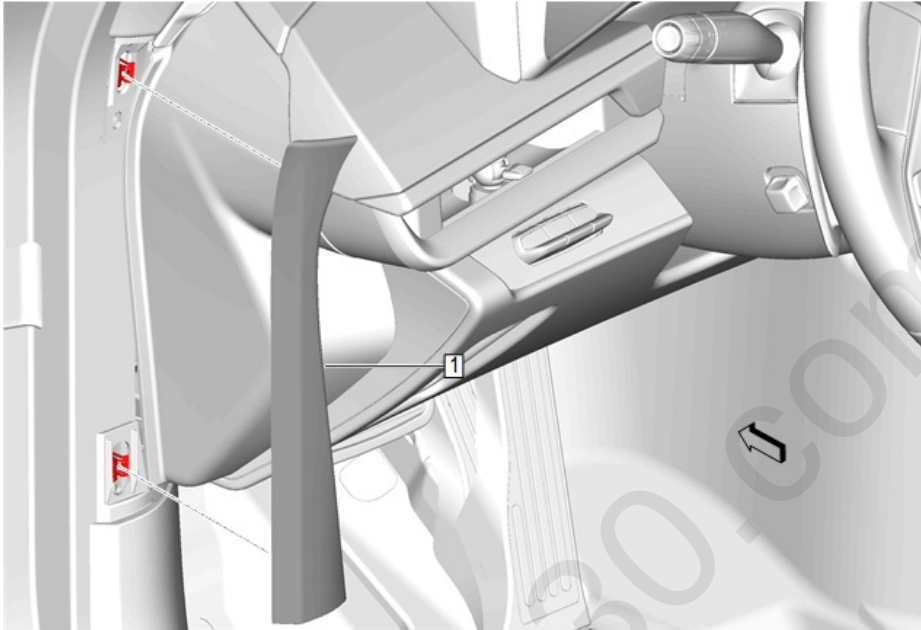
1. [Click here for full size](#)
2. Remove the right body hinge pillar garnish molding (1). [Body Hinge Pillar Garnish Molding Replacement](#)

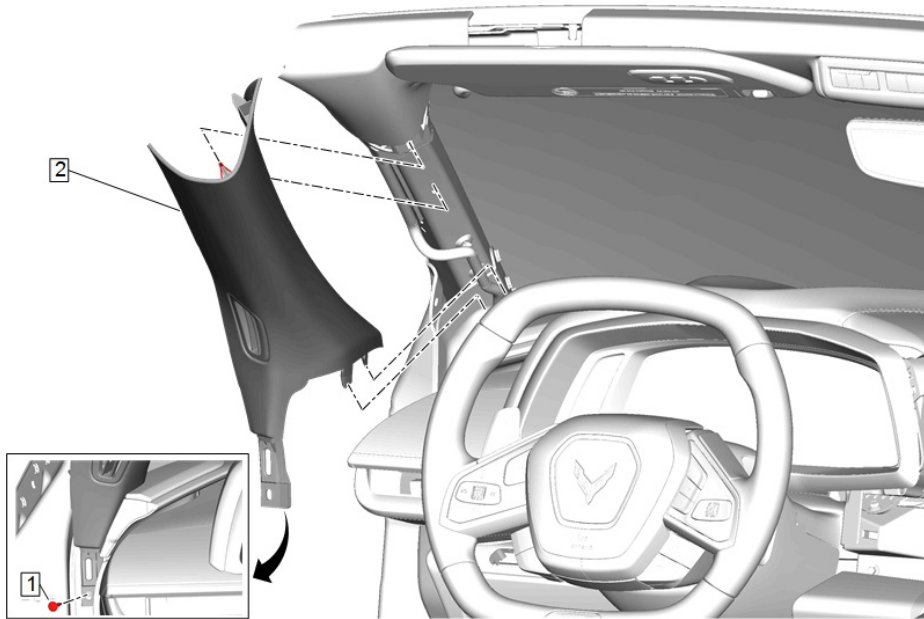
4. Remove the right windshield garnish molding (2). Windshield Garnish Molding Replacement

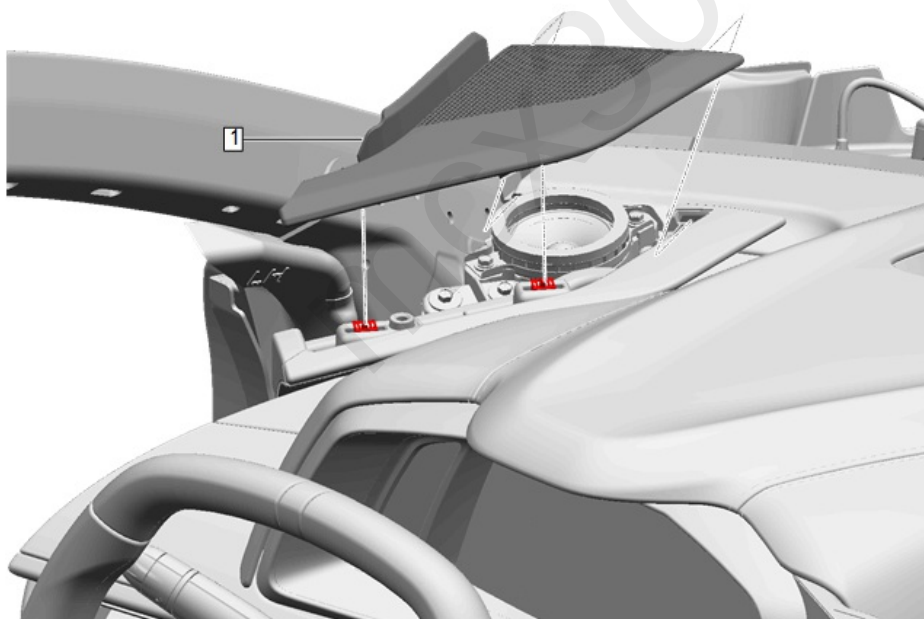
6. Remove the right instrument panel trim pad radio speaker opening cover (1). Instrument Panel Trim Pad Radio Speaker Opening Cover Replacement

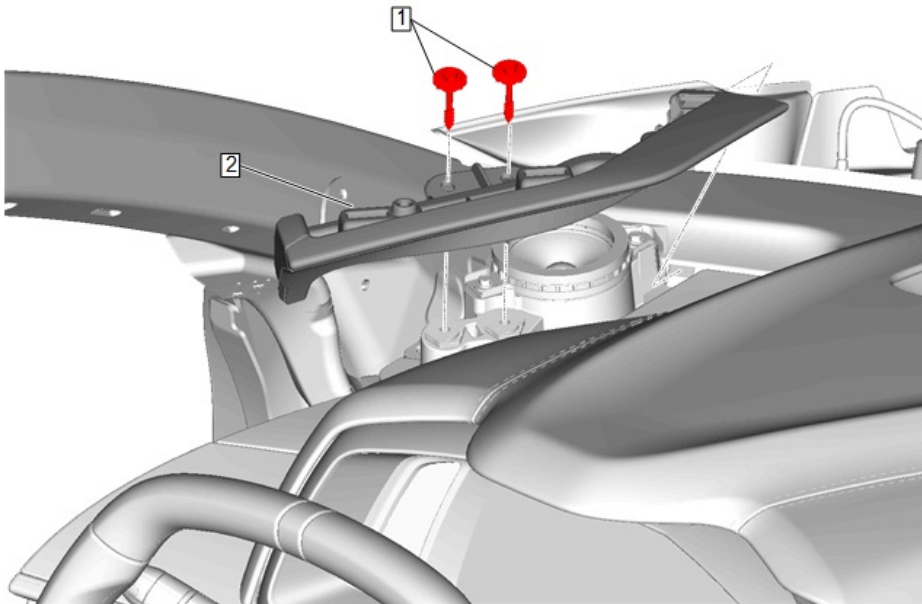
8. Remove the right radio front speaker grille molding (2).Radio Front Speaker Grille Molding Replacement

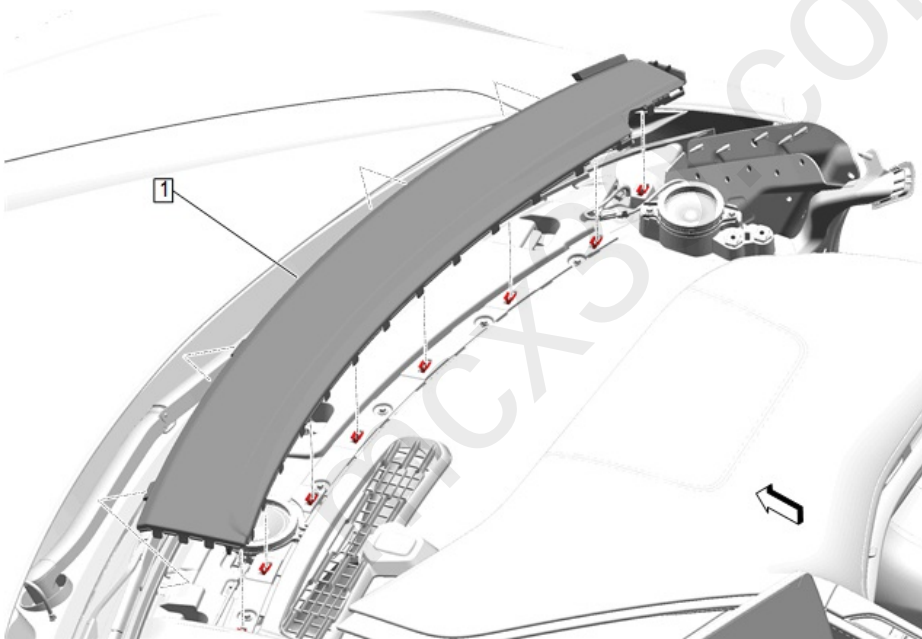
10. Using a flat-bladed plastic trim tool, release the retaining clips.

11. Release the forward tabs by pulling the radio front center speaker grille (1) rearward.

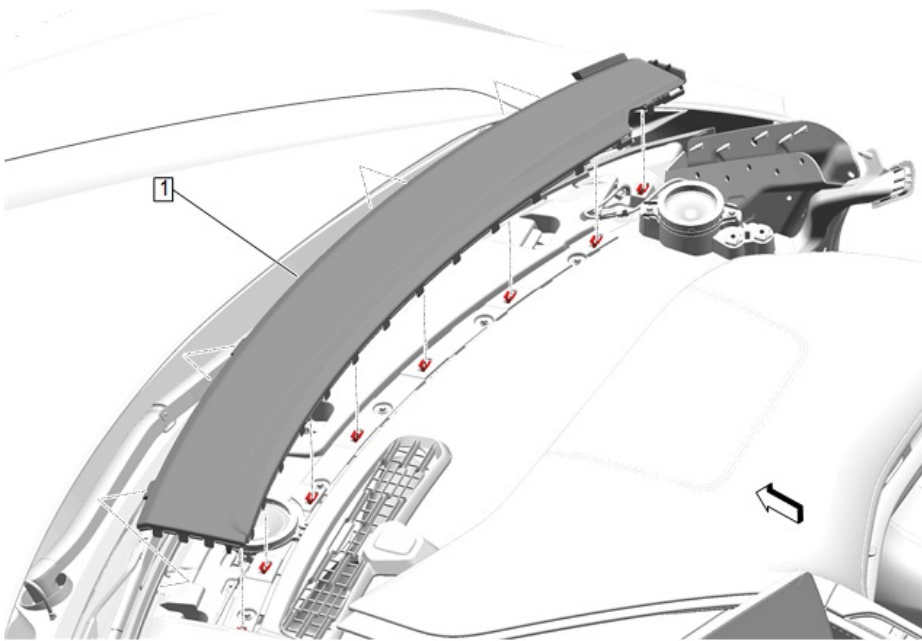
1.  
Click here for full size
2. Radio Front Center Speaker Grille (1) >> Install

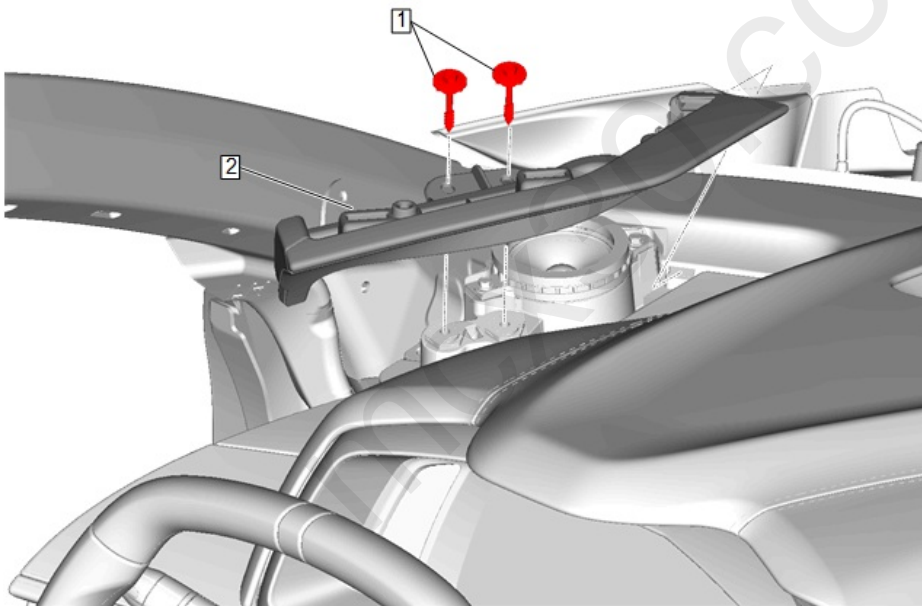
3.  
Click here for full size
4. Install the right radio front speaker grille molding (2).Radio Front Speaker Grille Molding Replacement

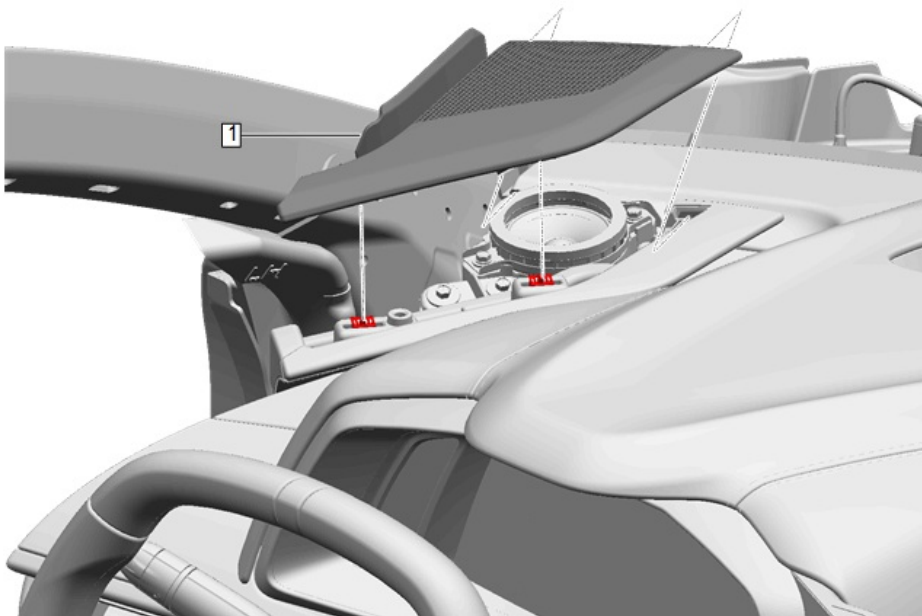
5. [Click here for full size](#)
6. Install the right instrument panel trim pad radio speaker opening cover (1).Instrument Panel Trim Pad Radio Speaker Opening Cover Replacement

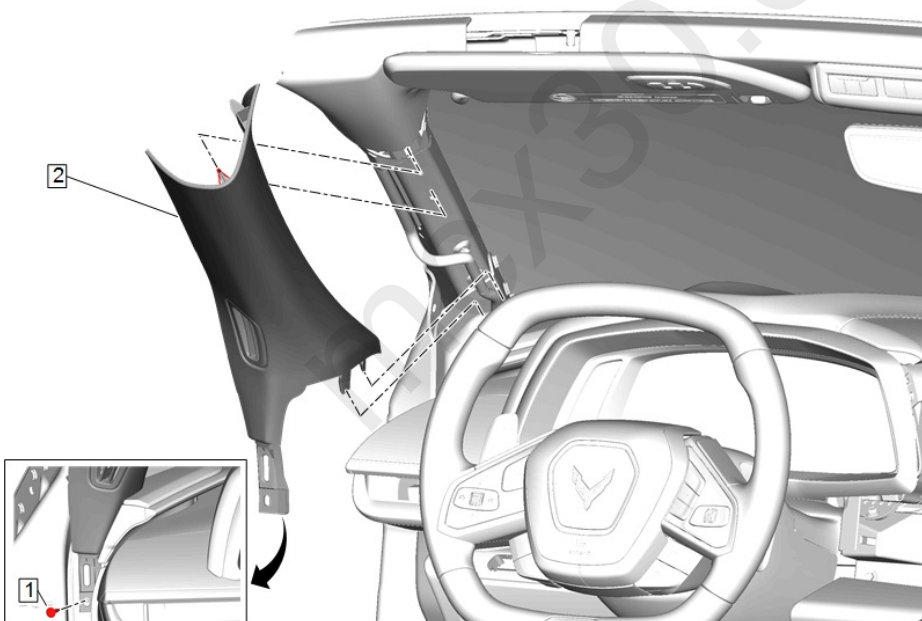
7. [Click here for full size](#)
8. Install the right windshield garnish molding (2).Windshield Garnish Molding Replacement

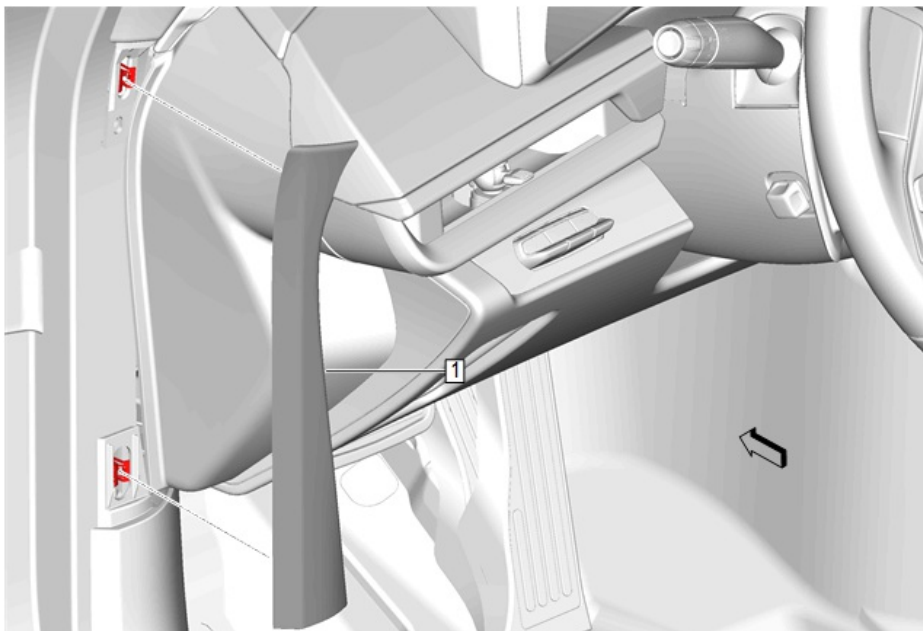
10. Install the right body hinge pillar garnish molding (1).Body Hinge Pillar Garnish Molding Replacement
