## 2018 DRIVELINE/AXLE

### Propeller Shaft - Equinox & Terrain

### TWO-PIECE PROPELLER SHAFT REPLACEMENT

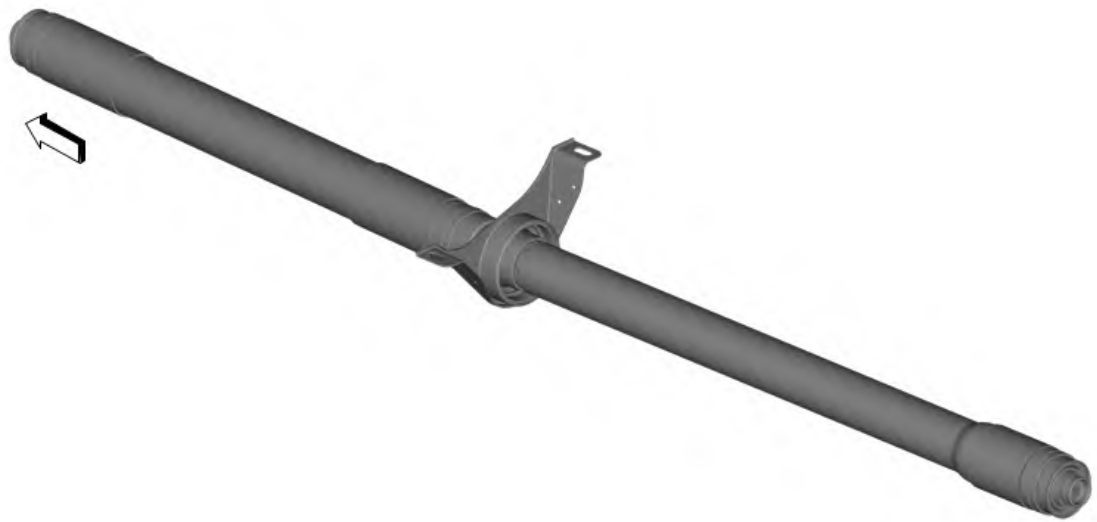
**Fig. 13: Propeller Shaft**

The propeller shaft assembly is a 2-piece design. The front shaft consists of a plunging constant velocity joint at the front and the rear.

The front and rear shafts are joined together at the center support bearing and are coupled with barreled snap rings. The center bearing provides support where the front and rear shafts mate and is bolted to the underbody.

The front female splines are retained to the male splines of the output shaft on the power take-off unit (PTU). This interface is retained by a barreled snap ring.

The rear female splines are retained to the male splines of the input shaft on the rear drive axle. This interface is retained by a barreled snap ring.

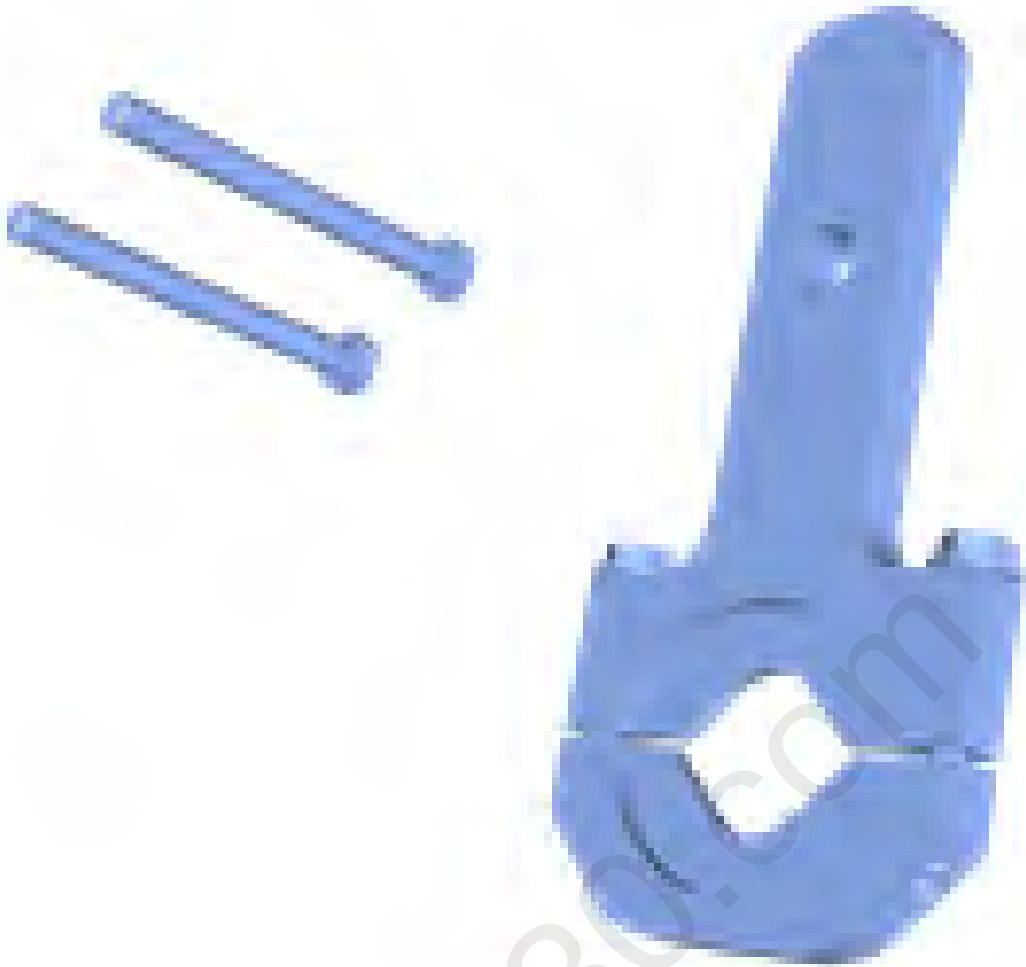
| Illustration | Tool<br>Number/Description |
|---|---|
| <p>The illustration shows a blue metal tool, identified as a driveshaft remover adapter. It has a long, vertical handle with a circular hole near the top. The base of the tool is a wide, flat plate with a central circular opening. To the left of the tool are three long, thin, blue pins or bolts, arranged in a slightly fanned-out manner. A large, diagonal watermark reading 'mcx30.com' is visible across the entire image.</p> | <p>DT-51329<br/>Driveshaft Remover<br/>Adapter</p> |
