## REMOVAL AND INSTALLATION > INNER CONSTANT VELOCITY (CV) JOINT BOOT

## REMOVAL AND INSTALLATION > INNER CONSTANT VELOCITY (CV) JOINT BOOT > REMOVAL

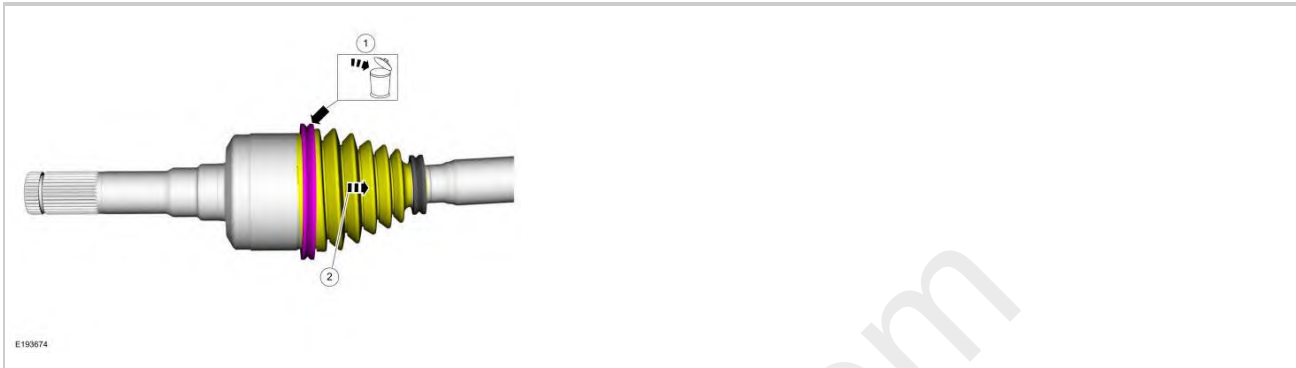
2.

Remove and discard the large CV boot clamp.

Position the CV boot to access the inner CV housing retaining ring.

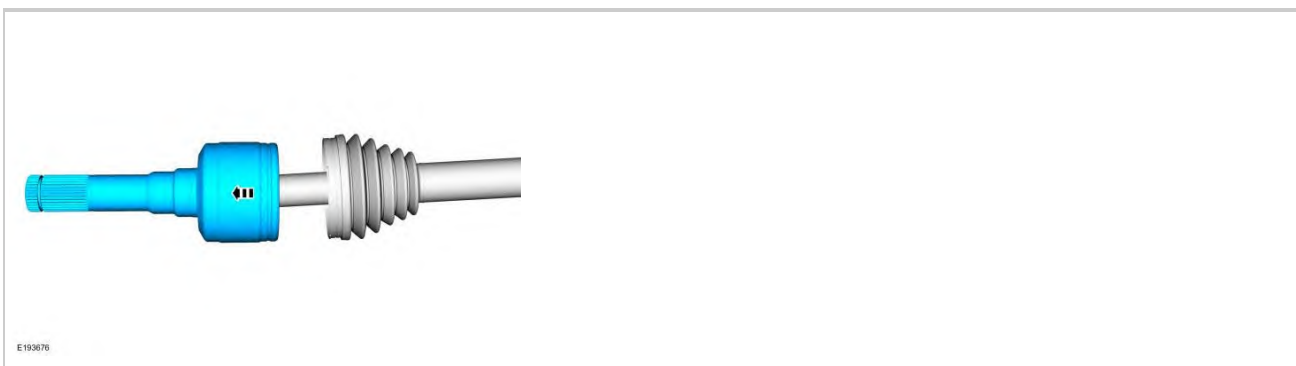
4.

Remove the inner CV joint housing.
