### General Procedures

## Adjustment

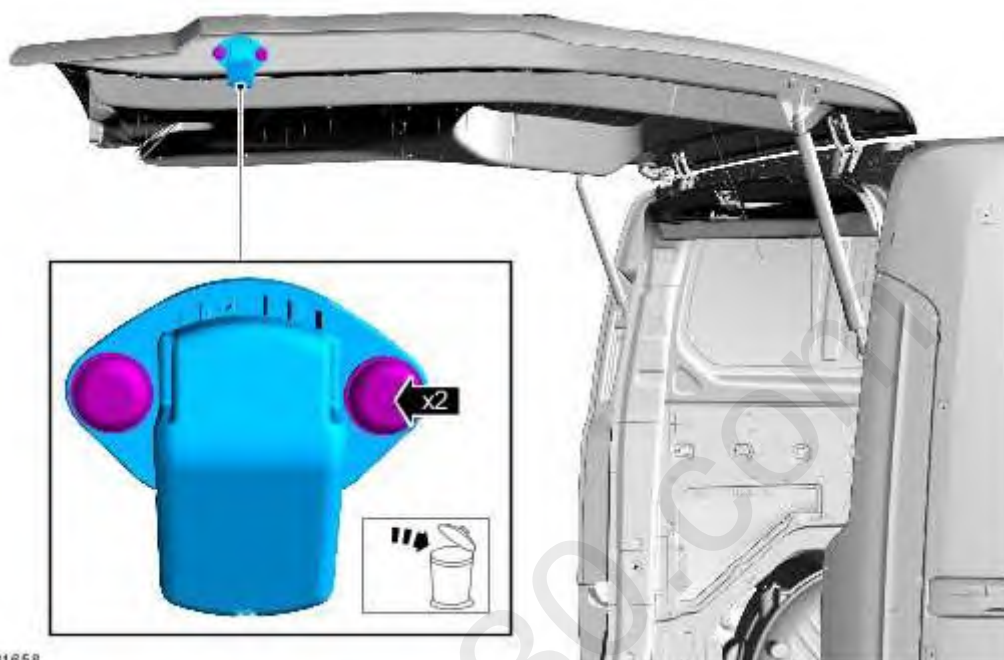
E231658

1. Refer to: [Body and Frame](#) (501-26 Body Repairs - Vehicle Specific Information and Tolerance Checks, Description and Operation).
2. On both sides.

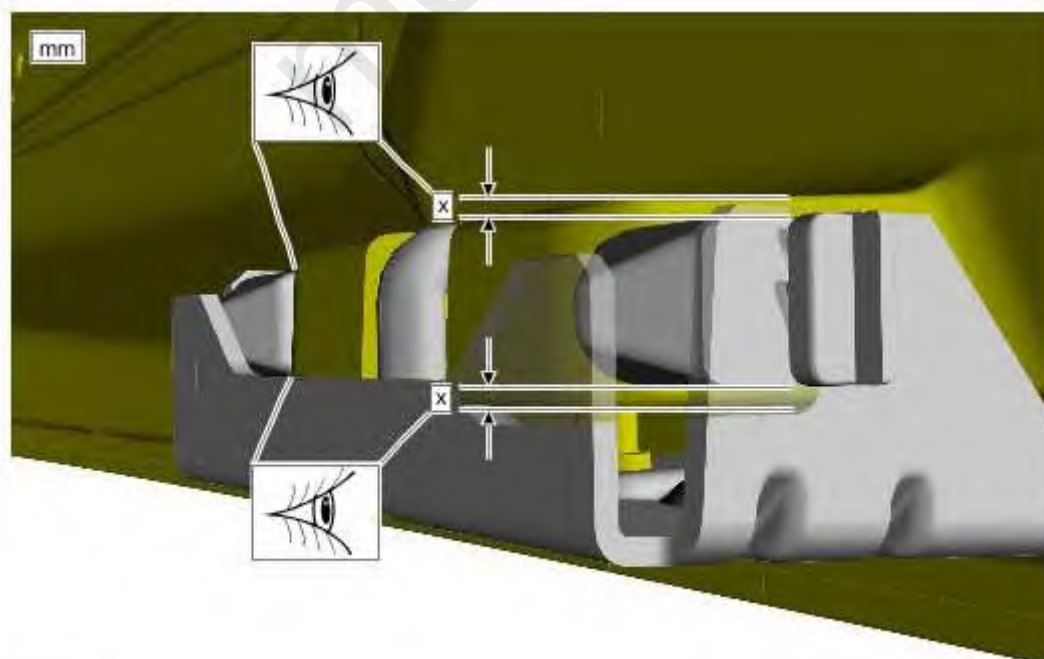
E232759

3.
  1. Spotting the latch cover with chalk before closing and opening the liftgate.
  2. Check the footprint of the striker bumpstops to the latch cover. If measurement X differs more than 2 mm, correct the alignment of the liftgate.

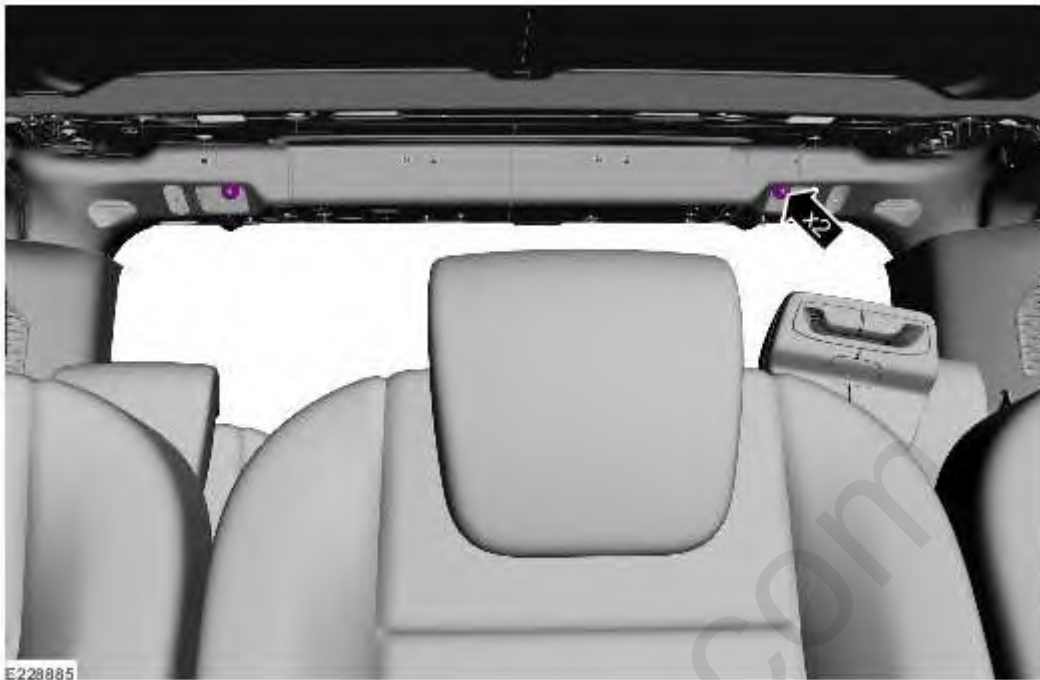
1. Refer to: [Headliner - Lowering](#) (501-05 Interior Trim and Ornamentation, Removal and Installation).
2. Do not loosen the bolts more than 2 turns.

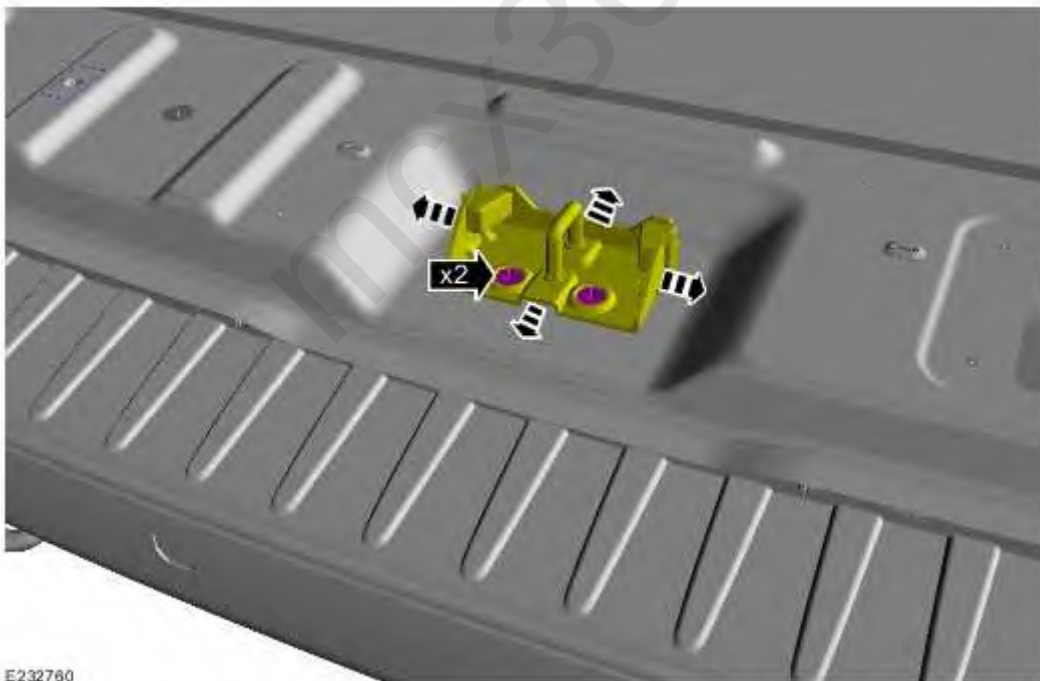
3. Do not loosen the bolts more than 2 turns.

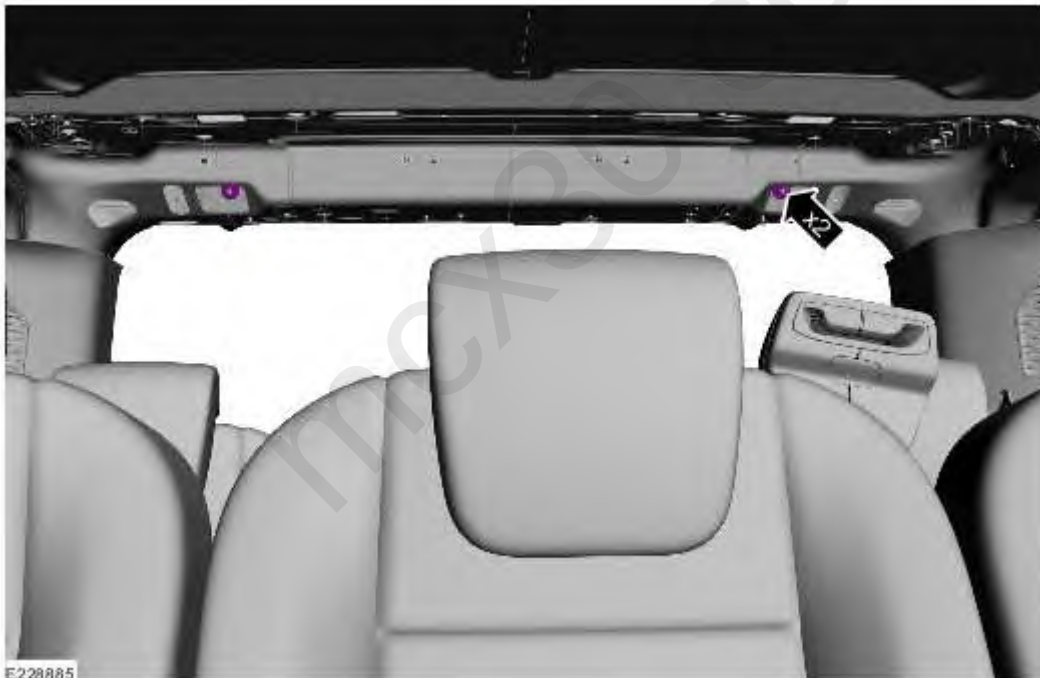
E228885

5. Torque: 51 Nm

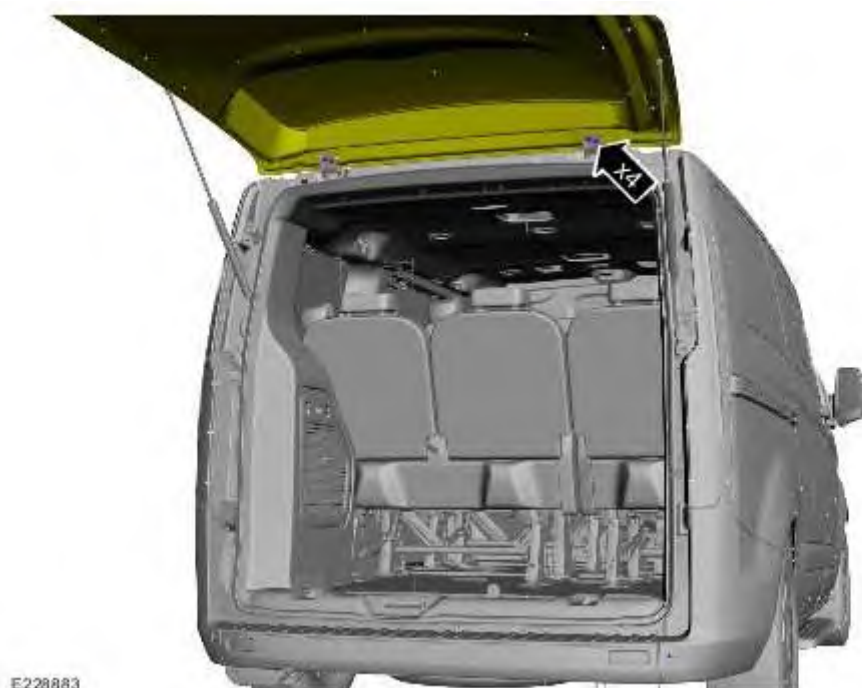
6. Do not loosen the bolts more than 2 turns.

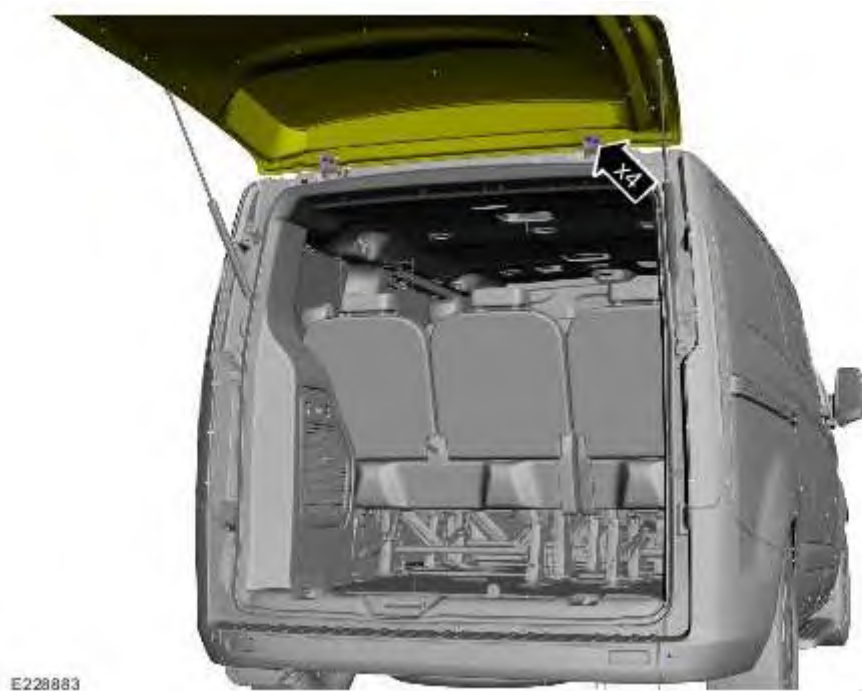
8. Torque: 25 Nm

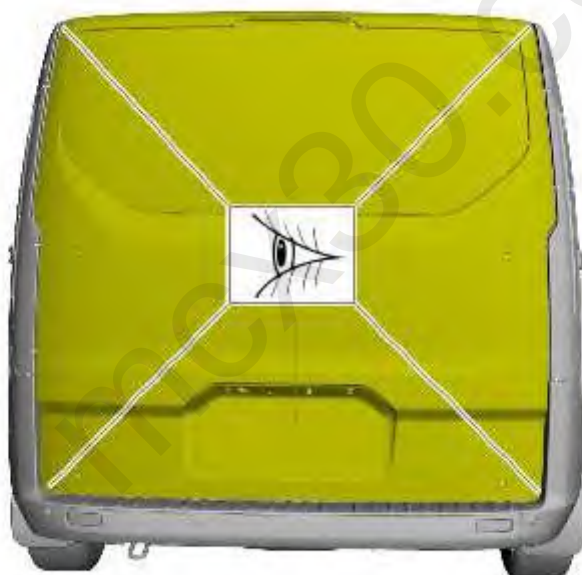
9. After operation check the alignment and correct if necessary.

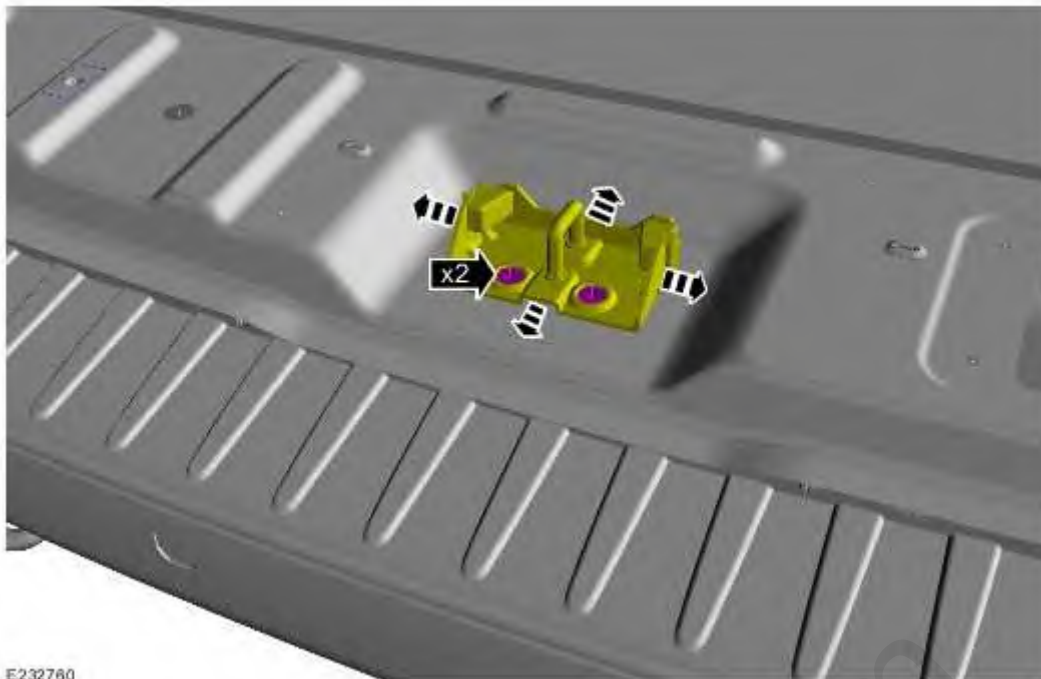
10. Torque: 25 Nm

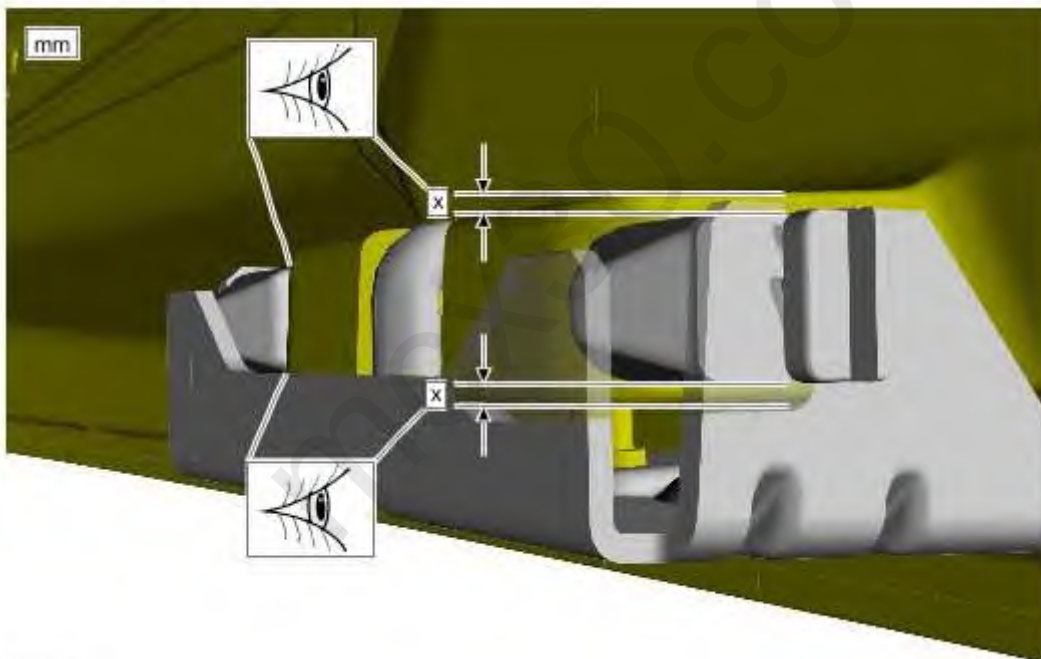
11. After operation check the alignment and correct if necessary.

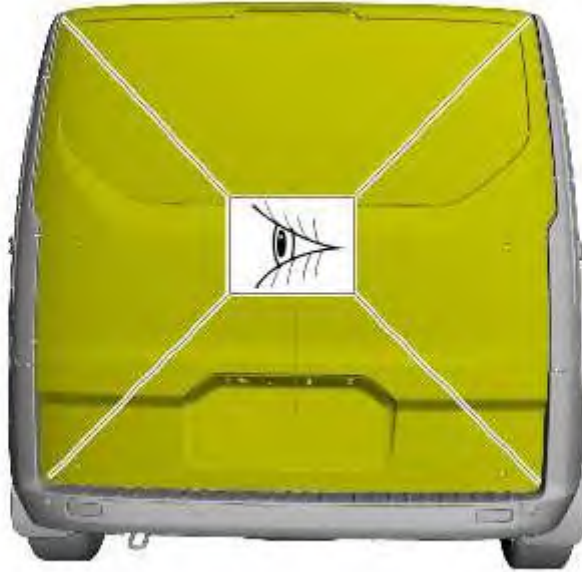
E228887

12. After operation check the alignment and correct if necessary.

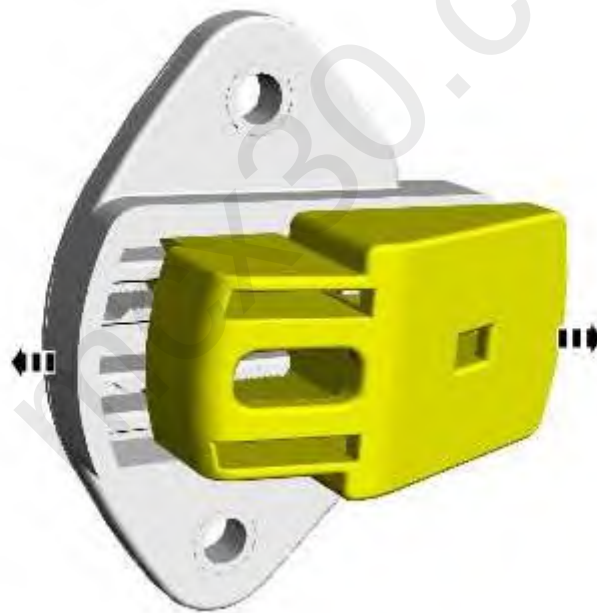
E231635

13. **NOTE:** Make sure that the component is in the end position.  
On both sides.

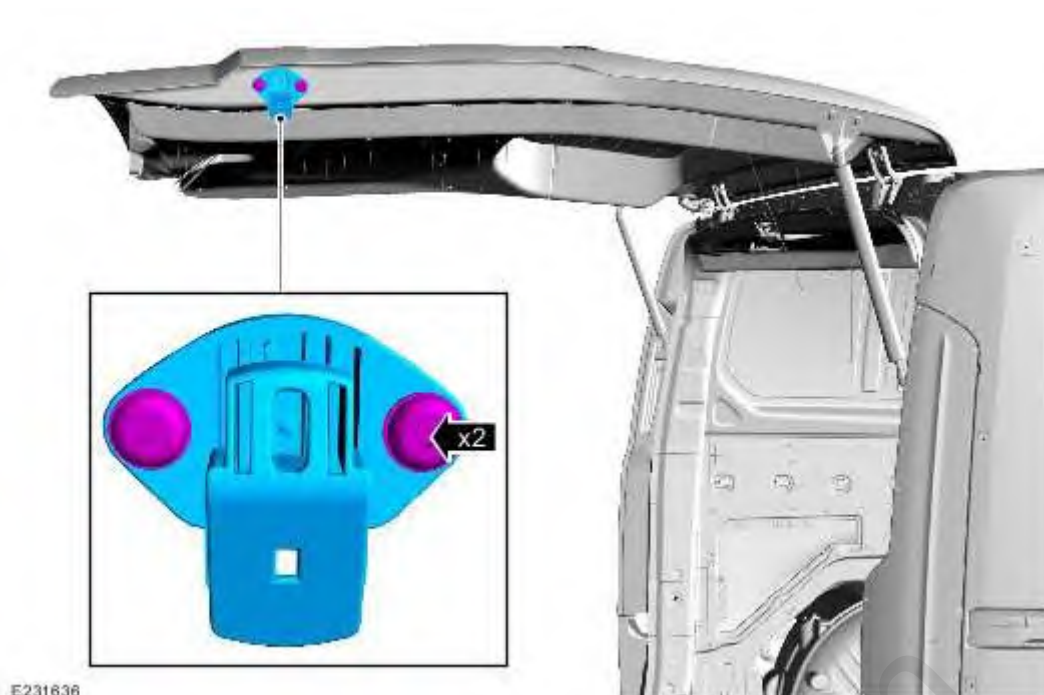
14. **NOTE:** Make sure that new components are installed.  
On both sides.

*Torque:* 11 Nm

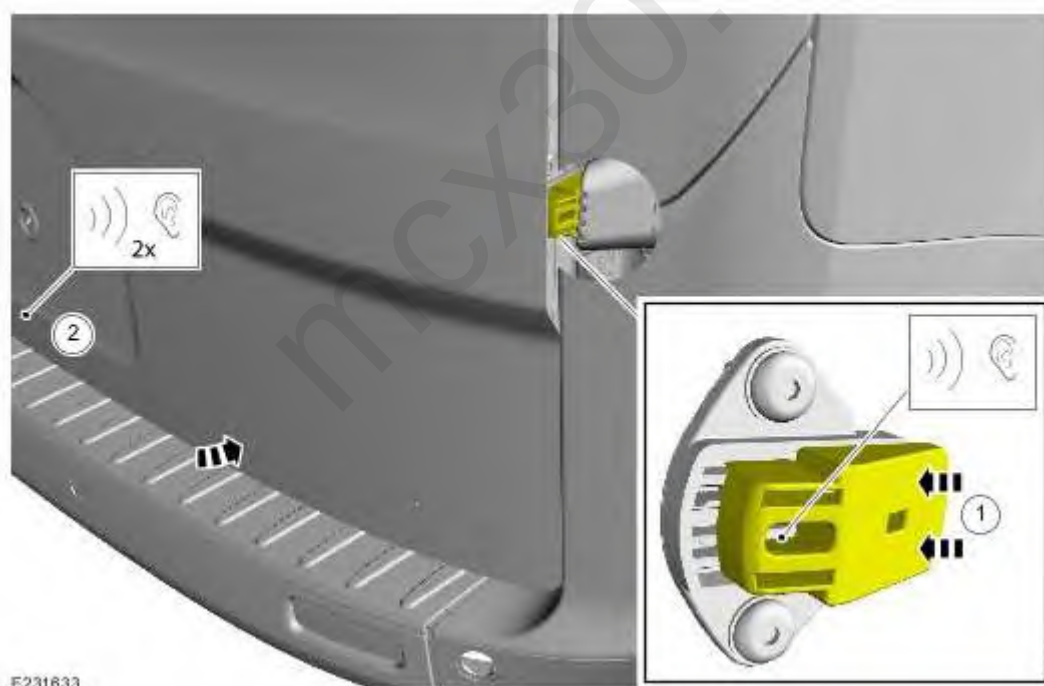
**NOTICE:** Make sure that equal force is applied to the underside of the body panel. On both sides.
2. Carefully close the liftgate until the secondary locking noise of the latch is heard.

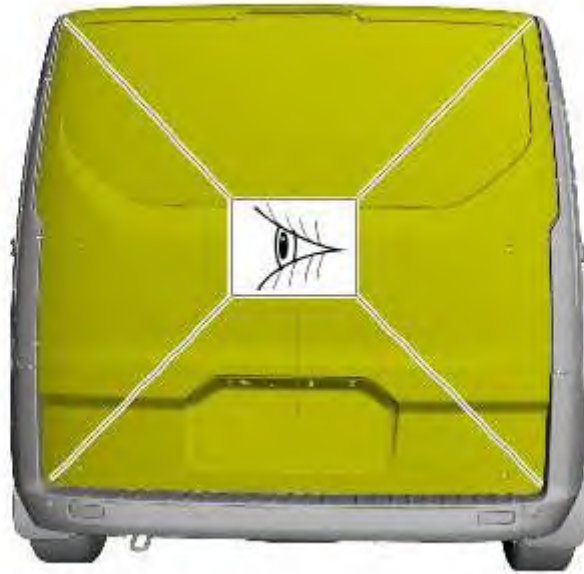
E228887

**NOTICE:** Make sure that equal force is applied to the underside of the body panel. After operation check the alignment and correct if necessary.

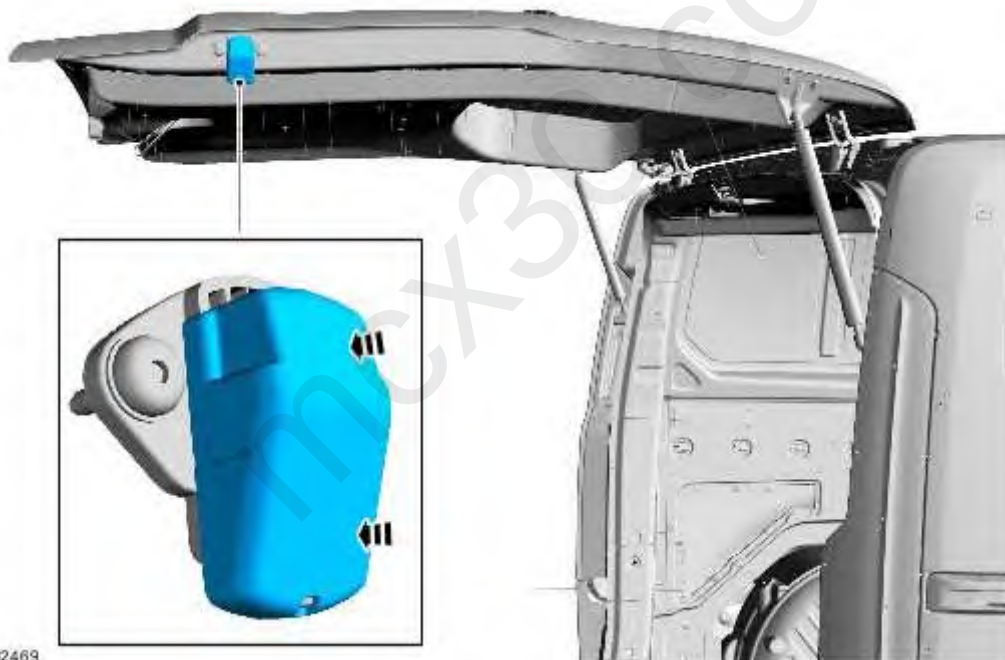
E232469

17. On both sides.

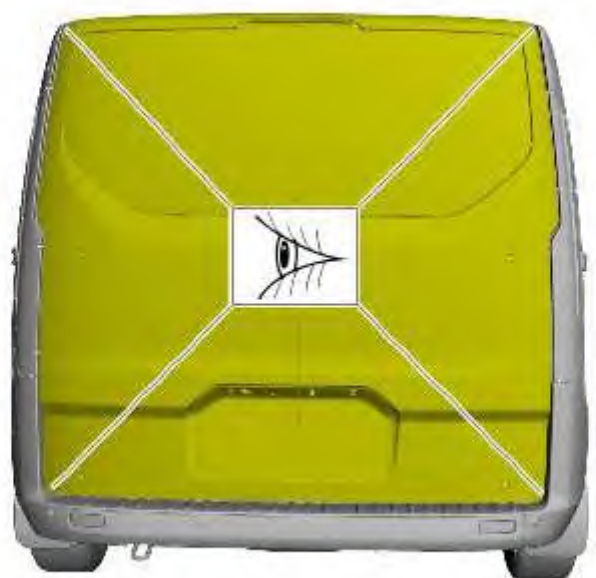
E228887

18. After operation check the alignment and correct if necessary.
