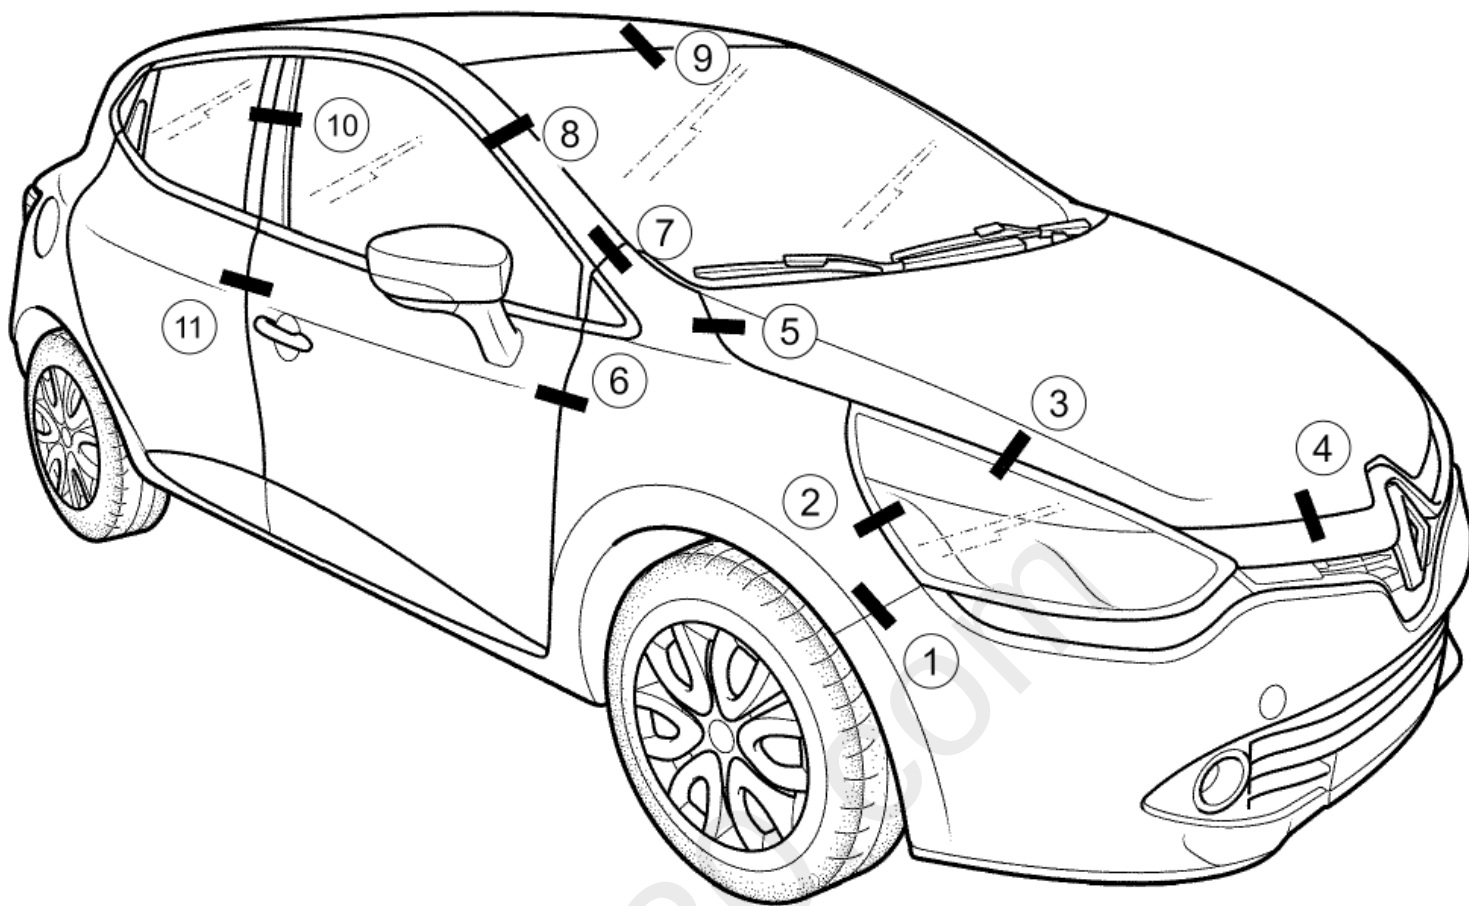
155531

| No. | Location | Clearances (mm) |
| (1) | Front bumper - front wing | $0 \pm 1$ |
| (2) | Headlight - front wing | $1.5 \pm 1.5$ |
| (3) | Bonnet - headlight | $3.5 \pm 1.7$ |
| (4) | Superior trim - bonnet | $6 \pm 2.5$ |
| (5) | Front wing - bonnet | $3.5 \pm 1.5$ |
| (6) | Front side door - front wing | $4.5 \pm 1.3$ |
| (7) | Front wing - A-pillar | $3.5 \pm 1.5$ |
| (8) | Windscreen - windscreen aperture pillar | $4 \pm 2$ |
| (9) | Windscreen - roof panel | $3 \pm 1.5$ |
| (10) | Front side door - rear side door | $4 \pm 1.6$ |
| (11) | Front side door - rear side door | $4 \pm 1.3$ |

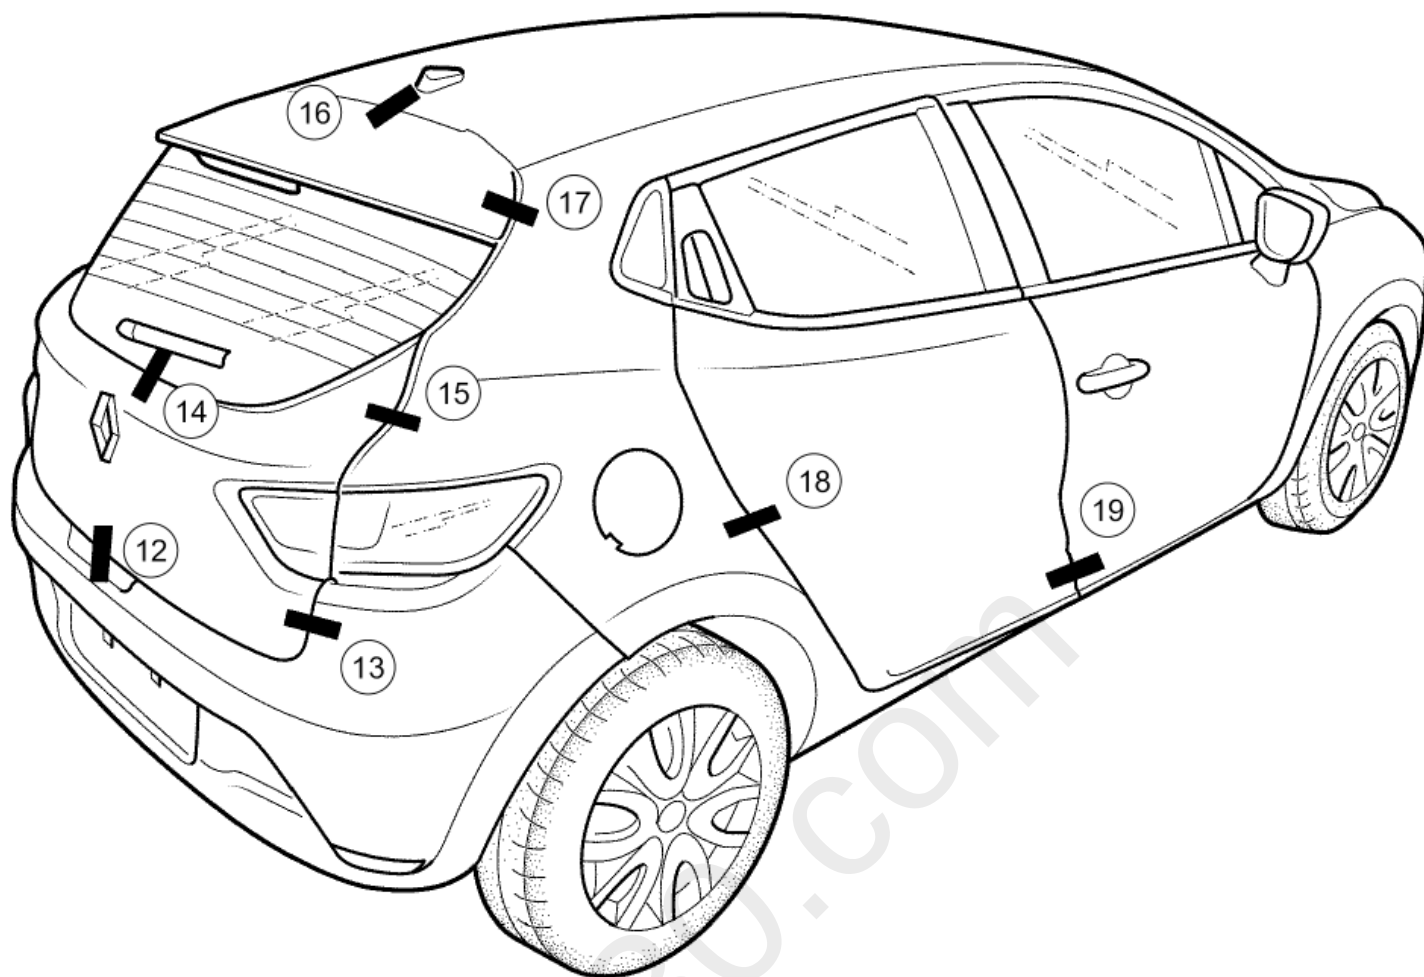
155530

| No. | Location | Clearances (mm) |
| (12) | Luggage compartment lid - rear bumper | $6 \pm 2.3$ |
| (13) | Luggage compartment lid - rear bumper | $4 \pm 2$ |
| (14) | Rear screen - tailgate | $3 \pm 0.9$ |
| (15) | Body side - luggage compartment lid | $4 \pm 1.9$ |
| (16) | Roof - rear spoiler | $5 \pm 1.8$ |
| (17) | Body side - rear spoiler | $4 \pm 2$ |
| (18) | Rear side door - body side | $4 \pm 1.3$ |
| (19) | Front door protective strip - rear door protective strip | $6 \pm 2.8$ |
