## EXTERIOR REAR OPENING ELEMENT ASSEMBLY: EXPLODED VIEW

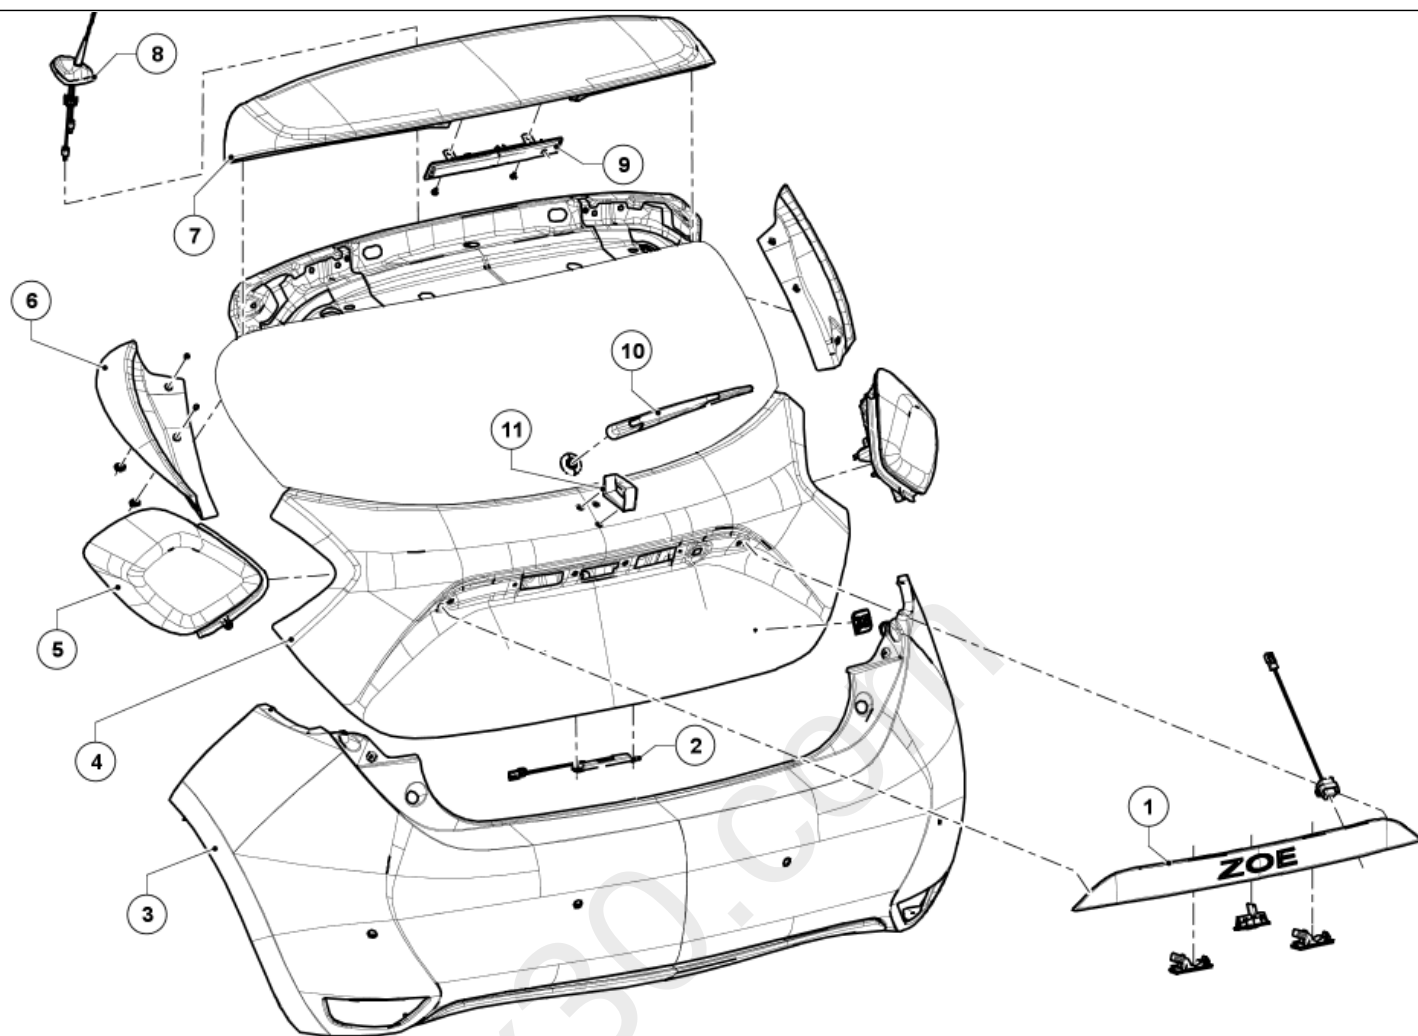
| Marks | Designations | Informations |
| 1 | Rear opening element strip | (see <b>Rear opening element strip: Removal - Refitting</b> )<br>Material: ABS |
| 2 | Radio aerial detection swipes | |
| 3 | Rear bumper assembly | <a href="#">Rear bumper assembly: Exploded view</a> |
| 4 | Tailgate | (see <b>Tailgate: Removal - Refitting</b> ) |
| 5 | Rear light assembly | (see <b>Rear light assembly: Exploded view</b> ) |
| 6 | Rear screen trim | |
| 7 | Spoiler | Material: ABS |
| 8 | Radio aerial base | (see <b>Radio aerial: Removal - Refitting</b> ) |
| 9 | 3rd brake light | 3rd brake light: Removal - Refitting@80,02,06,08-01,37-1 |
| 10 | Wipers/washing assembly | <a href="#">Wiping and washing: List and location of components</a> |
| 11 | Rear badge | (see <b>Rear badges: Removal - Refitting</b> ) |
