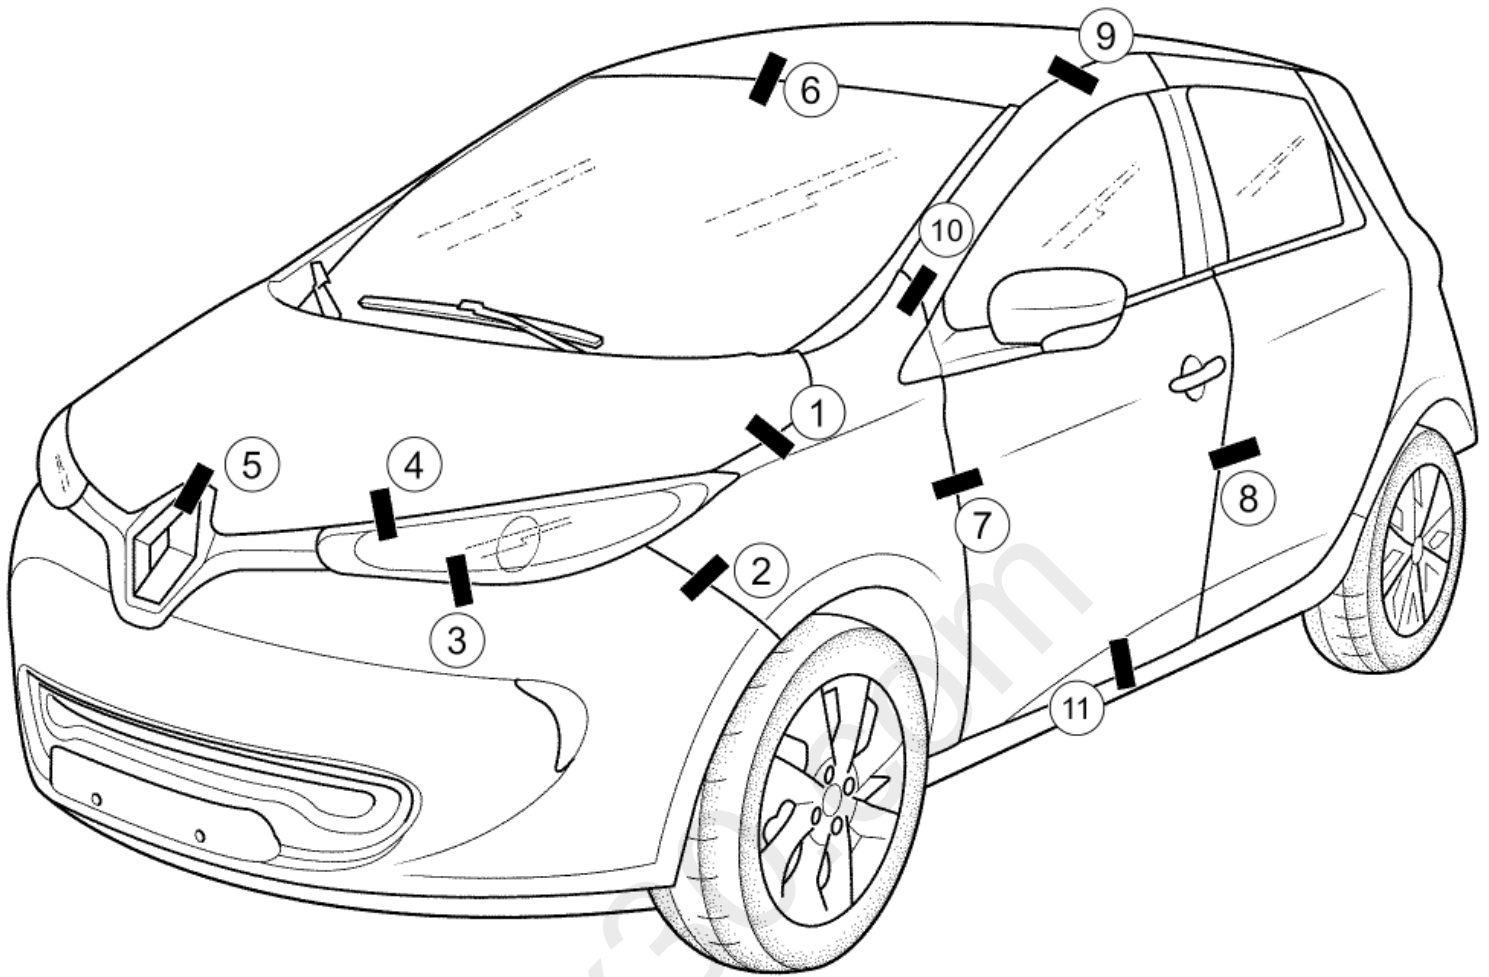
156199

| No. | Location | Clearances (mm) |
| (1) | Front wing - bonnet | $3.5 \pm 1.5$ |
| (2) | Front bumper - front wing | $0 \pm 0.4$ |
| (3) | Headlight - front bumper | $1.5 \pm 1.1$ |
| (4) | Headlight - bonnet | $3.5 \pm 1.8$ |
| (5) | Bonnet - radiator grille | $6.2 \pm 1.7$ |
| (6) | Windscreen - roof panel | $4 \pm 1.5$ |
| (7) | Front wing - front side door | $4 \pm 1.3$ |
| (8) | Front side door - rear side door | $4.5 \pm 1.2$ |
| (9) | Door pillar - roof | $7 \pm 2$ |
| (10) | Front wing - windscreen pillar | $4 \pm 1.3$ |
| (11) | Front door - sill panel | $4.5 \pm 2$ |

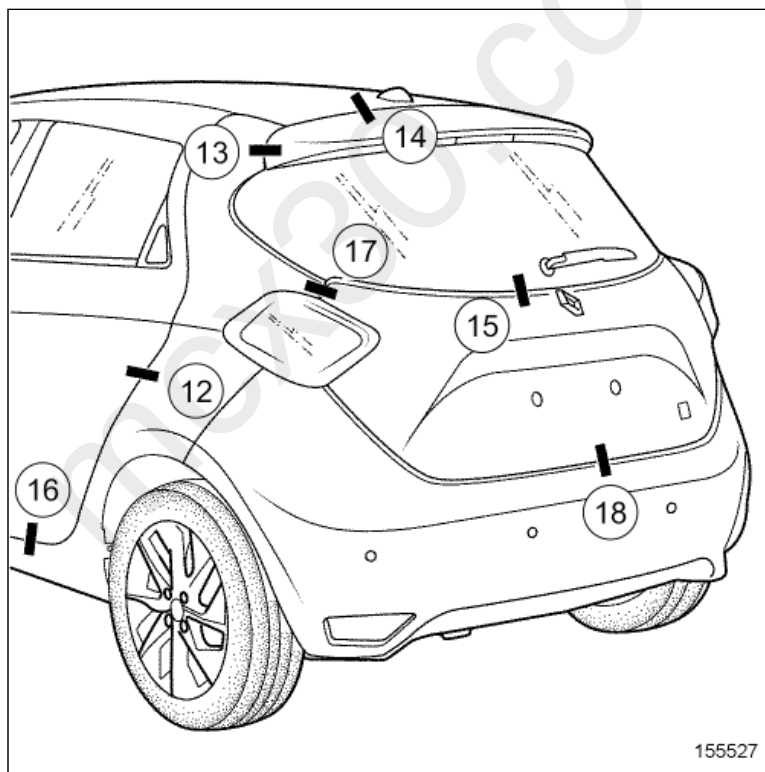
| No. | Location | Clearances (mm) |
| (12) | Rear side door - body side | 4 ± 1 |
| (13) | Rear spoiler - body side | 4 ± 1.9 |
| (14) | Rear spoiler - roof | 7 ± 1.9 |
| (15) | Rear screen - tailgate | 3 ± 1 |
| (16) | Rear door -sill | 4.5 ± 2 |
| (17) | Body side - luggage compartment lid | 4 ± 2 |
| (18) | Luggage compartment lid - rear bumper | 6 ± 2.2 |
