PUBLISHED: 01-OCT-2019  
2020.0 DEFENDER (LE), 501-30

REAR END SHEET METAL REPAIRS

# REAR FLOOR PANEL SIDE EXTENSION LOWER REINFORCEMENT (G2394501)

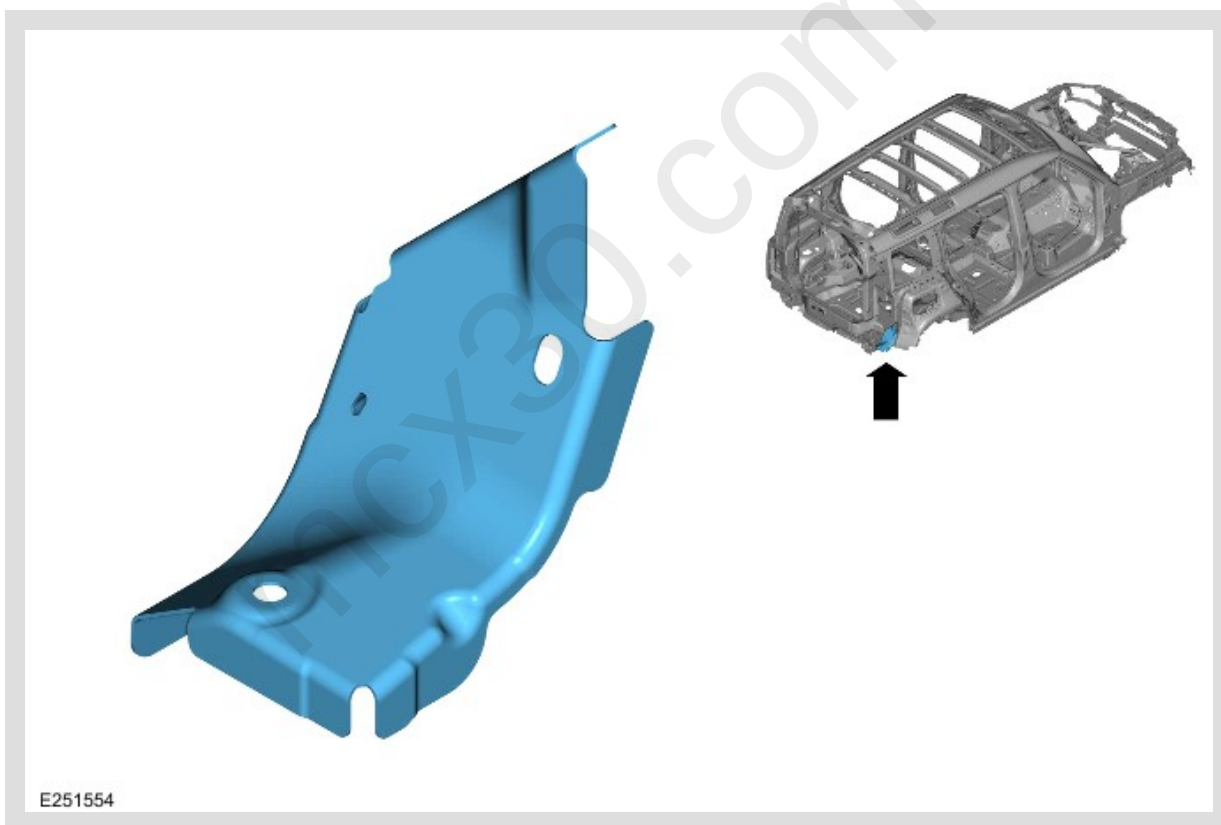
1.

The rear floor panel side extension lower reinforcement is serviced as indicated.

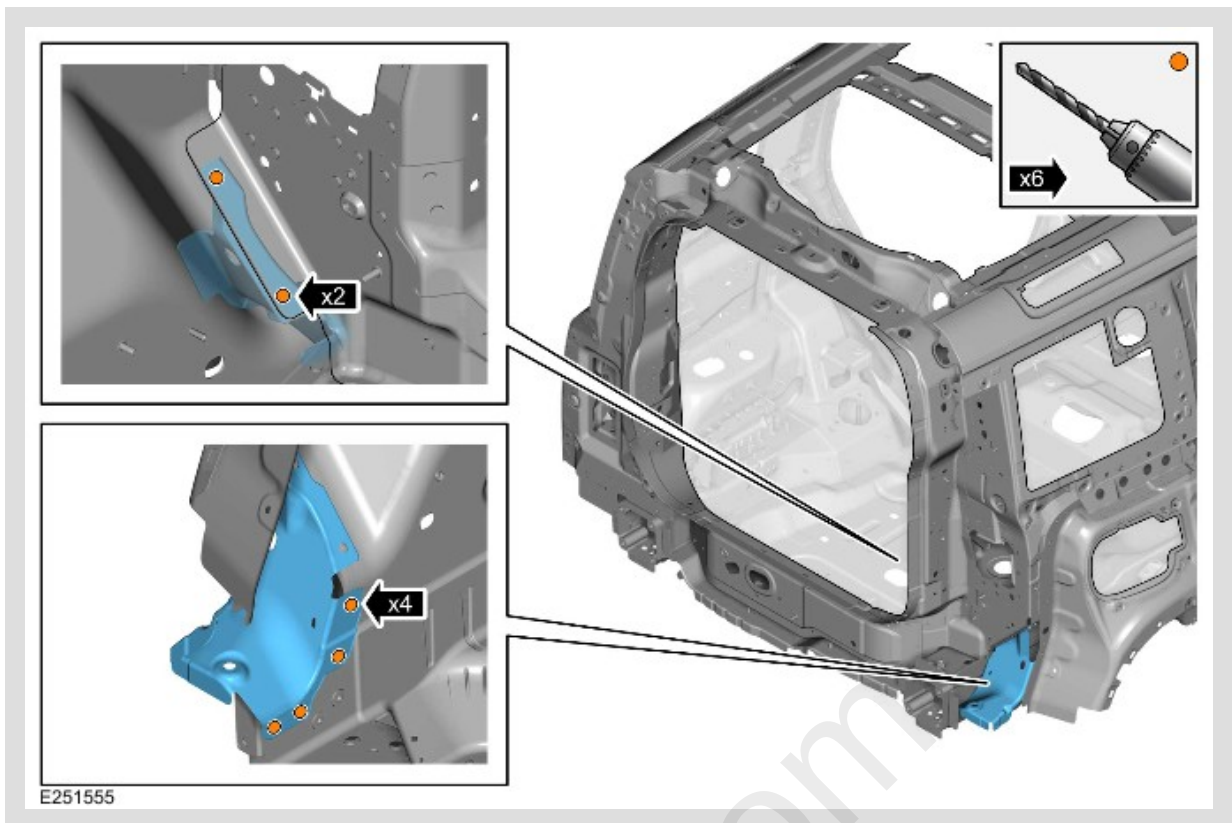
7.

Remove the self piercing rivets as indicated.

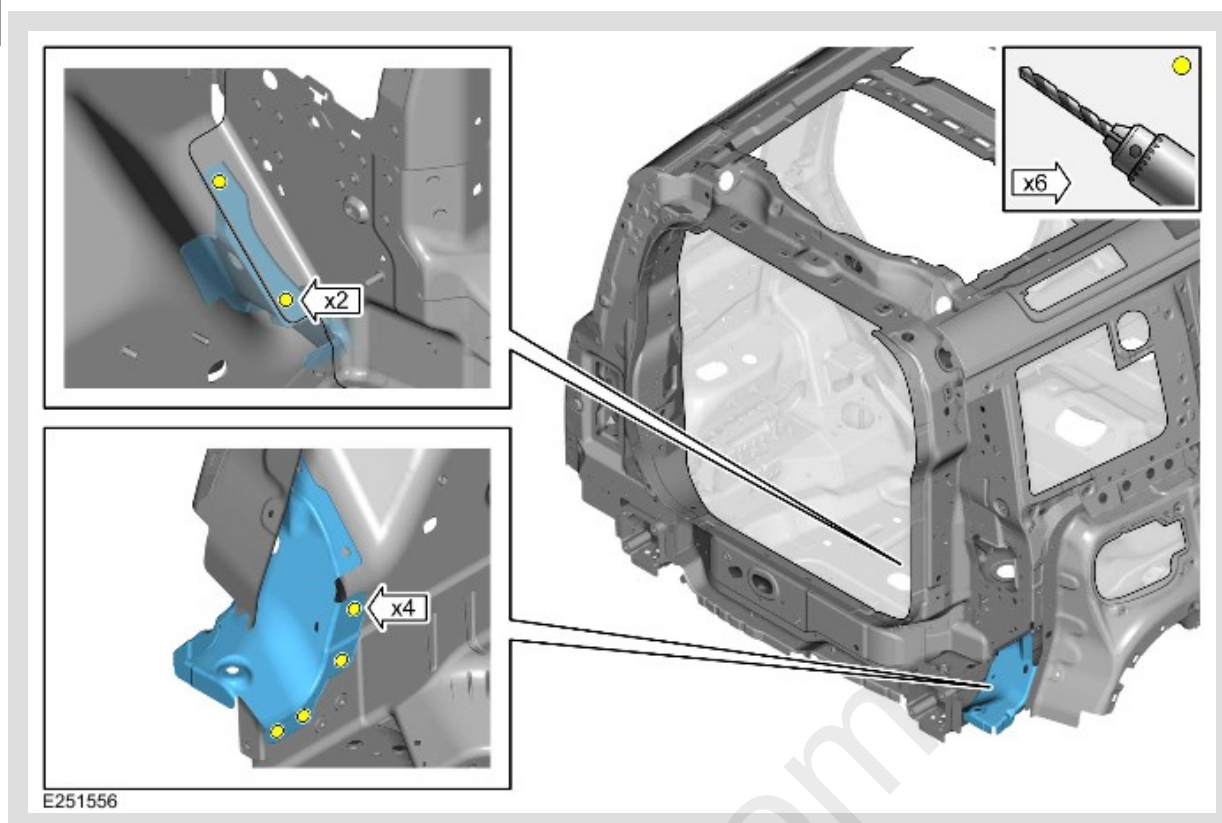
4.

Drill holes where the Breakstem Fasteners (BSFs) are to be installed as indicated.

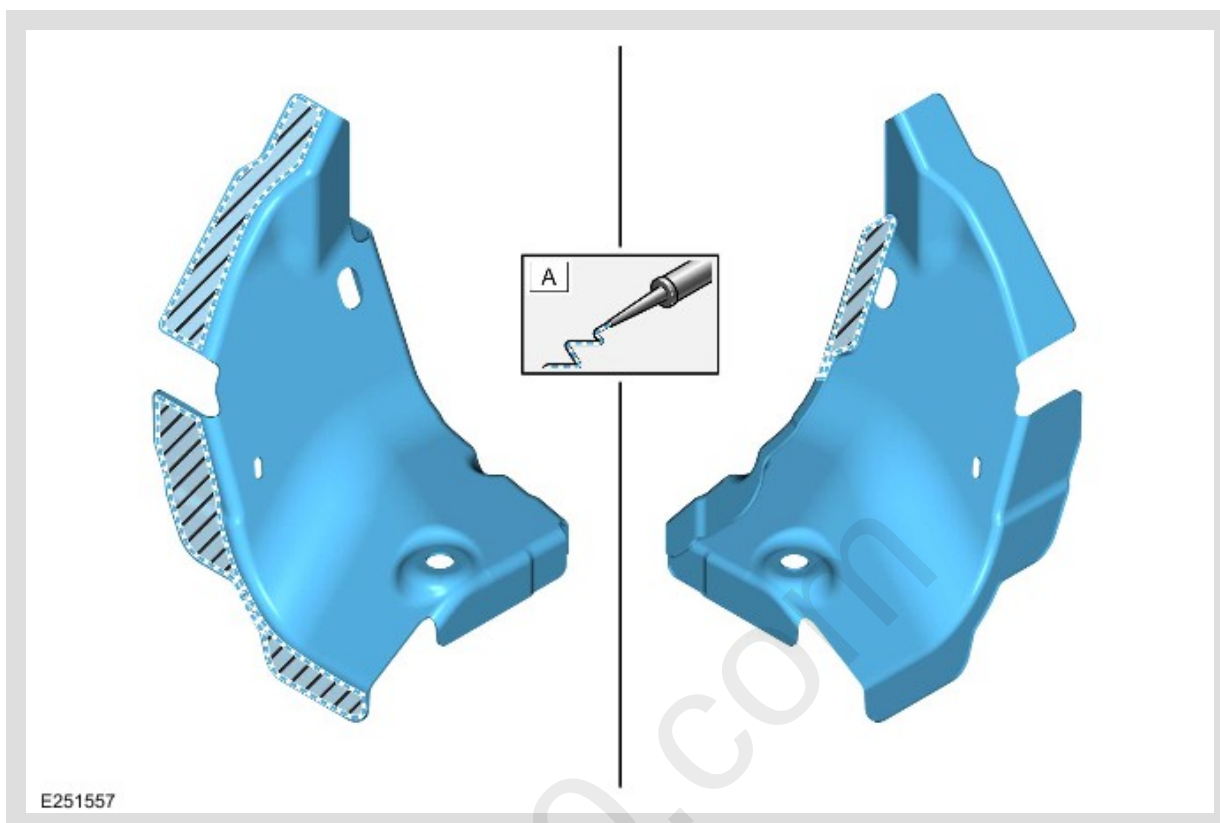
8.

Make sure a continuous bead of adhesive surrounds fixing holes.

Apply a 5 mm zig zag bead of the Jaguar Land Rover (JLR) recommended bonding material as indicated.

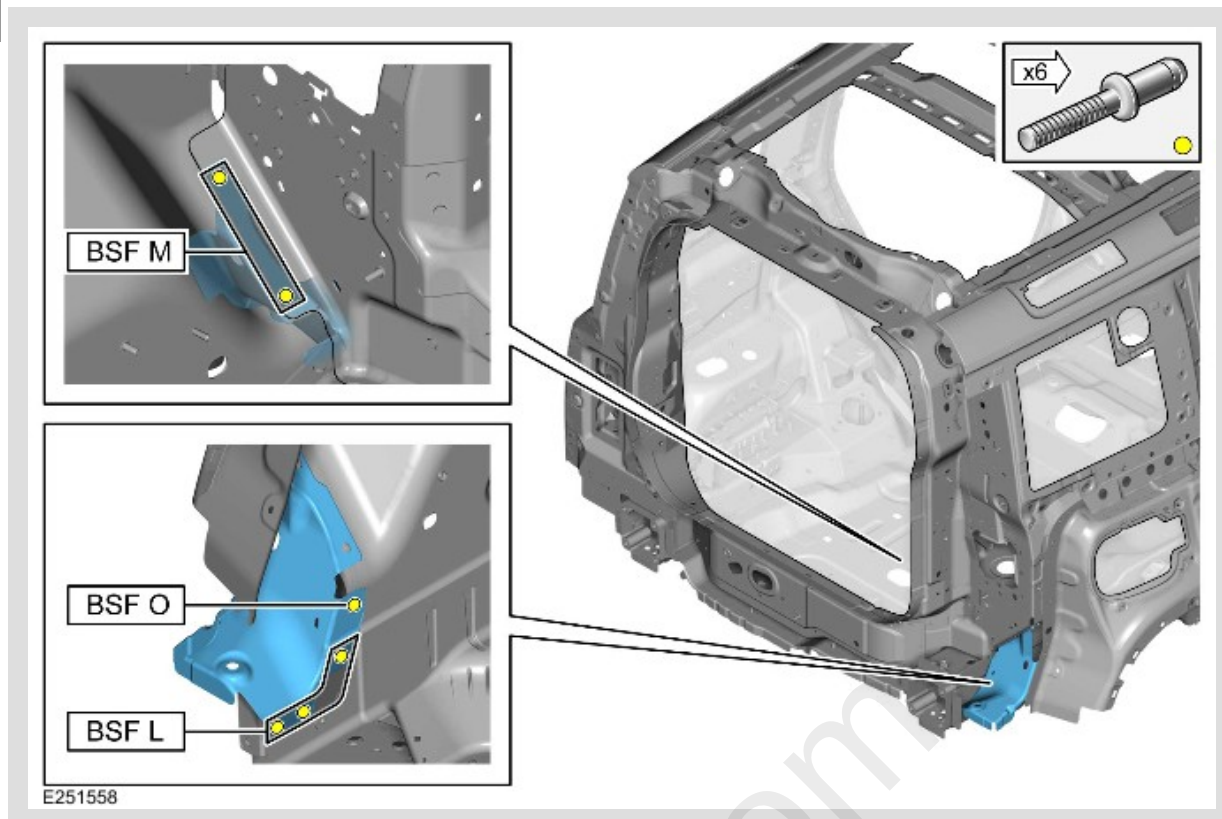
10.

Install the BSFs as indicated.
