PUBLISHED: 28-JAN-2020  
2020.0 DEFENDER (LE), 501-30

REAR END SHEET METAL REPAIRS

# REAR FLOOR PANEL SIDE EXTENSION LOWER REINFORCEMENT - 90 [G2452664]

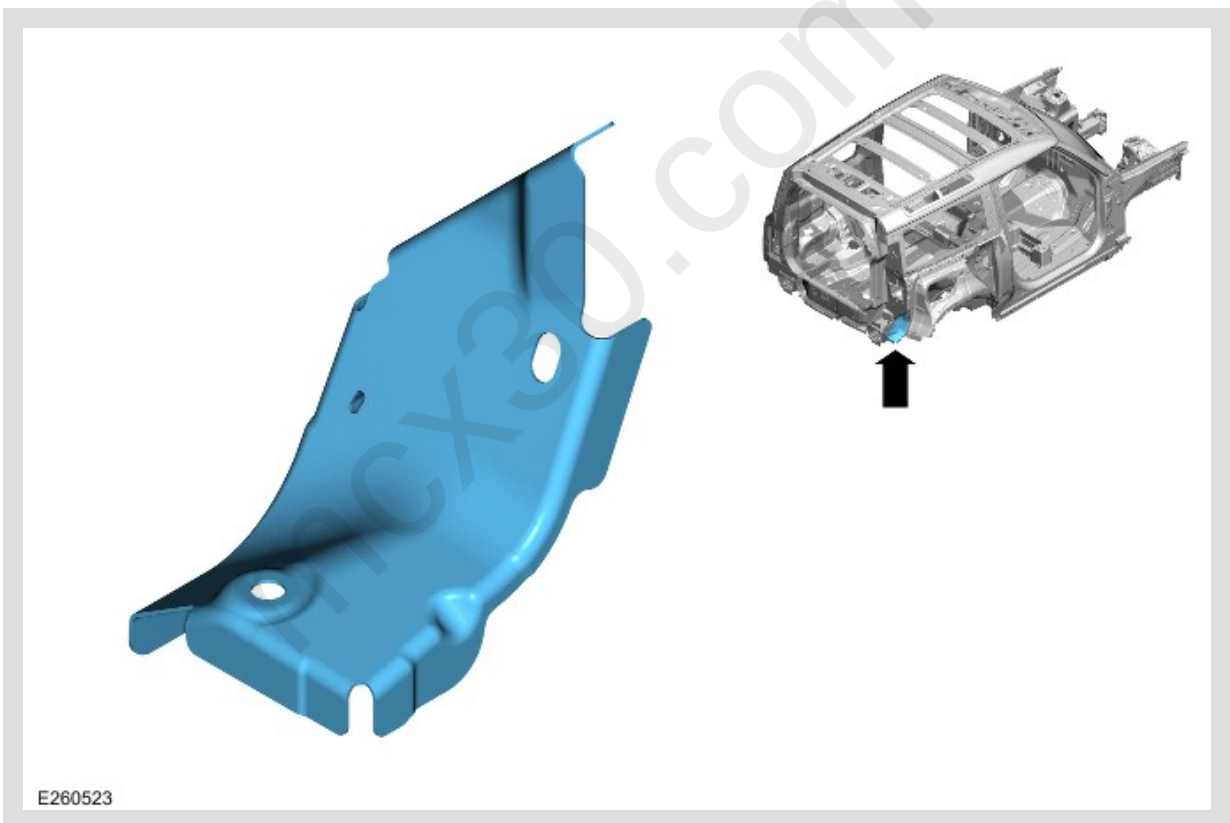
1.

The rear floor panel side extension lower reinforcement is serviced as indicated.

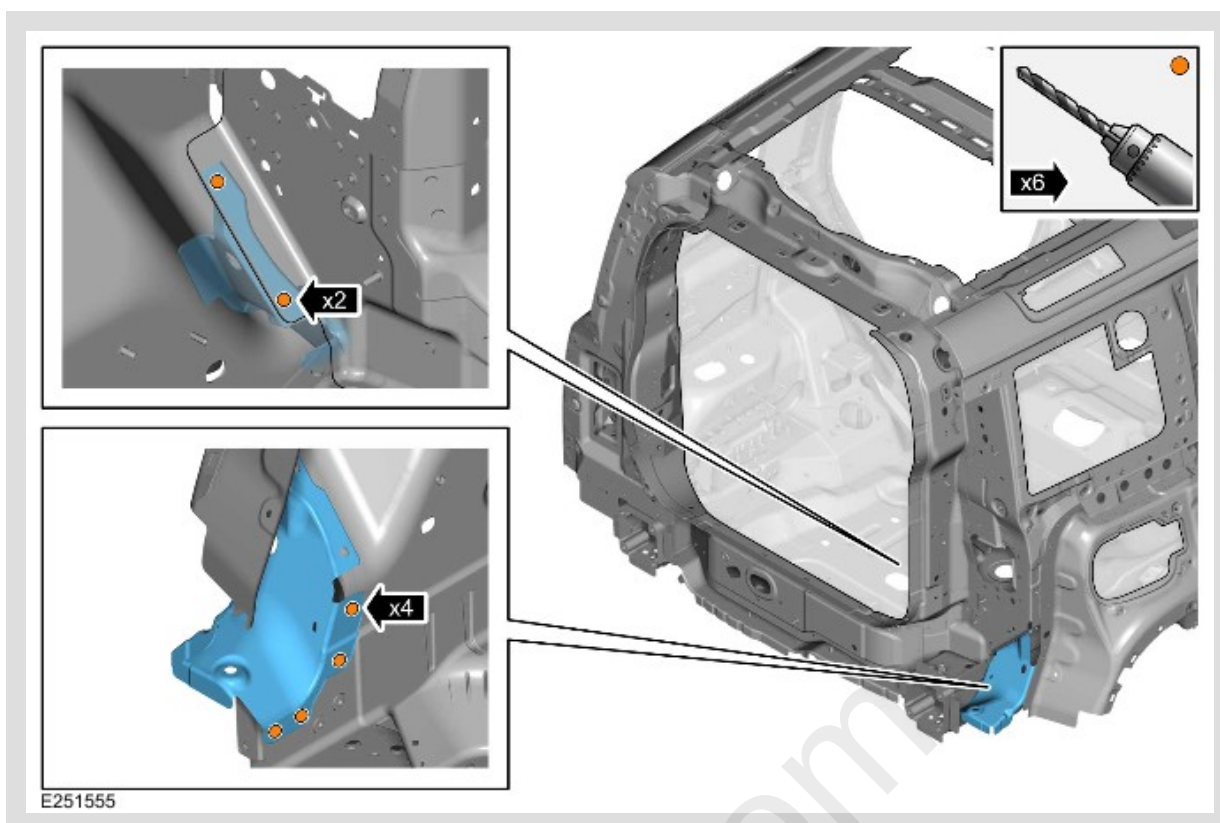
7.

Remove the self piercing rivets as indicated.

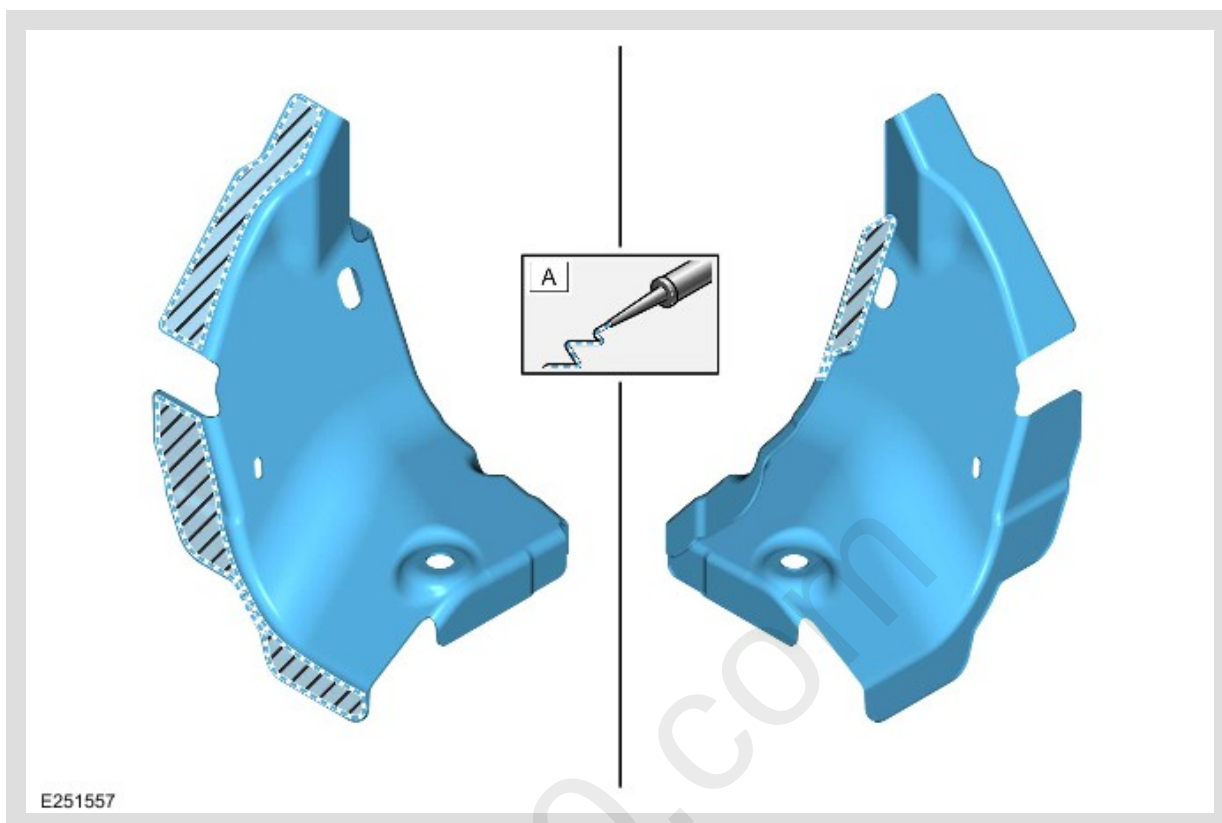
8.

Make sure a continuous bead of adhesive surrounds fixing holes.

Apply a 5 mm zig zag bead of the JLR recommended bonding material as indicated.

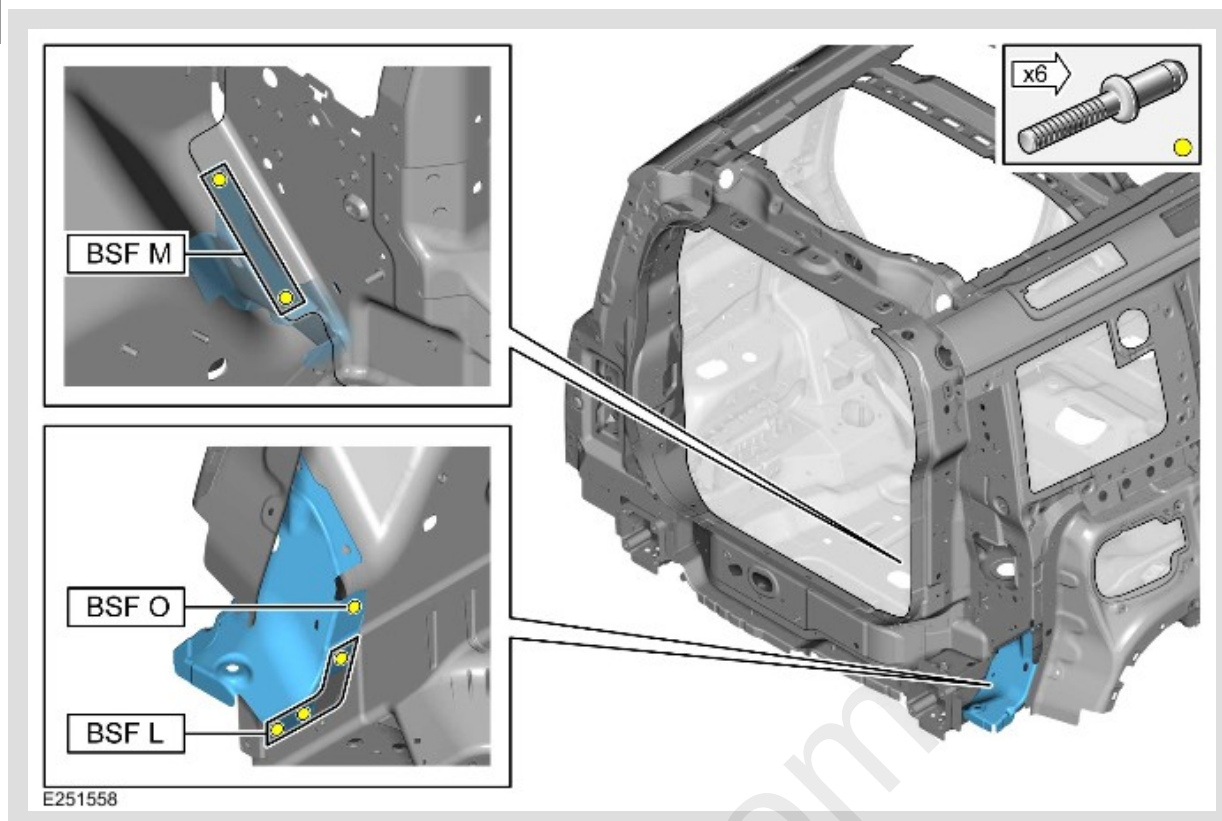
10.

Install the BSFs as indicated.

14. Make sure that all installed BSFs are sealed using a JLR recommended sealer.
