# 2022 CHEVROLET CORVETTE SERVICE MANUAL

## Tire-to-Wheel Match-Mounting (Vectoring)

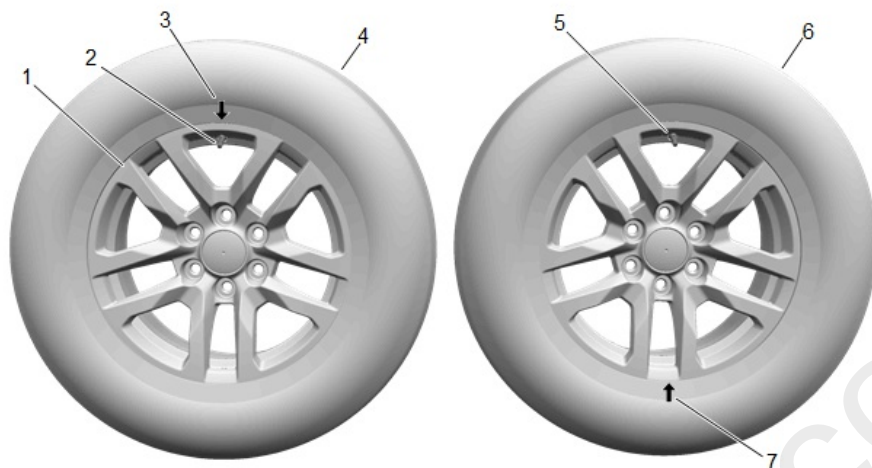
1. Mark the location of the high spot (4) on the tire as determined during the off-vehicle tire and wheel assembly runout measurement.
2. Place a reference mark (3) on the tire sidewall at the location of the valve stem (2).

3.
  - Always refer to the valve stem (2) as the 12 o'clock position.
  - Refer to the location of the high spot (4) by its clock position on the wheel, relative to the valve stem (2).

4. Mount the tire and wheel assembly (1) on a tire machine and break down the bead. Do not dismount the tire from the wheel at this time.
5. Rotate the tire 180 degrees on the rim so that the valve stem reference mark (7) is now at the 6 o'clock position in relation to the valve stem (5). You may need to lubricate the bead in order to easily rotate the tire on the wheel (1).

6. Reinflate the tire and seat the bead properly.
7. Mount the assembly on the tire balancer and remeasure the runout. Mark the new location of the assembly runout high spot on the tire.

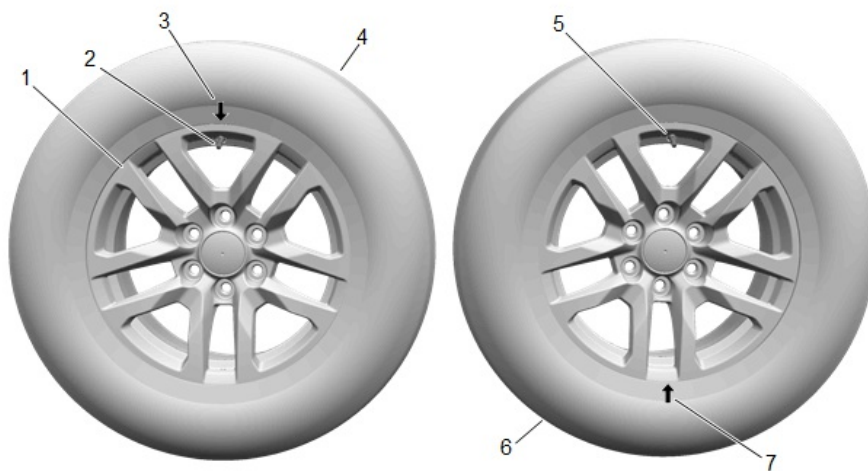
10. If the clock location of the high spot remained at or near the original clock location of the high spot (6) and the assembly runout has NOT been reduced, the wheel (1) is the major contributor to the assembly runout concern.

11.  
[Click here for full size](#)
12. If the clock location of the high spot has moved, however the assembly runout has NOT been reduced, perform the following steps:
- 13.
1. If the clock location of the high spot (6) is now at or near a position 180 degrees from the original clock location of the high spot (4), the tire is the major contributor to the assembly runout concern.
  2. If the clock location of the high spot is now in-between the 2 extremes, then both the tire and the wheel (1) are both contributing to the assembly runout concern. Rotate the tire an additional 90 degrees in both the clockwise and the counterclockwise directions to obtain the lowest amount of assembly runout.
