# 2022 CHEVROLET CORVETTE SERVICE MANUAL

1. **Engine/Propulsion**
2. **Engine Controls and Fuel - 6.2L (LT2)**
3. **Repair Instructions**
- 4.

## **Engine Control Module Replacement**

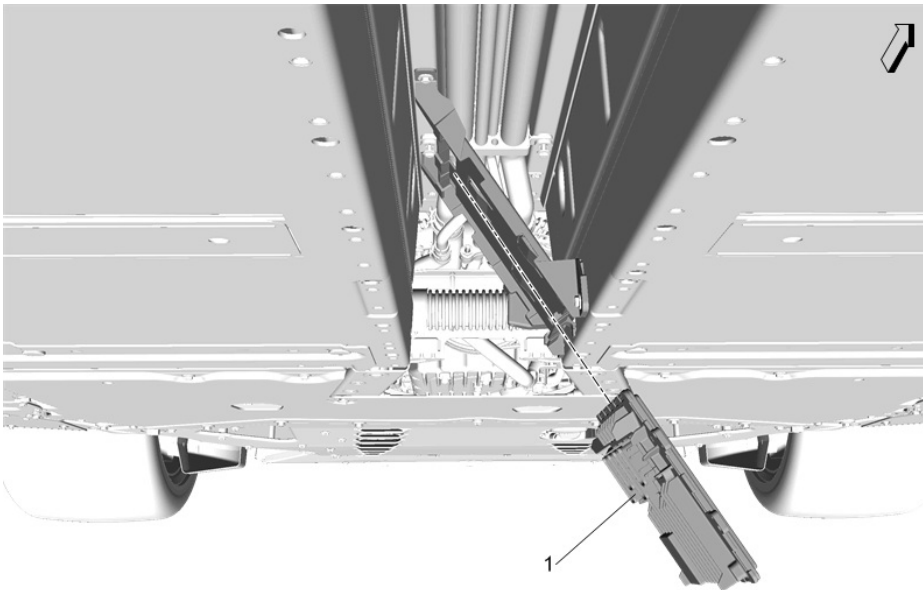
4. [Click here for full size](#)
5. Disconnect the engine control module electrical connectors and release the retaining tabs.
6. Engine Control Module (1>) >> Remove

1. Before removing the engine control module (ECM), record the oil life percentage remaining.
2. Disconnect the negative battery cable. Battery Negative Cable Disconnection and Connection
3. Floor Panel Tunnel Panel Front Reinforcement - Mid-Tunnel >> Remove - Floor Panel Tunnel Panel Front Reinforcement Replacement - Mid-Tunnel

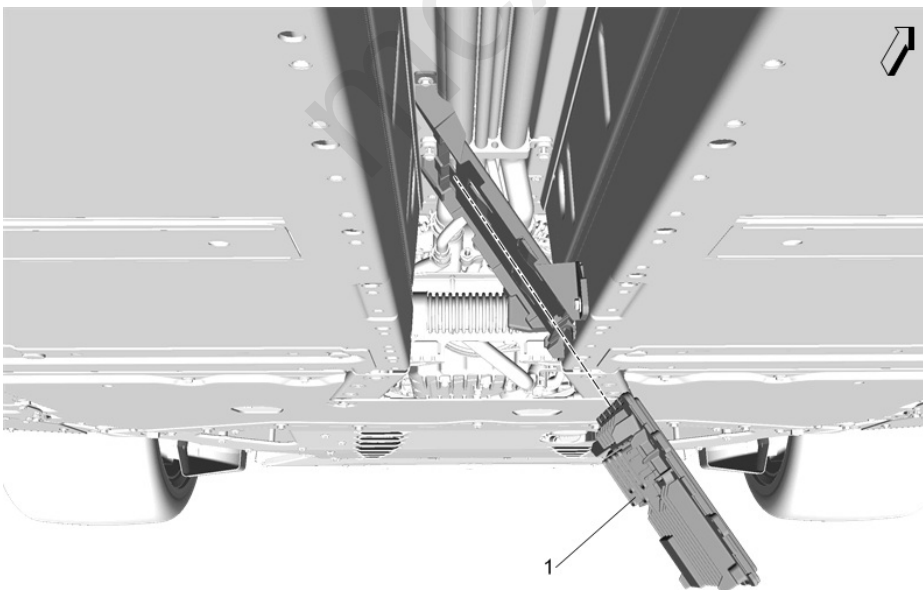
1. [Click here for full size](#)
2. Engine Control Module (1>) >> Install

3. Connect the electrical connectors to the engine control module.
4. Floor Panel Tunnel Panel Front Reinforcement - Mid-Tunnel >> Install - Floor Panel Tunnel Panel Front Reinforcement Replacement - Mid-Tunnel
5. Connect the negative battery cable. Battery Negative Cable Disconnection and Connection
6. Program the replacement module. Control Module References
7. Perform the particulate filter service regeneration. Particulate Filter Service Regeneration
8. Use the scan tool to reset the engine oil life remaining back to the original percentage recorded.
