## Power Steering Assist Motor Replacement

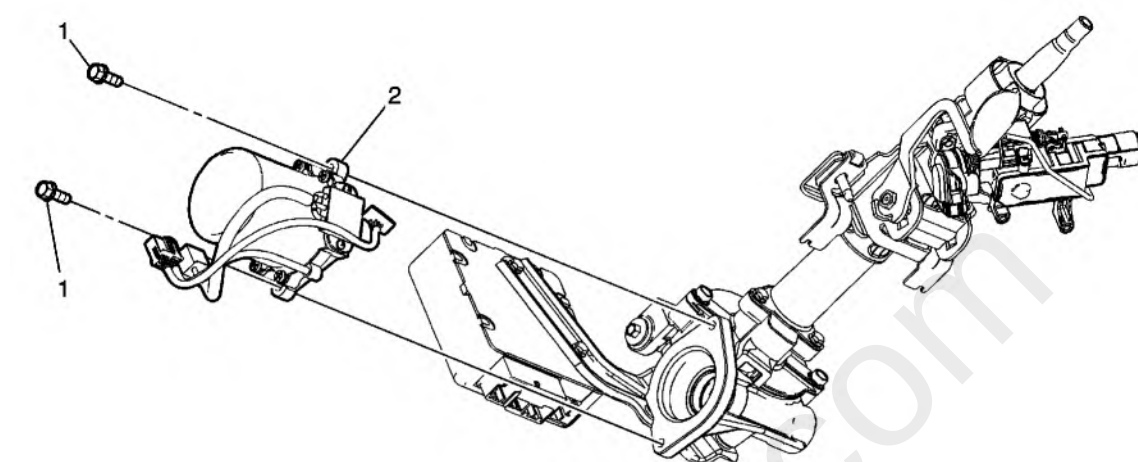
| Callout | Component Name |
| 1 | Power Steering Assist Motor Bolt (Qty: 2)<br><br><b>Caution:</b> Refer to <a href="#">Fastener Caution</a> in the Preface section.<br><br><b>Tighten</b><br>18 N·m (13 lb ft) |
| 2 | Power Steering Assist Motor<br><br><b>Procedure</b><br><br>Disconnect any electrical connectors as needed. |

| Callout | Component Name |
|---|---|
| <h3>Preliminary Procedures</h3> <ol style="list-style-type: none"><li>1. Remove the left side instrument panel outer trim cover. Refer to <a href="#">Instrument Panel Outer Trim Cover Replacement - Left Side</a>.</li><li>2. Remove the left side instrument panel insulator panel. Refer to <a href="#">Instrument Panel Insulator Panel Replacement - Left Side</a>.</li><li>3. Remove the driver knee bolster reinforcement. Refer to <a href="#">Driver Knee Bolster Reinforcement Replacement</a>.</li></ol> | |
