# REARSIDEMEMBERASSEMBLY:REPLACEMENT

## 1. COMPOSITION OF THE SPARE PART

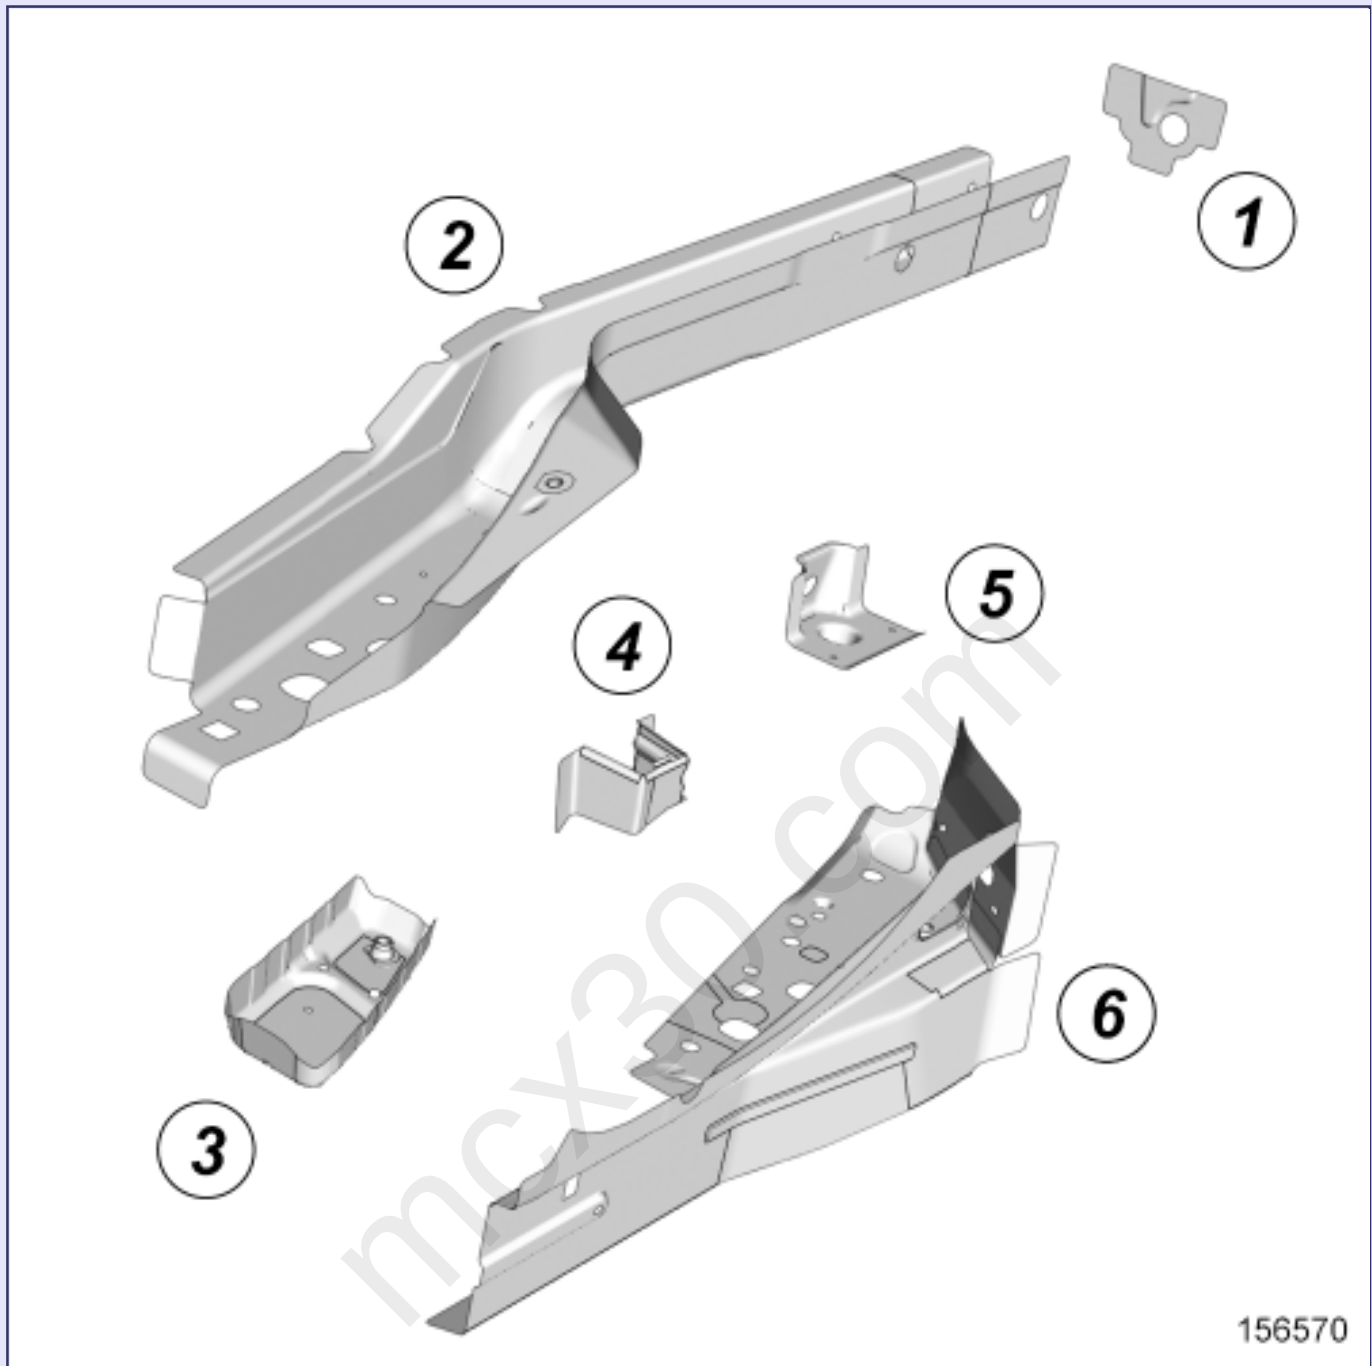
156570

| No. | Description | Type | Thickness (mm) |
| (1) | Closure panel component on rear side member | HLE | 2.2 |
| (2) | Rear side member | HLE | 1.5 |

| (3) | Rear axle assembly mounting reinforcement | HLE | 2.8 |
| (4) | Rear side member centre reinforcement | HLE | 1.5 |
| (5) | Rear suspension spring support | HLE | 2 |
| (6) | Sill panel reinforcement | HLE | 1.5 |

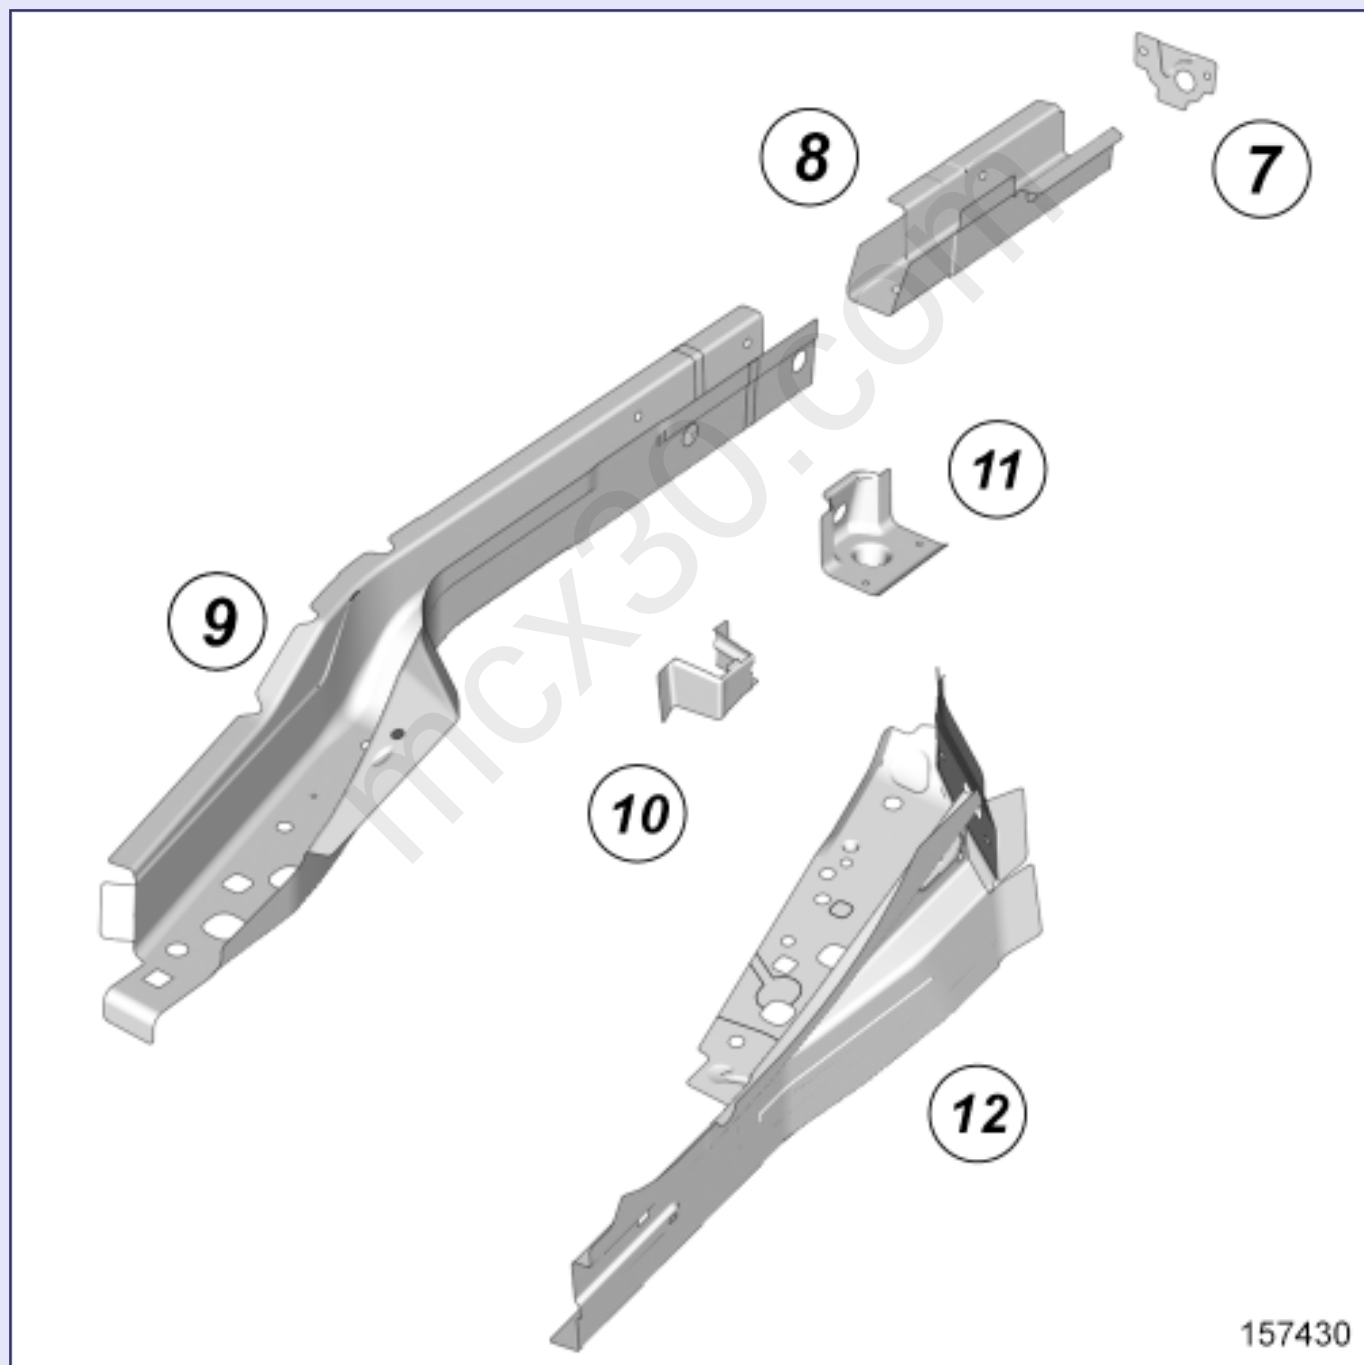
157430

K98(K98)

| No. | Description | Type | Thickness (mm) |
| (7) | Closure panel component on rear side member | HLE | 2.2 |
| (8) | Rear side member extension | HLE | 2 |
| (9) | Rear side member | HLE | 1.5 |
| (10) | Rear side member centre reinforcement | HLE | 1.5 |
| (11) | Rear suspension spring support | HLE | 2 |
| (12) | Sill panel reinforcement | HLE | 1.5 |

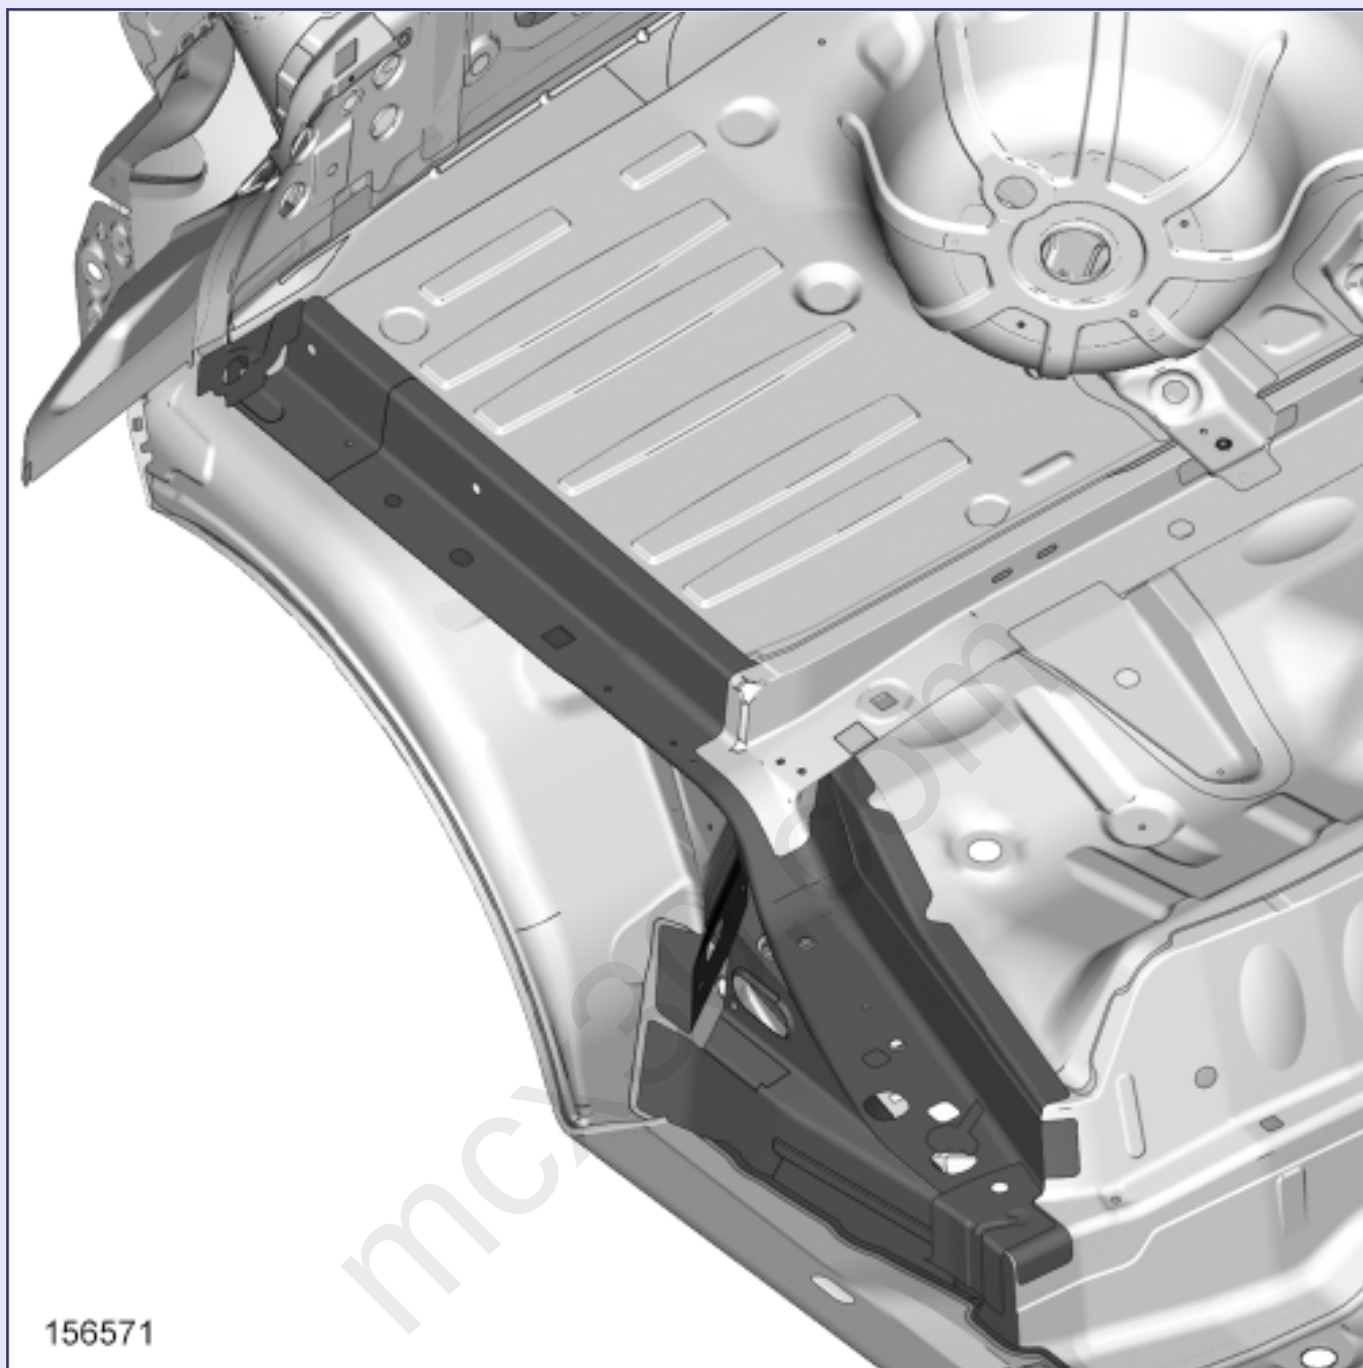
**B98(B98) VIEW FROM BELOW**

1)PART IN POSITION
