# REAR SIDEMEMBER: REPLACEMENT

## 1. COMPOSITION OF THE SPARE PART

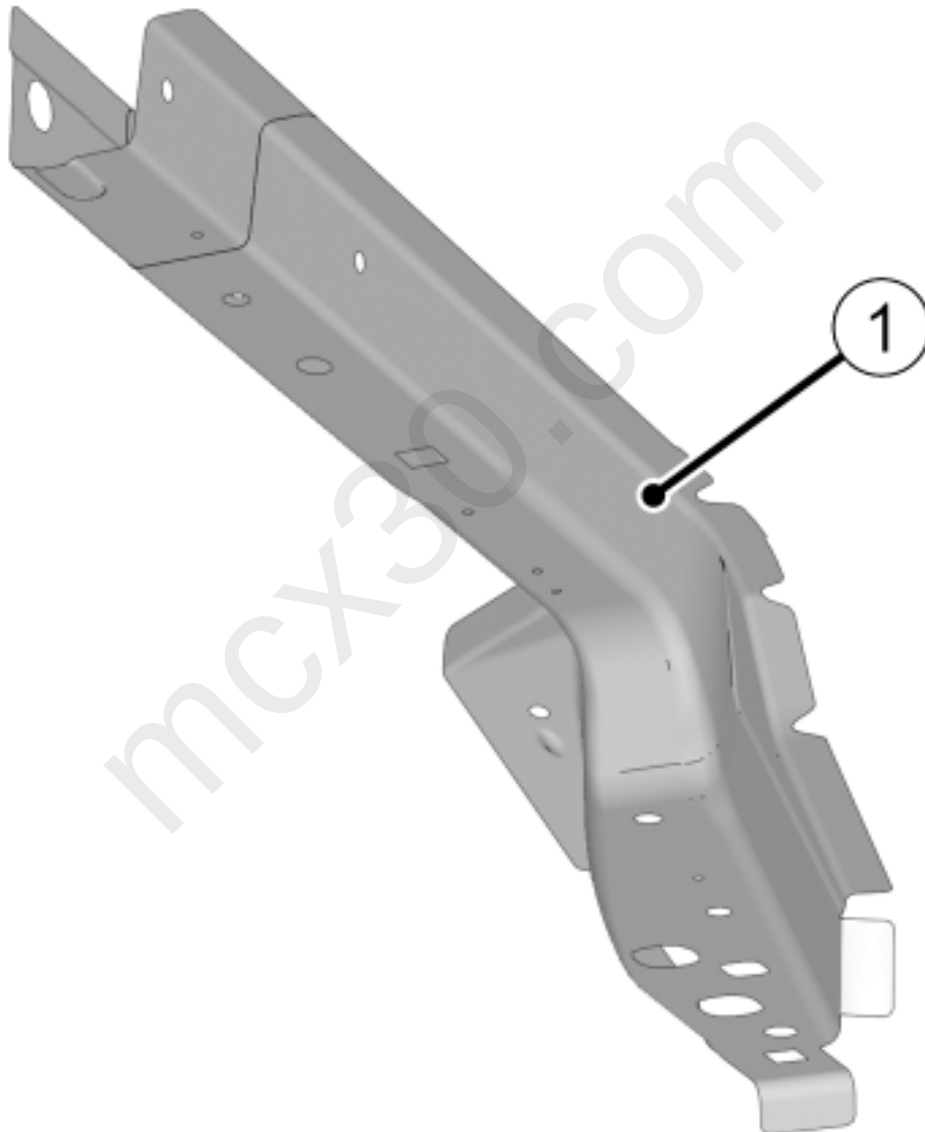
156566

| No. | Description | Type | Thickness (mm) |
| (1) | Rear side member | | 1.5 |

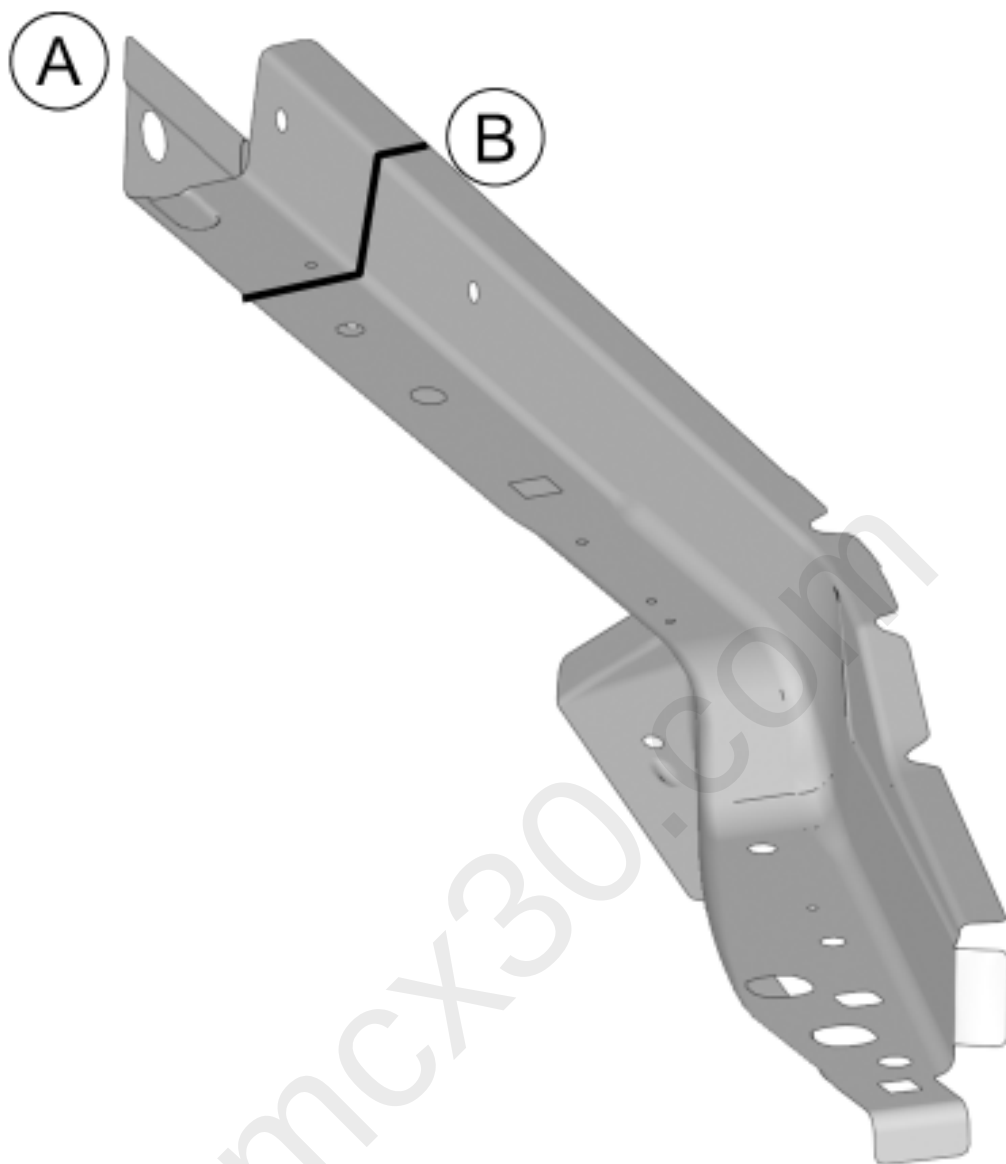
156564

There is only one way of replacing this part:

- partial replacement A-B.

#### 1- PARTIAL REPLACEMENT A-B

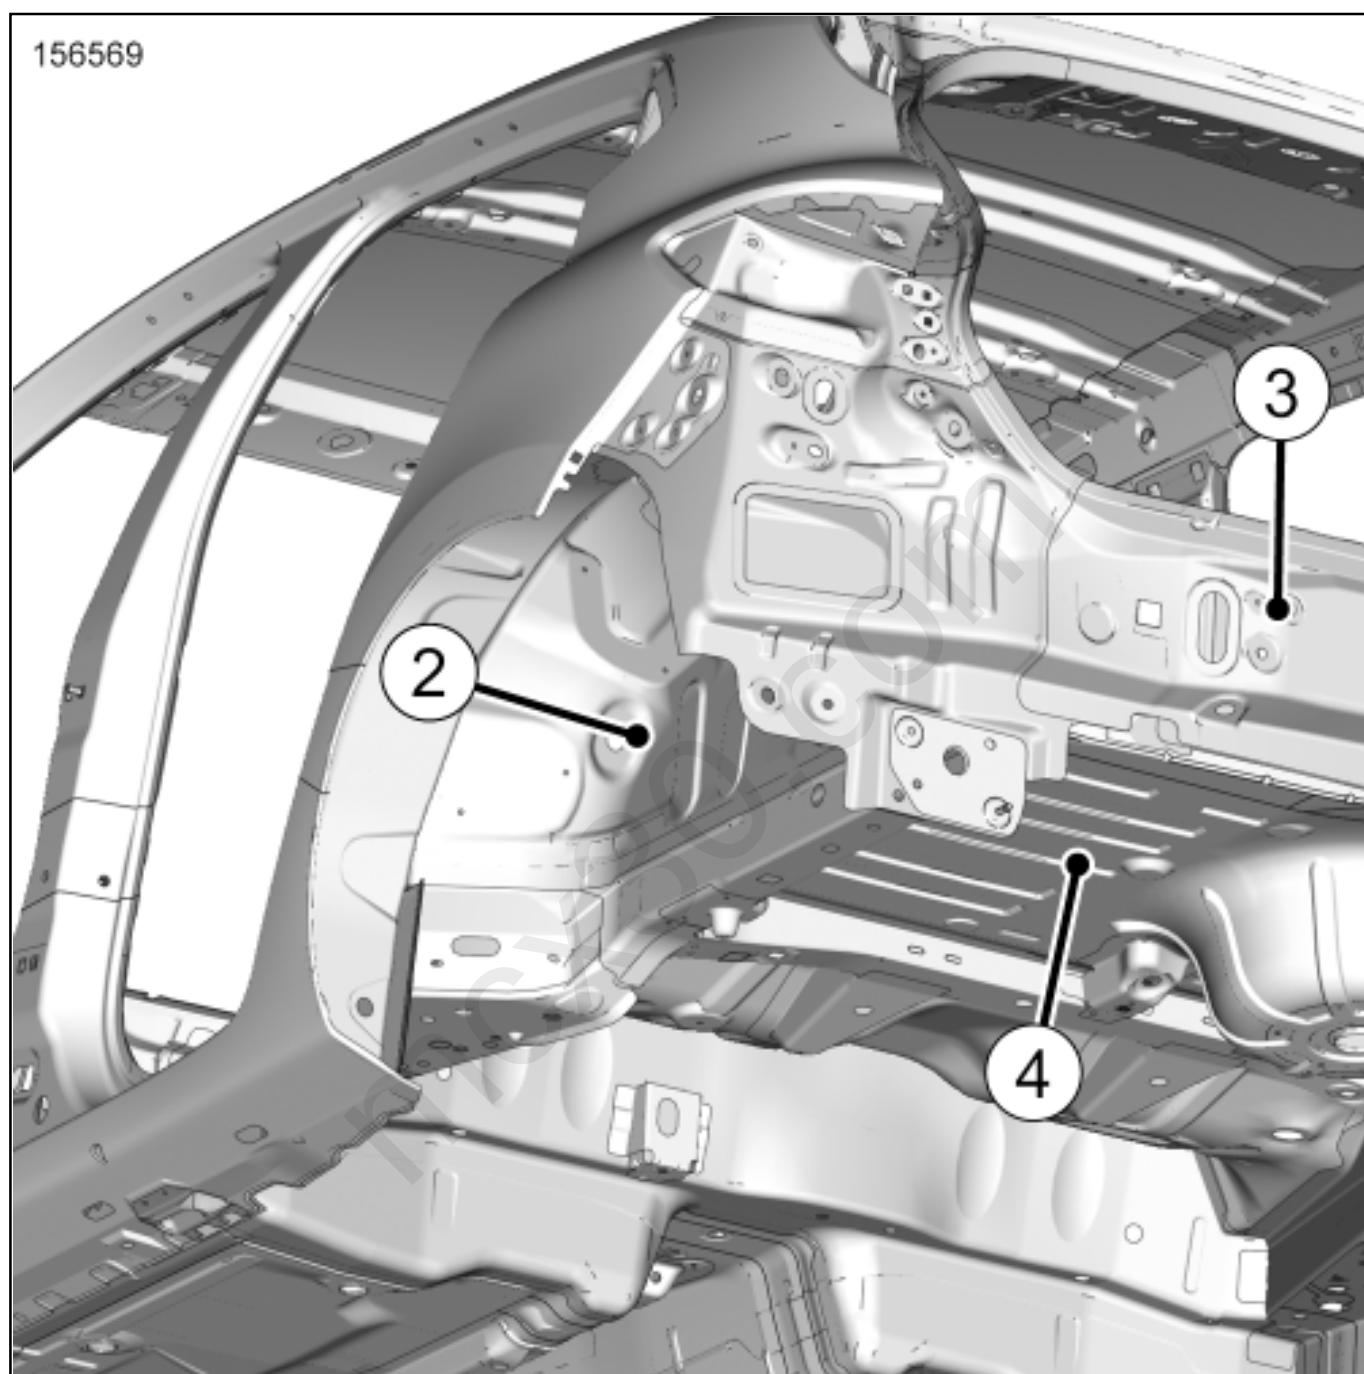
3) BODYWORK COMPONENTS THAT CANNOT BE REMOVED - STRUCTURES TO BE REMOVED IN ORDER TO CARRY OUT THE REPLACEMENT OPERATION

Remove:

- the rear bumper assembly [Rear bumper assembly: Exploded view](#) ,
- the rear lights support [Rear light mounting: Replacement](#) ,
- the inner rear wheel arch (2) ,
- the rear end panel (3) ,
- the sill panel [Sill panel: Replacement](#) ,
- the rear section of rear floor (4) .
