# ROCKER COVER: REMOVAL - REFITTING

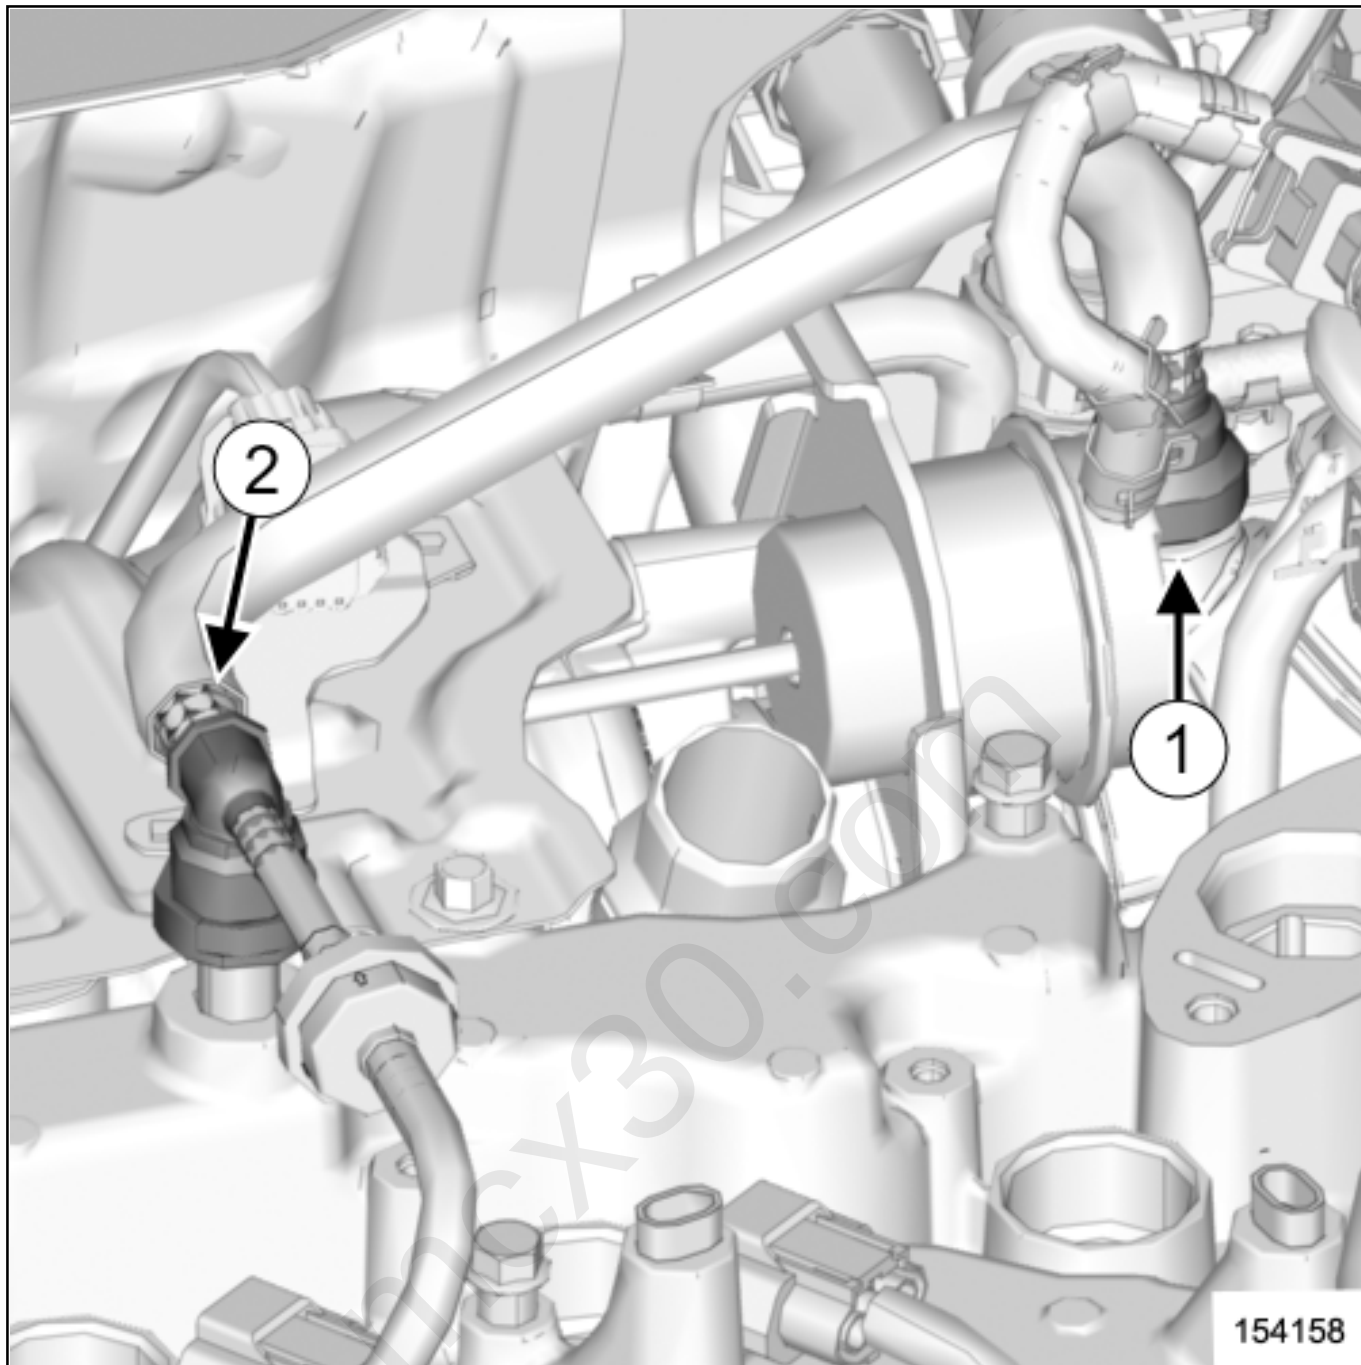
- the petrol vapour rebreathing pipe from the turbo-manifold air inlet pipe(1) ,
- the petrol vapour rebreathing pipe from the rocker cover(2) .

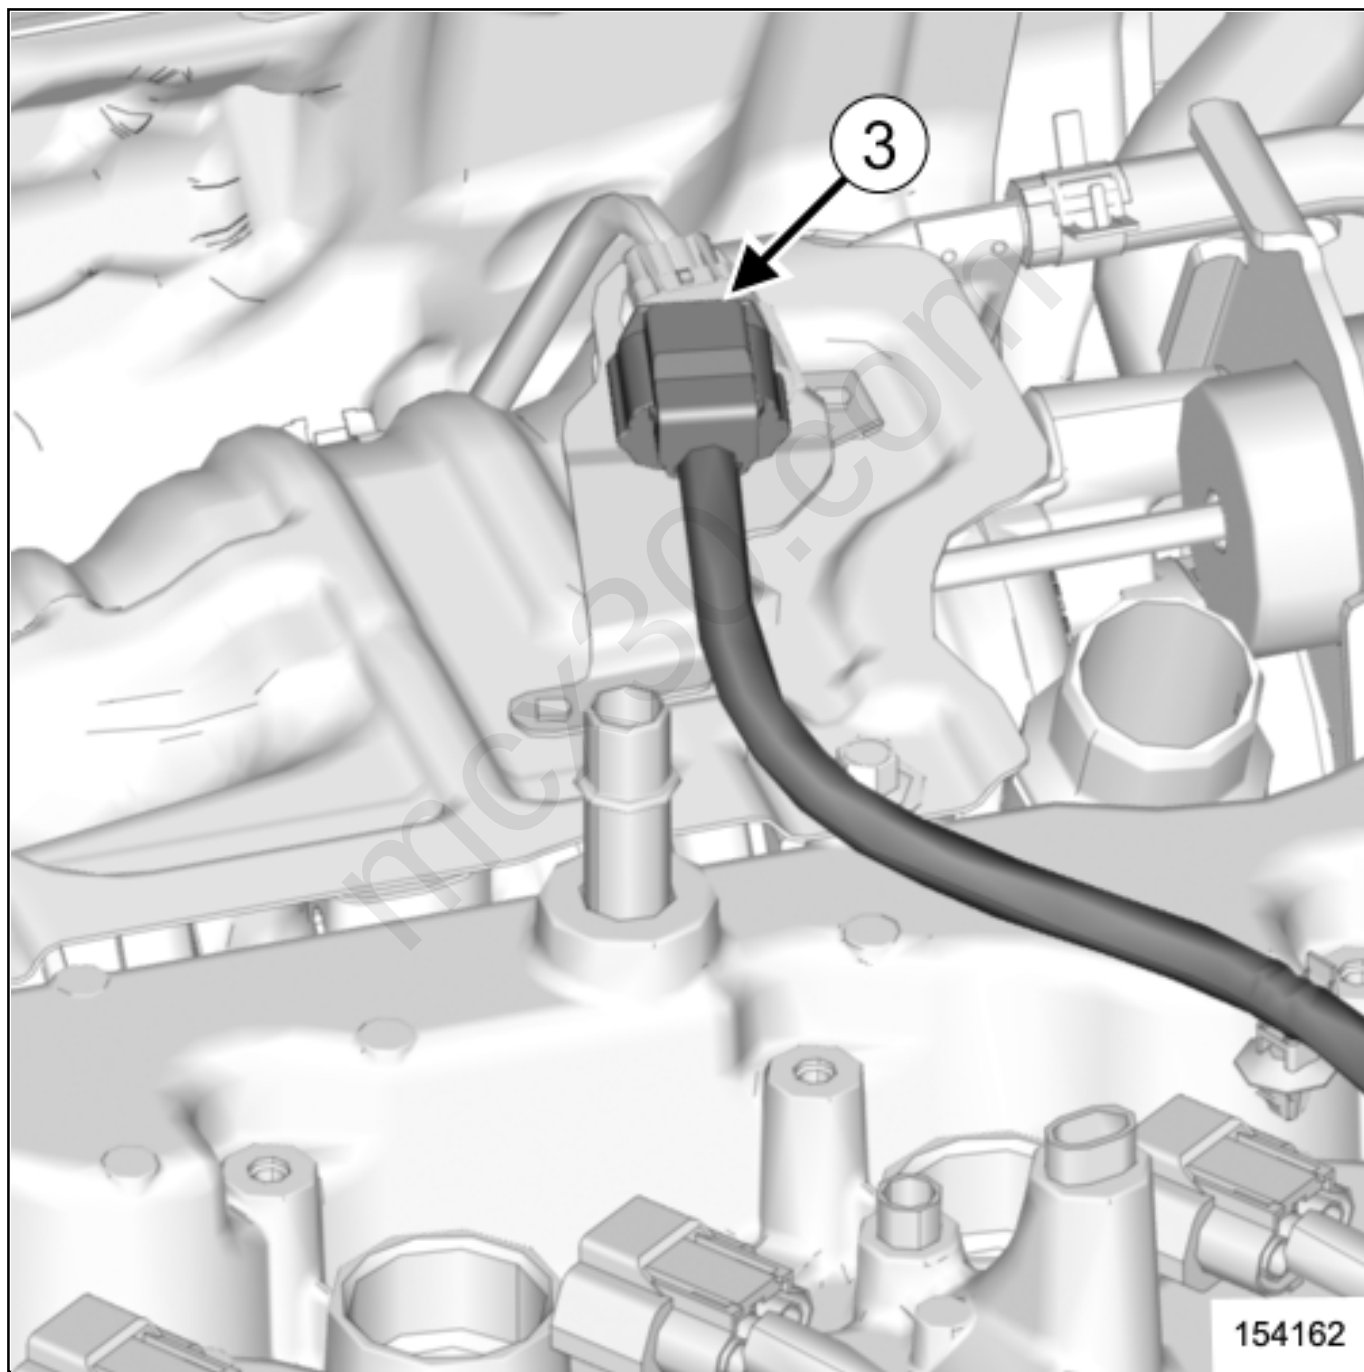
Disconnect the downstream oxygen sensor connector(3) .

Unclip the downstream oxygen sensor connector.

Move the downstream oxygen sensor wiring.

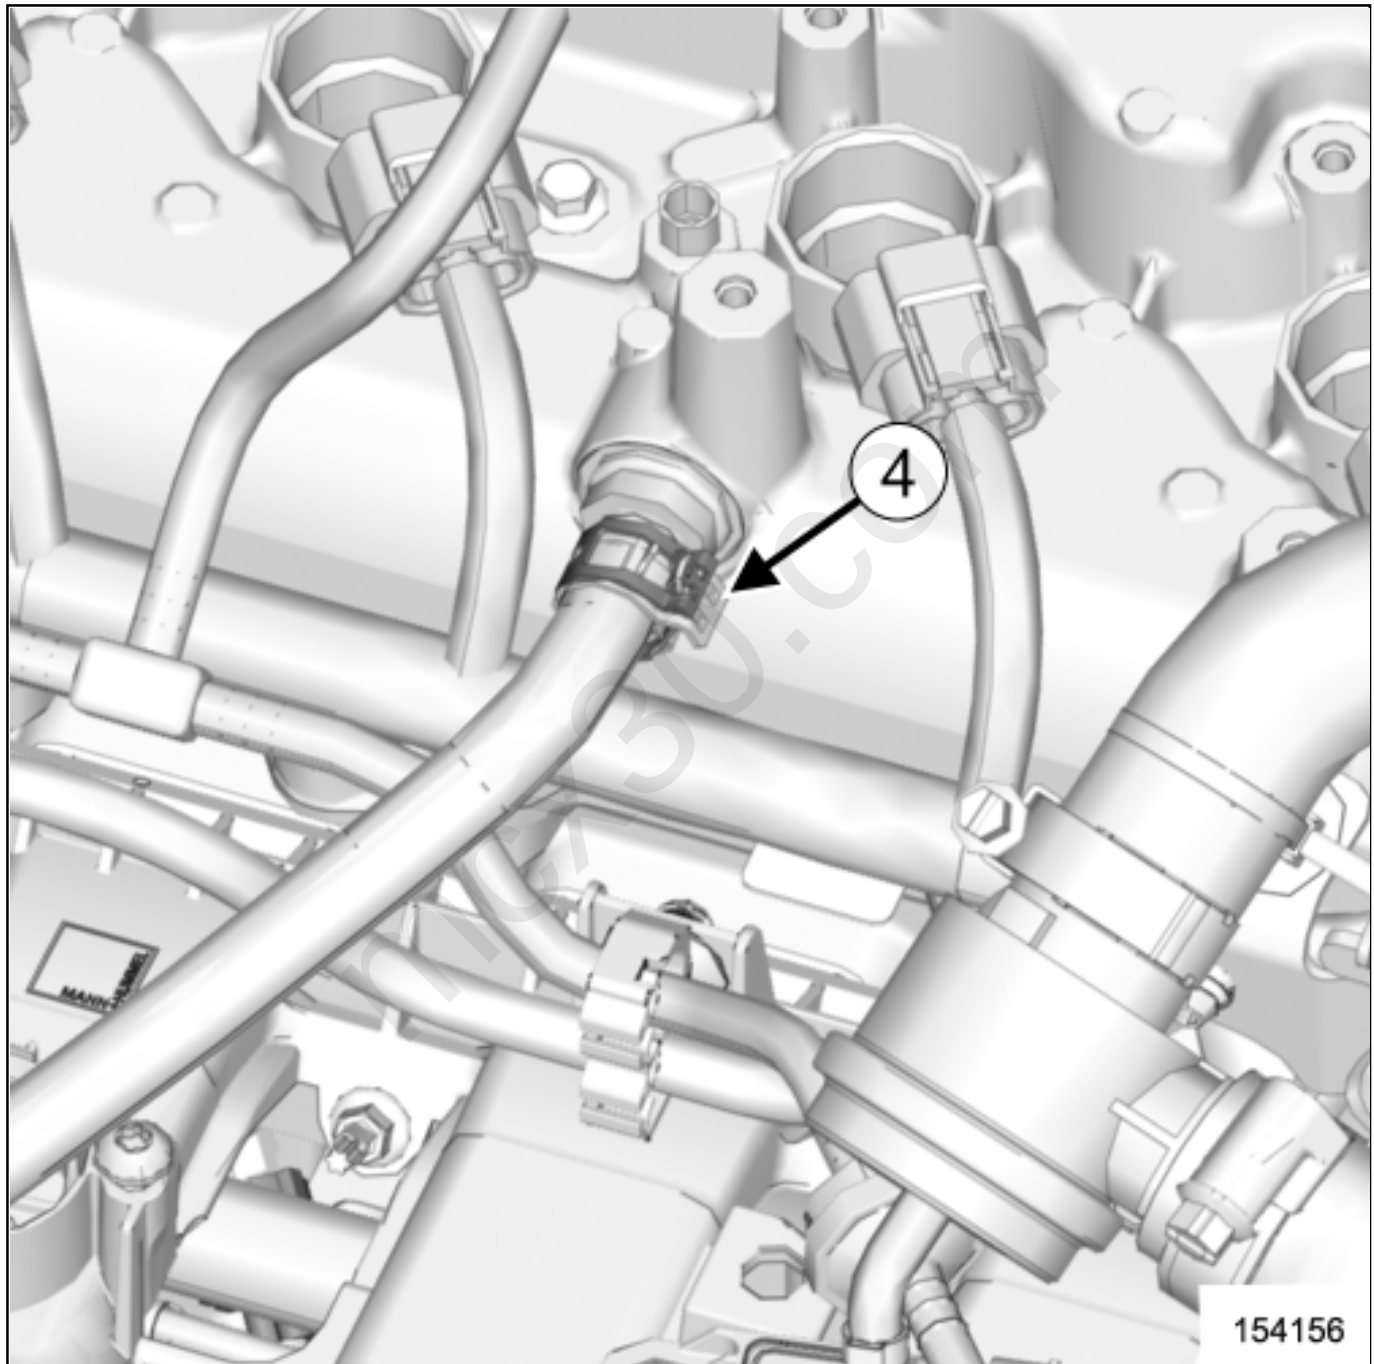
Move the clip from oil vapour re-breathing pipe(4) .

Disconnect the oil vapour rebreathing pipe from the rocker cover.

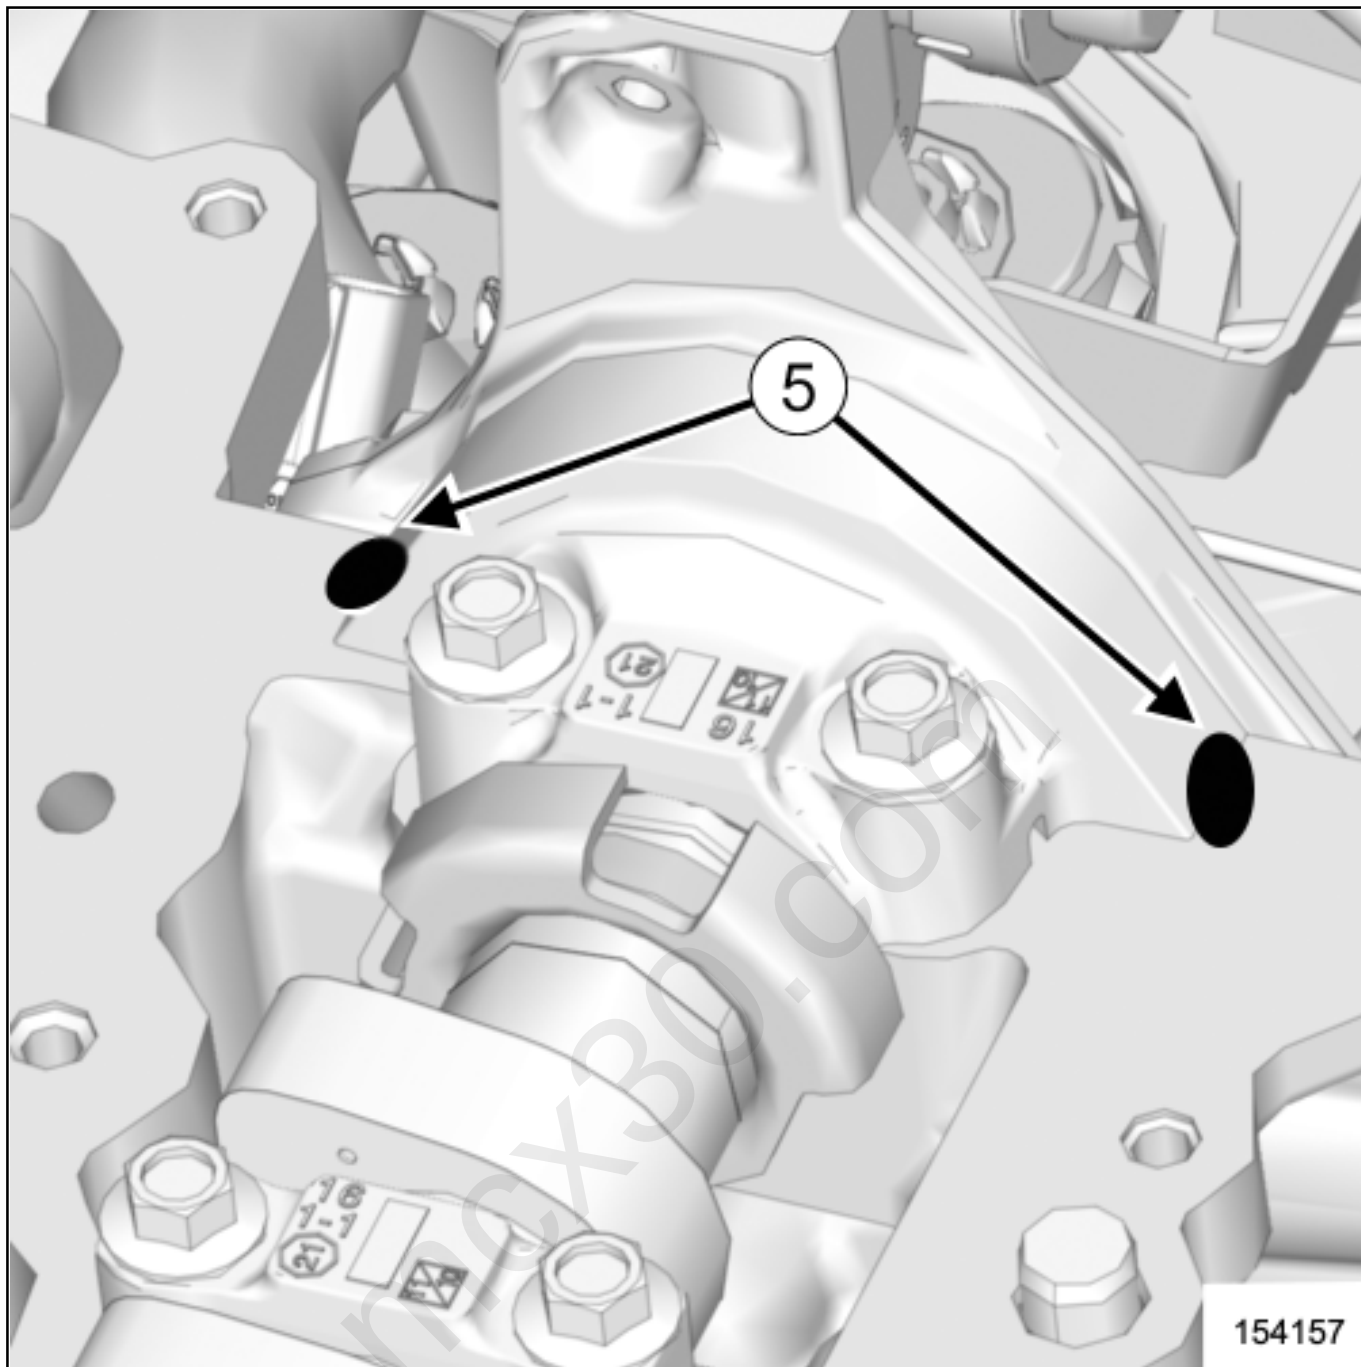
Apply dots (5) of silicone adhesive sealant [Vehicle: Parts and consumables for the repair](#) to the cylinder head.
