# MULTIMEDIA WIRING : REMOVAL - REFITTING

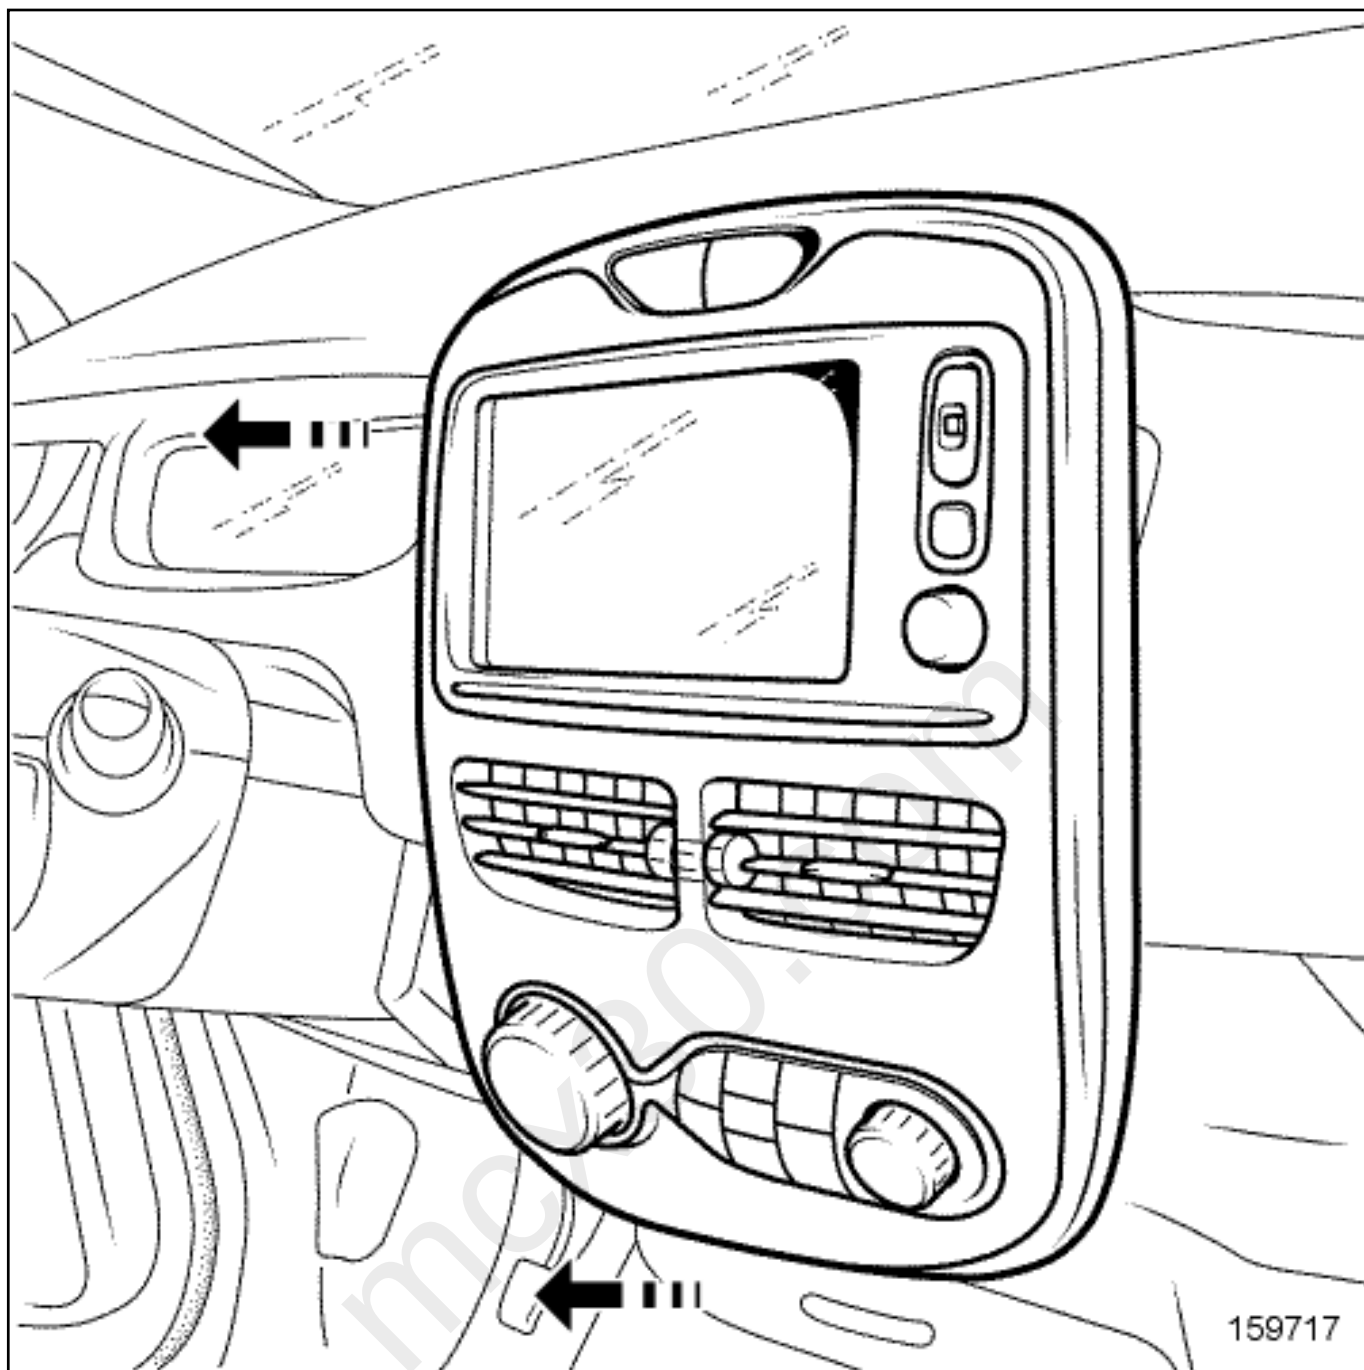
- Remove the centre front panel following the direction in the arrow.

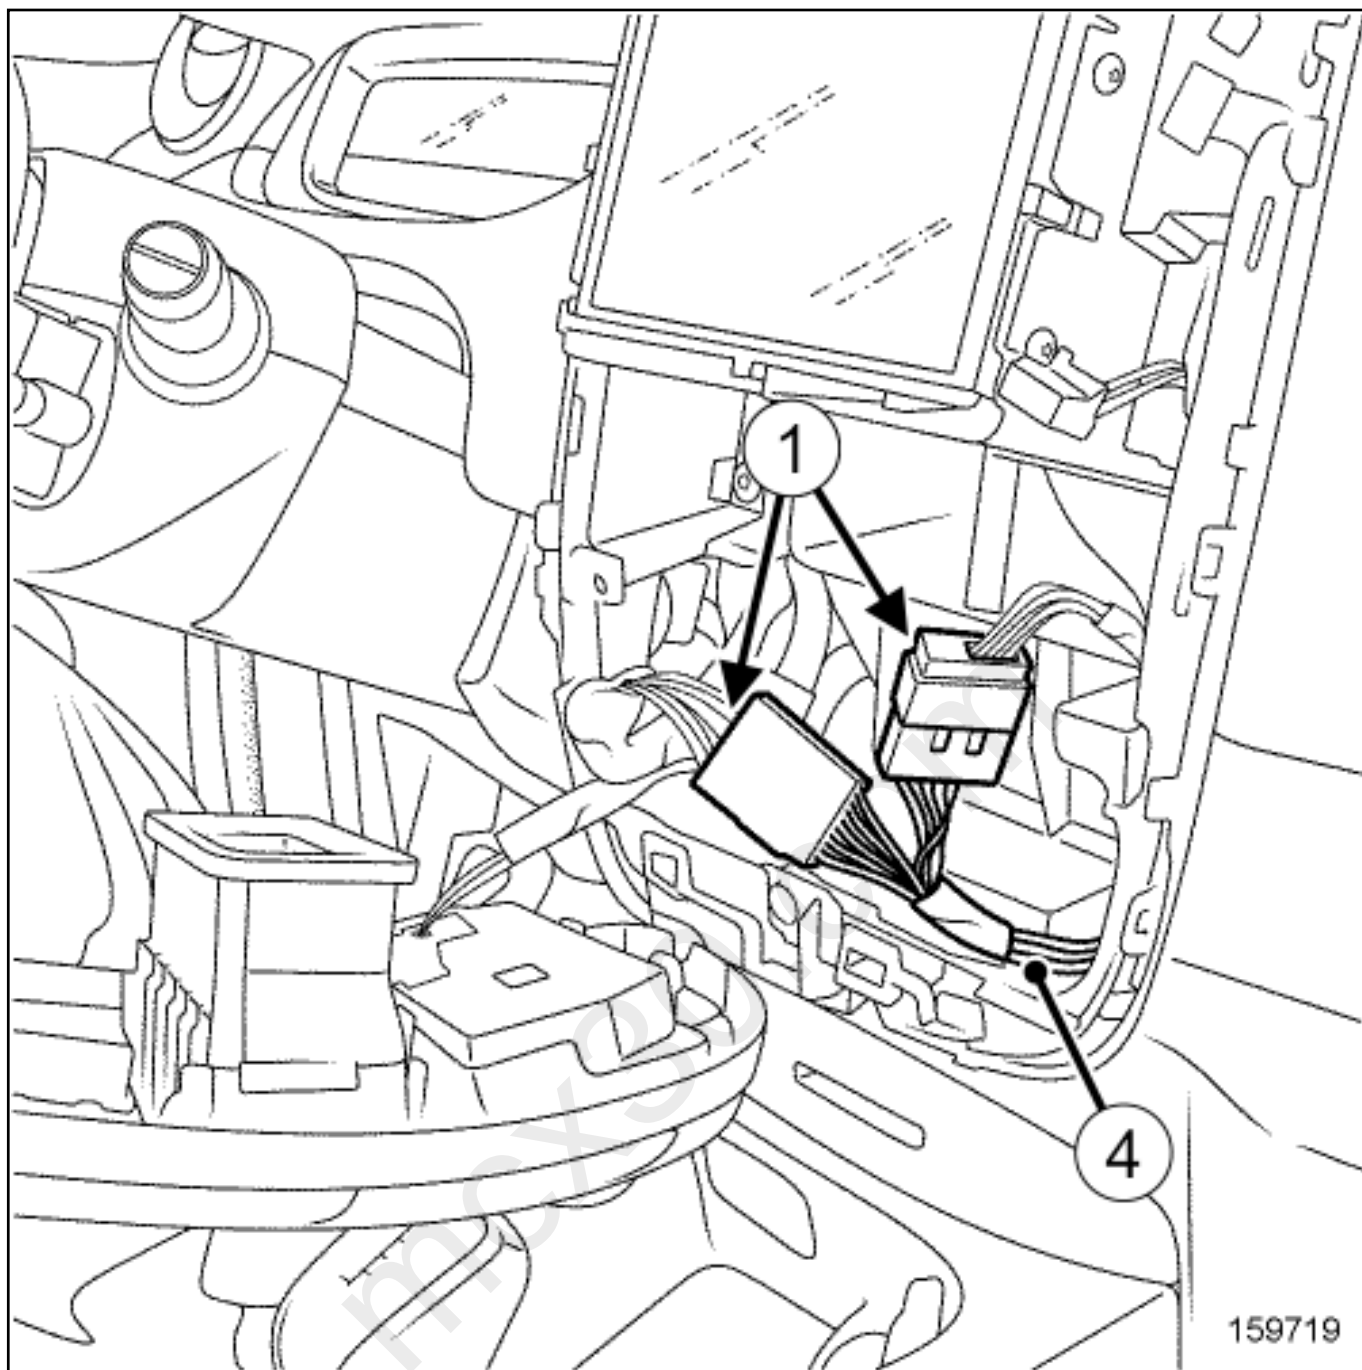
■ Disconnect (1) :

- the control panel connector,
- the radio navigation system connector.

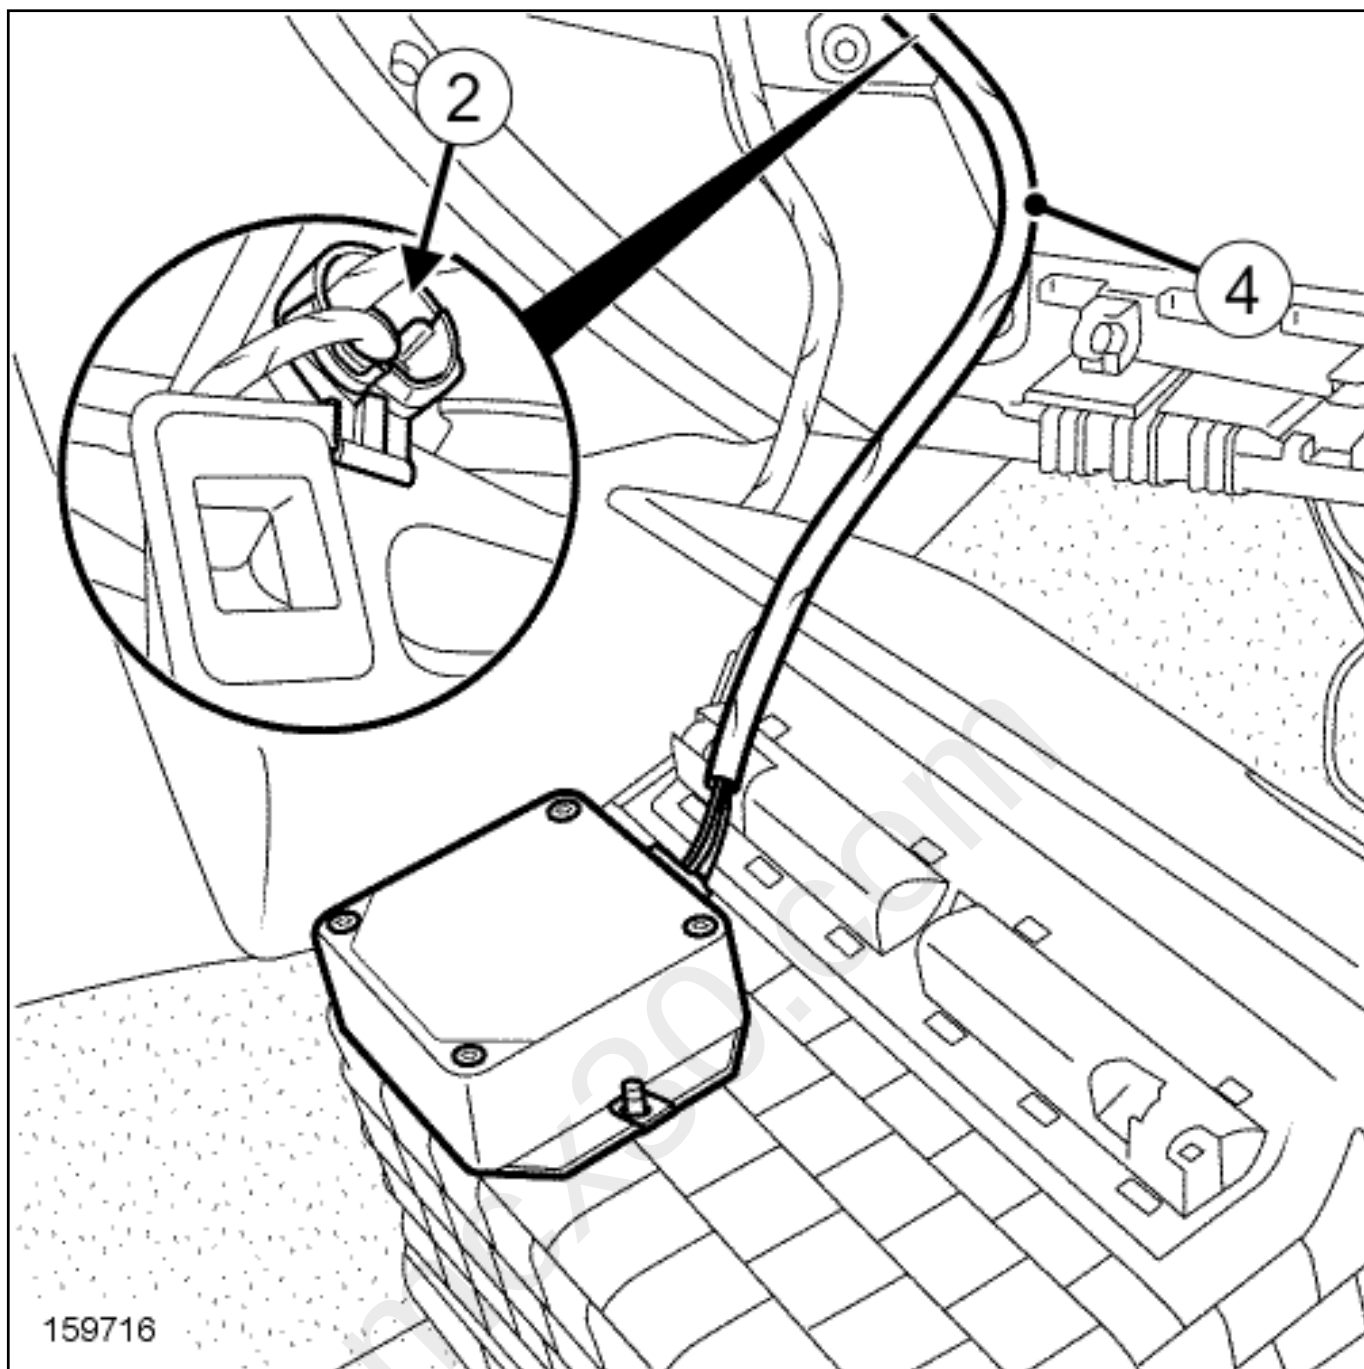
LEFT-HAND DRIVE

Pull the clip wiring(2) , (3) .

Remove the carsharing module wiring(4) .
