PUBLISHED: 23-MAY-2019  
2020.0 DEFENDER (LE), 205-02

REAR DRIVE AXLE/DIFFERENTIAL

## DIFFERENTIAL FLUID TEMPERATURE SENSOR (G2344692)

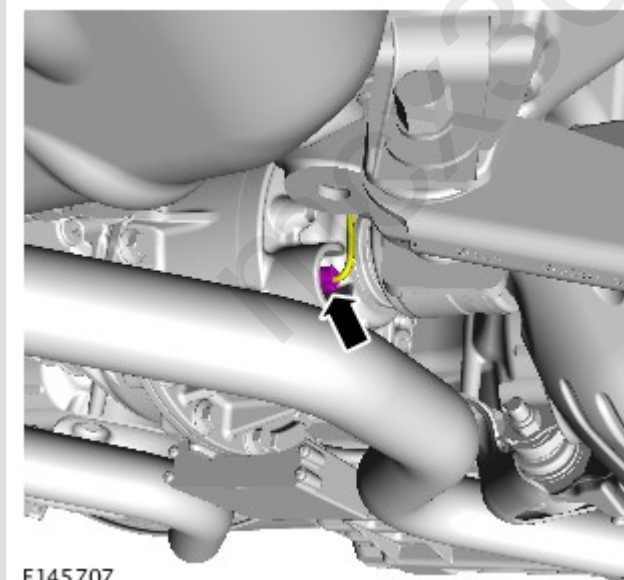
E145708

Disconnect the differential fluid temperature sensor electrical connector.
