PUBLISHED: 02-OCT-2019  
2020.0 DEFENDER (LE), 417-01

EXTERIOR LIGHTING

## PARKING, REAR AND LICENSE PLATE LAMPS (G2401024)

## DIAGNOSIS AND TESTING

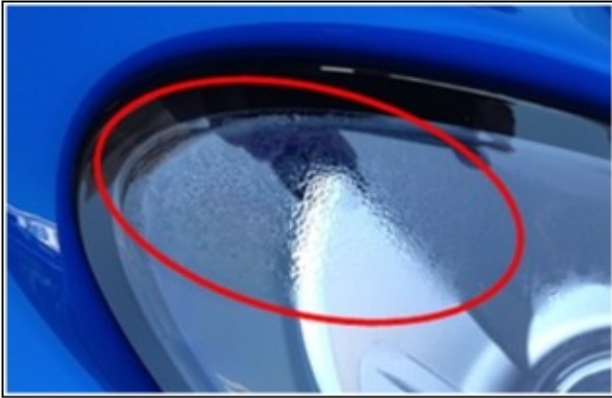
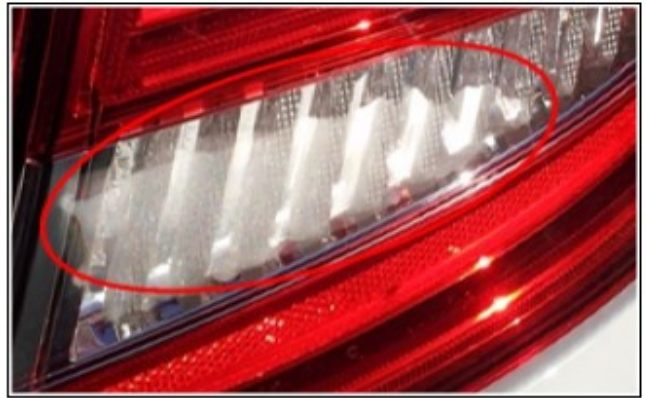
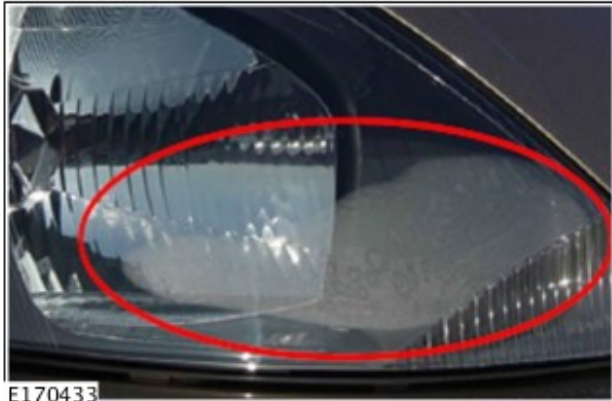
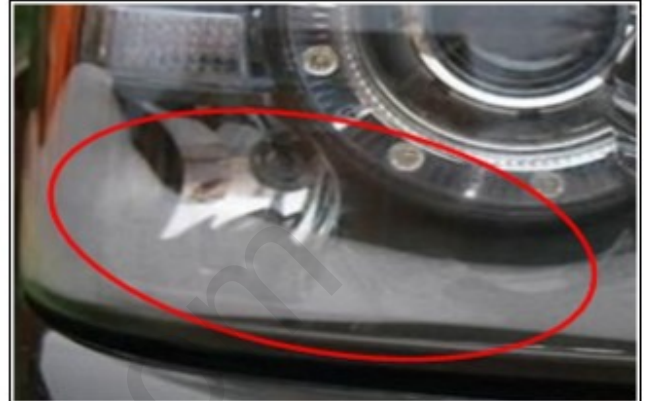
E170433

Shown below are examples of normal exterior lamp condensation. This would NOT be covered by warranty and the lamp(s) must not be replaced

**A lamp that exhibits condensation should be evaluated under warm (20°C ± 5°C) and dry conditions (50% RH ± 5% RH) with all functions operating for a minimum of 60 minutes for LED lamps or 30 minutes for all other lamps.** If the condensation **improves** (i.e.: it starts to clear, but has not necessarily completely cleared) during this time, it indicates that the lamp is functioning as normal . This means the lamp integrity has NOT been breached and **the lamp must NOT be replaced**

- This information bulletin contains examples of normal condensation generated from atmospheric conditions. A thin mist can form on the interior of clear plastic lenses, this is not detrimental to the lamp's performance. This thin mist will eventually clear through normal use, exiting through the lamp's venting system

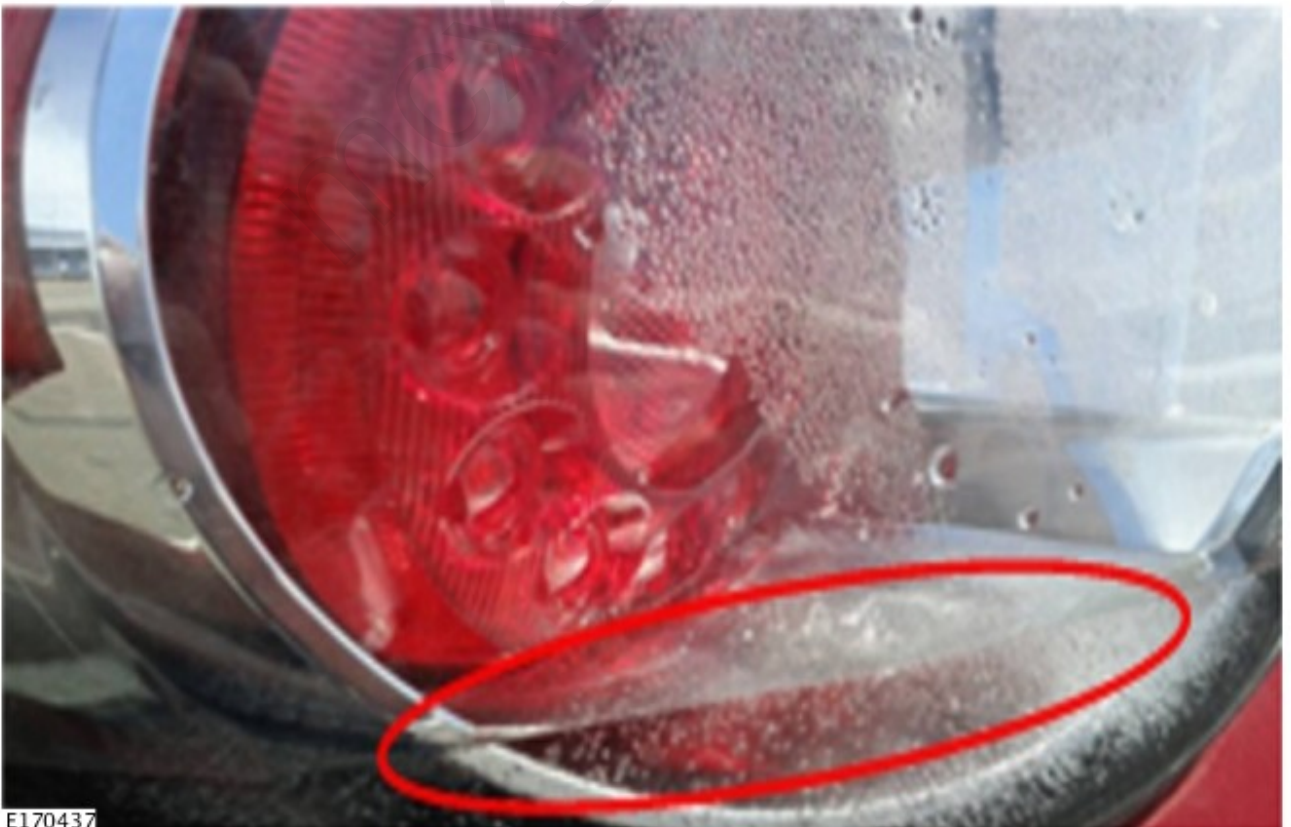
E170437

In the photograph shown below, note the standing water within the lamp, this is not acceptable and clearly shows a water ingress related fault with the lamp

- Pools of water and high levels of condensation would indicate that the lamps' sealing has been compromised. Check for damage and inspect the condition of caps and breathers
