PUBLISHED: 30-JUL-2020  
2020.0 DEFENDER (LE), 501-10

## SEATING

# SEATS (G2401036)

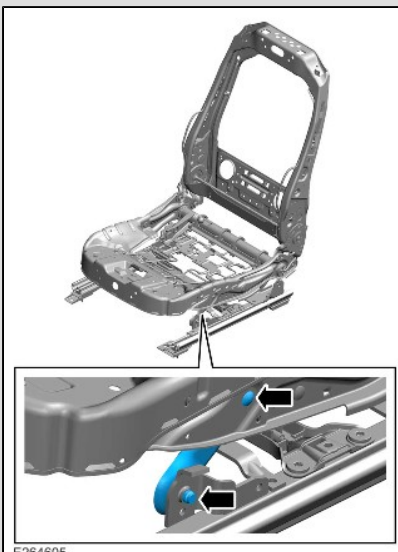
| TEST CONDITIONS | DETAILS/RESULTS/ACTIONS |
|---|---|
| | <p>accelerating. Use a listening/recording device to pinpoint the area of concern, if available use the Jaguar Land Rover approved diagnostic equipment (Steelman ChassisEAR) and determine the area of concern.</p> |
| | <p>Is there an audible click from the seat base frame area?</p> <p><b>Yes</b><br/>Install a new front seat base frame only. Refer to the relevant section of the workshop manual. <b>Do not install a seat backrest frame.</b></p> <p><b>No</b><br/>Refit the seat cushion trim, referring to relevant section of the workshop manual and re-check. If the click is still present, install a new front seat cushion trim.</p> |
