PUBLISHED: 11-SEP-2020  
2020.0 DEFENDER (LE), 501-12

INSTRUMENT PANEL AND CONSOLE

# INTERIOR TRIM INSPECTION (G2743611)

## WARRANTY COMPLIANCE AND PROCEDURES IN RELATION TO HIGH GLOSS VENEERS

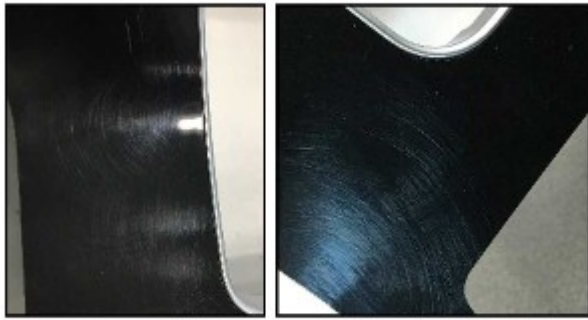
E270223

Example only: Use of an aggressive cleaning agent/contaminated cloth

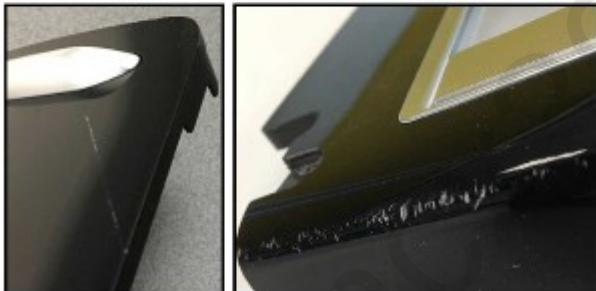
E270224

Example only: Severe scratching/abrasion damage

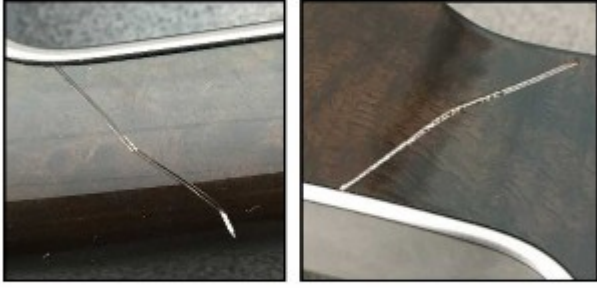
E270225

Example only: Impact/gouging damage
