PUBLISHED: 06-APR-2020  
2020.0 DEFENDER (LE), 501-26

**BODY REPAIRS - VEHICLE SPECIFIC INFORMATION AND TOLERANCE CHECKS**

## HOOD LATCH ALIGNMENT (G2394539)

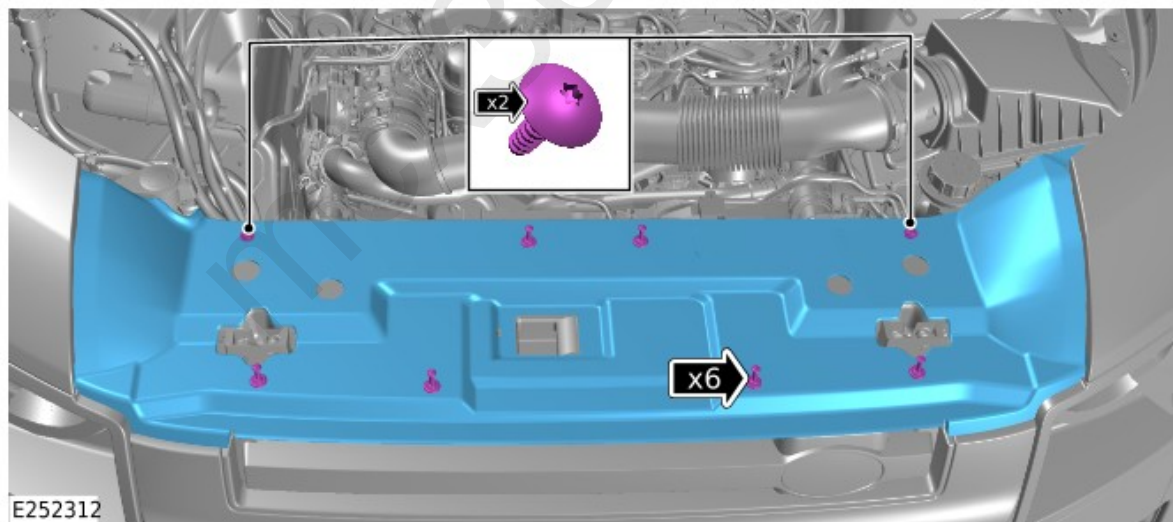
1.

- Release the 6 clips.
- Remove the 2 bolts.
- Remove the upper radiator grille panel for access.

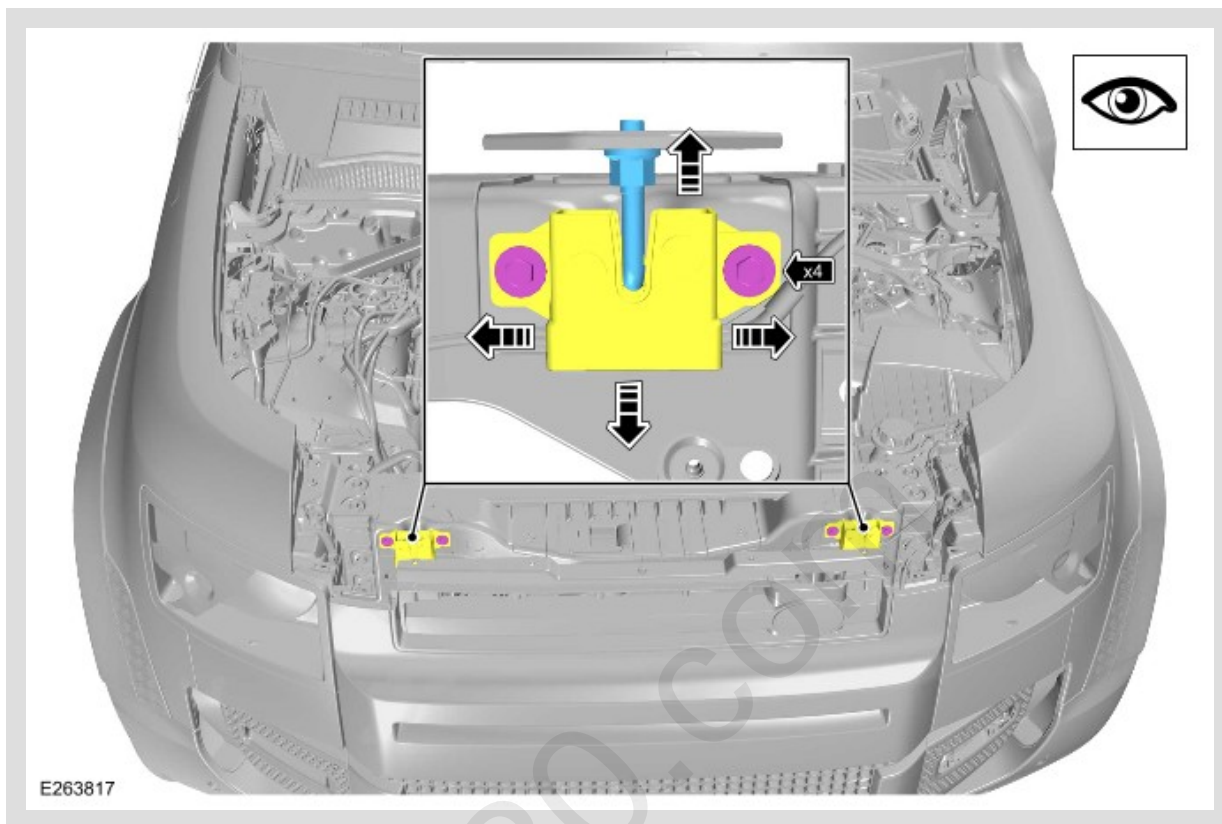
2.

Make sure that the clearance on either side of the hood is equal and no strain is placed on the hood latch.

- Loosen but do not fully remove the hood latch 4 retaining bolts.
- Adjust the hood latches as illustrated.
- Tighten the hood latch 4 retaining bolts.

*Torque: 10Nm*

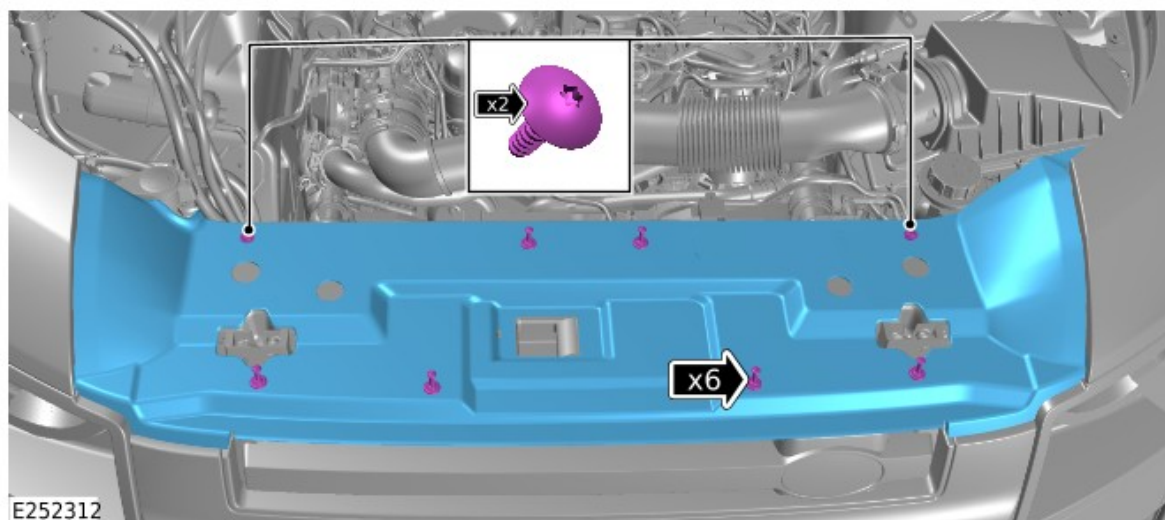
3.

- Install the upper radiator grille panel.
- Install the 6 clips.
- Install the 2 bolts.

*Torque: 3Nm*
