PUBLISHED: 06-FEB-2020  
2020.0 DEFENDER (LE), 501-30

REAR END SHEET METAL REPAIRS

## TAILGATE REINFORCEMENT LEFT SIDE - 110 (G2394519)

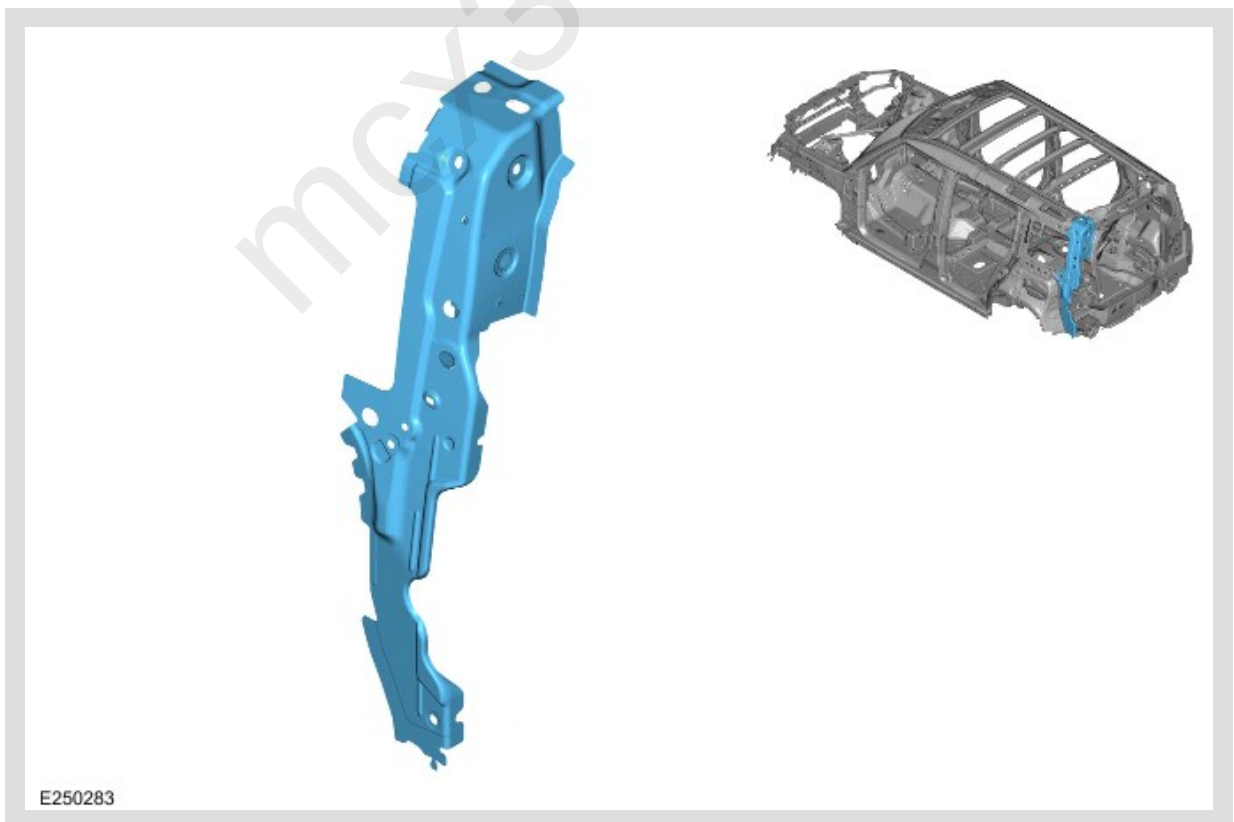
1.

The tailgate reinforcement left side is serviced as indicated.

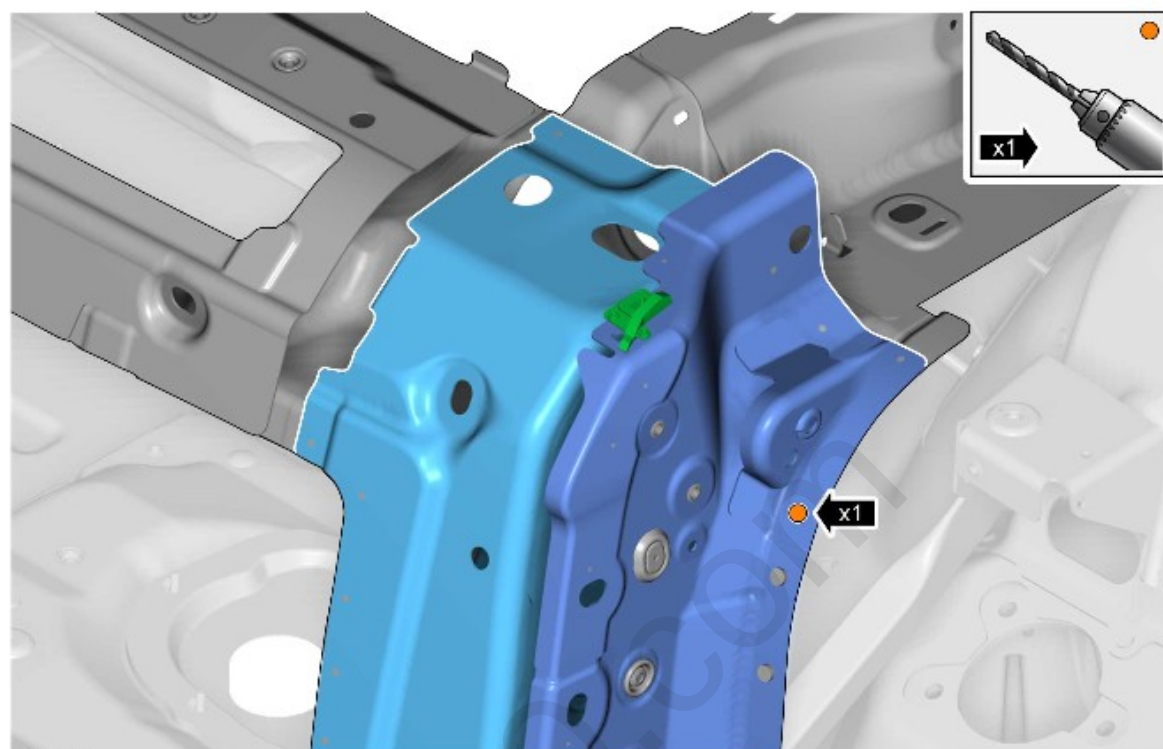
E250284

Remove the Self Piercing Rivet (SPR) as indicated.

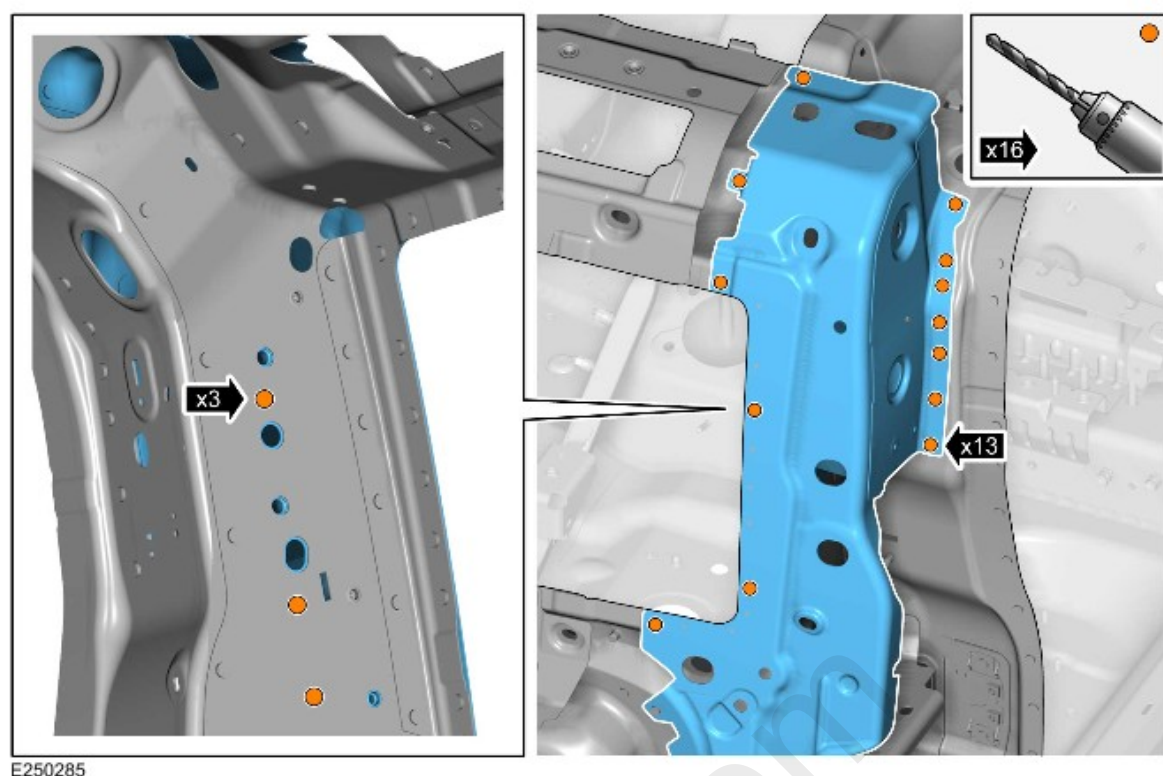
12.

Remove the SPRs as indicated.

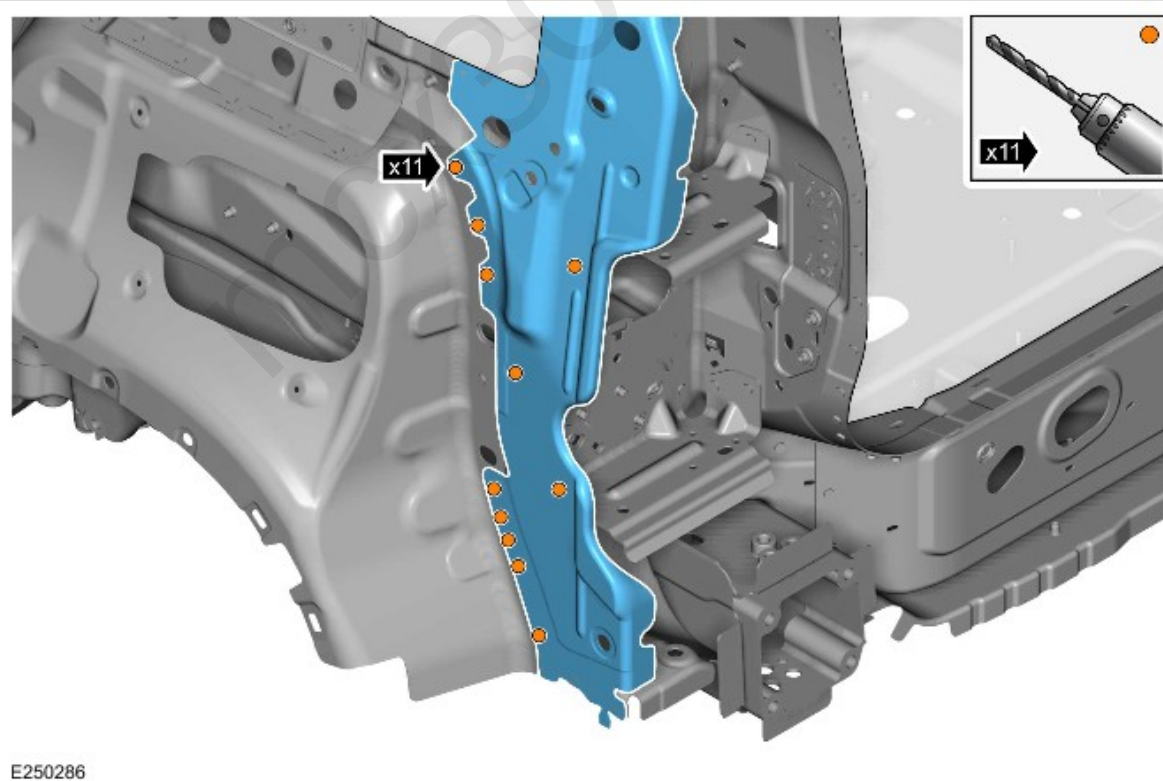
13.

Remove the SPRs as indicated.

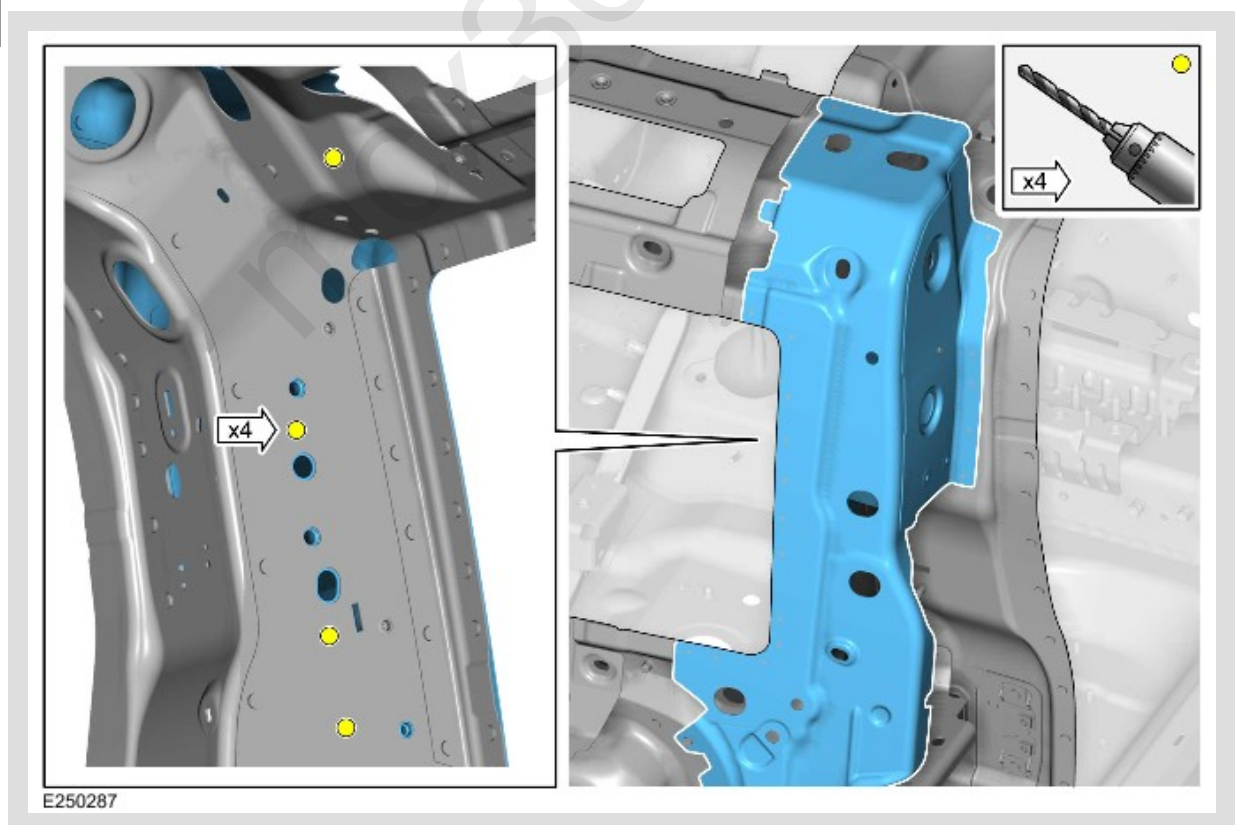
4.

Drill holes where the Breakstem Fasteners (BSFs) are to be installed as indicated.

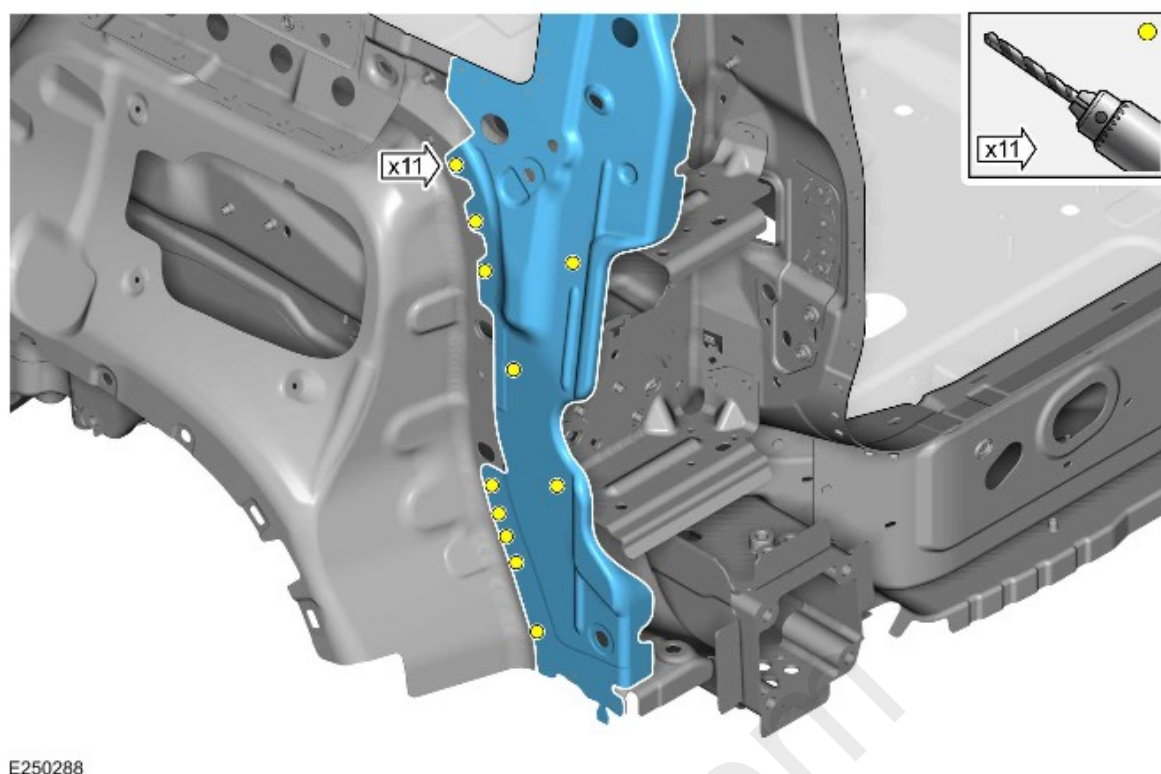
5.

Drill holes where the BSFs are to be installed as indicated.

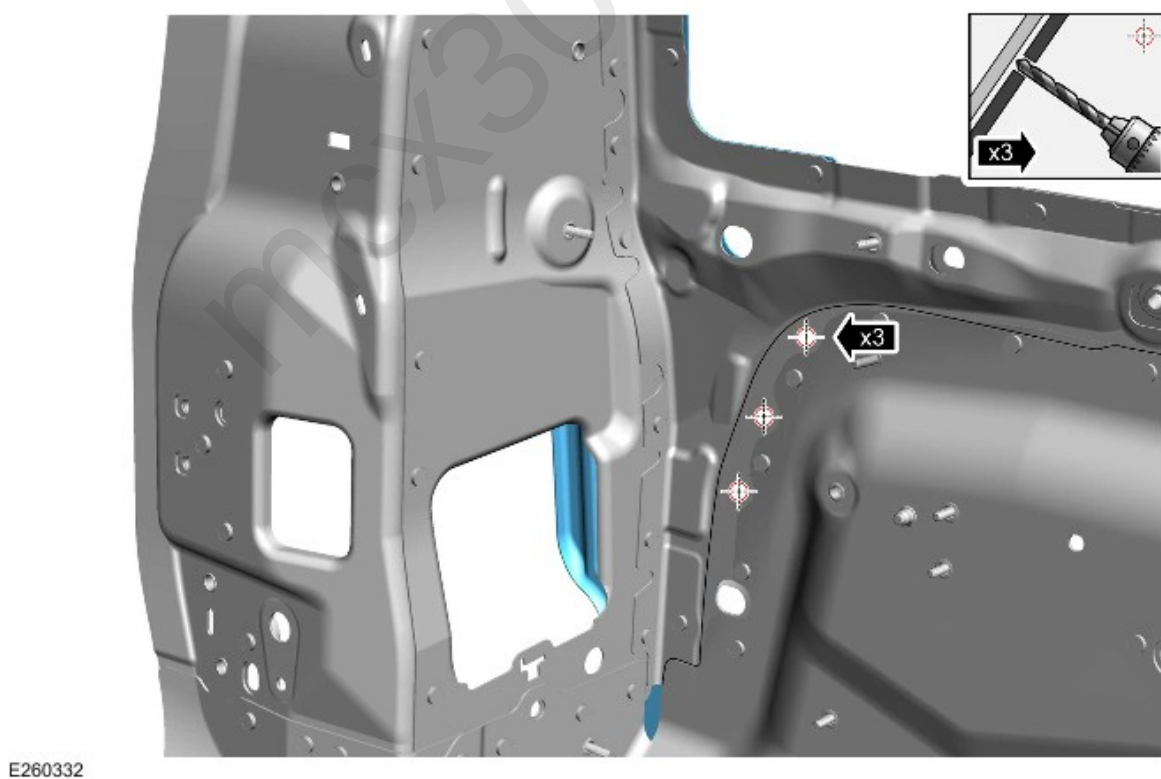
6.

Drill 12 mm clearance holes for BSF access as indicated.

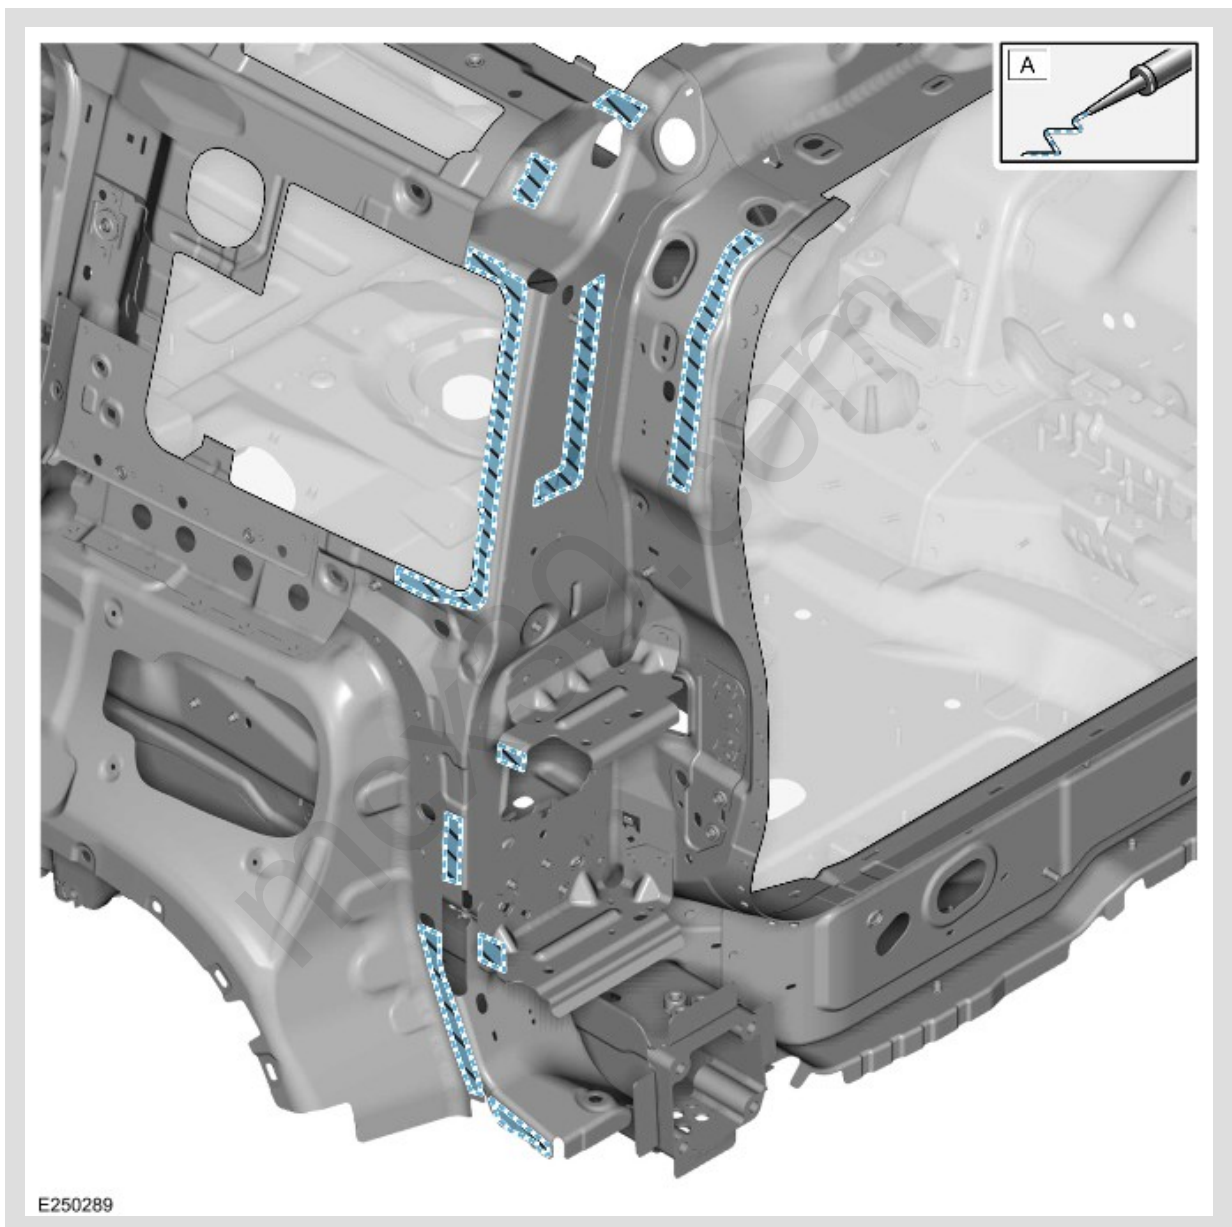
Make sure a continuous bead of adhesive surrounds the fixing holes.

Apply a 5 mm zig zag bead of the JLR recommended bonding material as indicated.

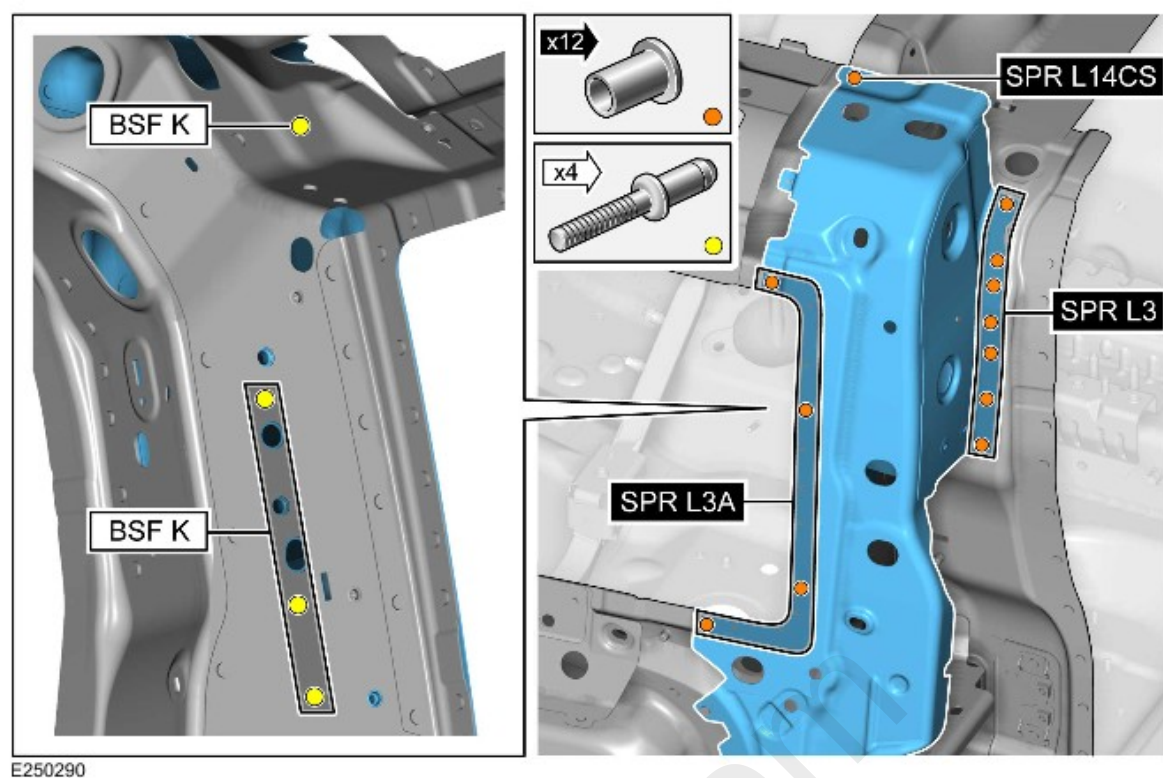
12.

Install the BSFs and Self Piercing Rivets (SPRs) as indicated.

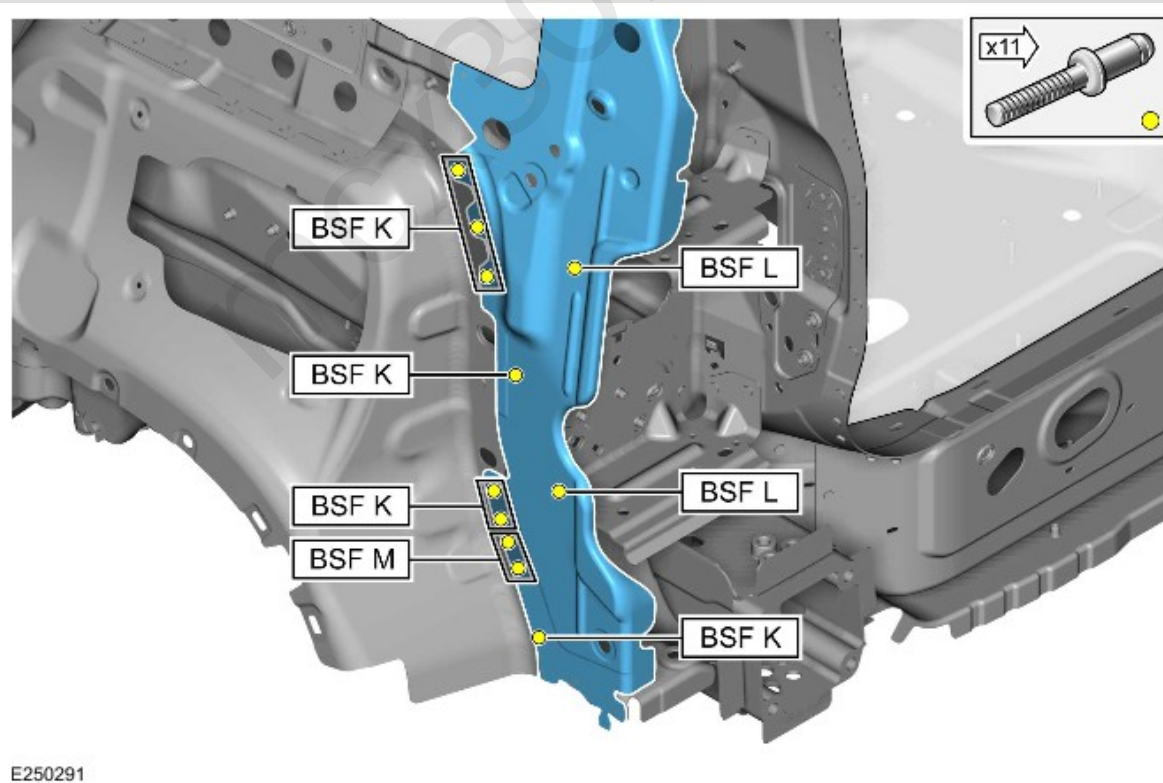
13.

Install the BSFs as indicated.

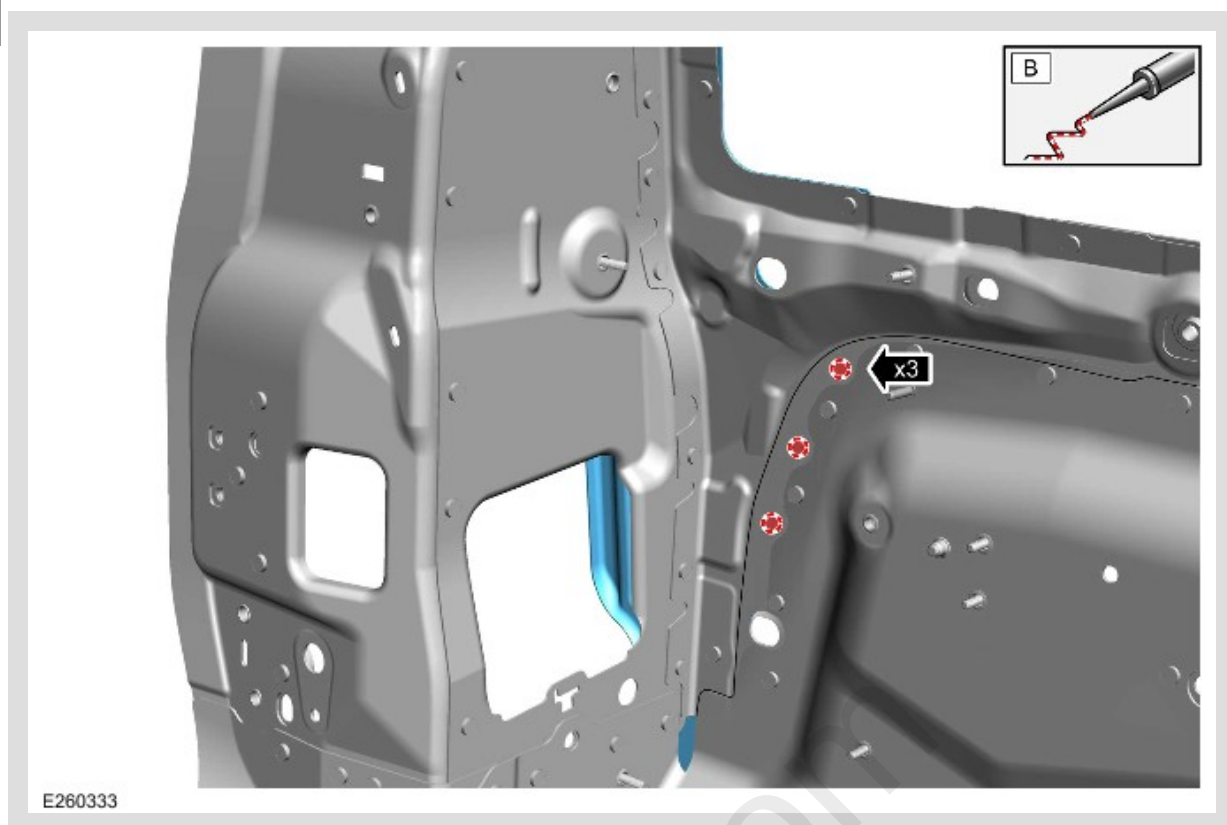
Apply a JLR recommended sealant to the BSF clearance holes as indicated.

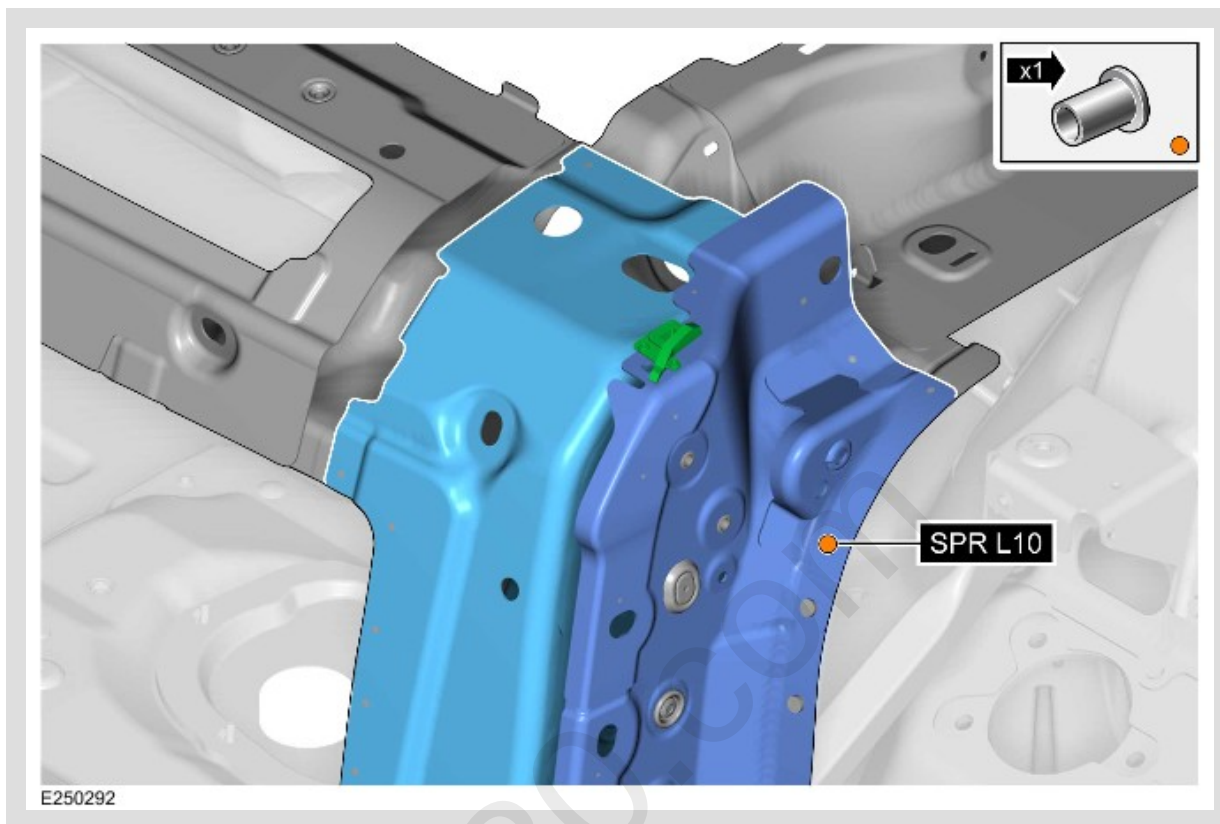
When installing the tailgate reinforcement left side in conjunction with the outer tail lamp outer panel left side.

Install the SPR as indicated.
