PUBLISHED: 02-OCT-2019  
2020.0 DEFENDER (LE), 501-30

REAR END SHEET METAL REPAIRS

## TAILGATE OPENING PANEL RIGHT SIDE - 110 (G2413835)

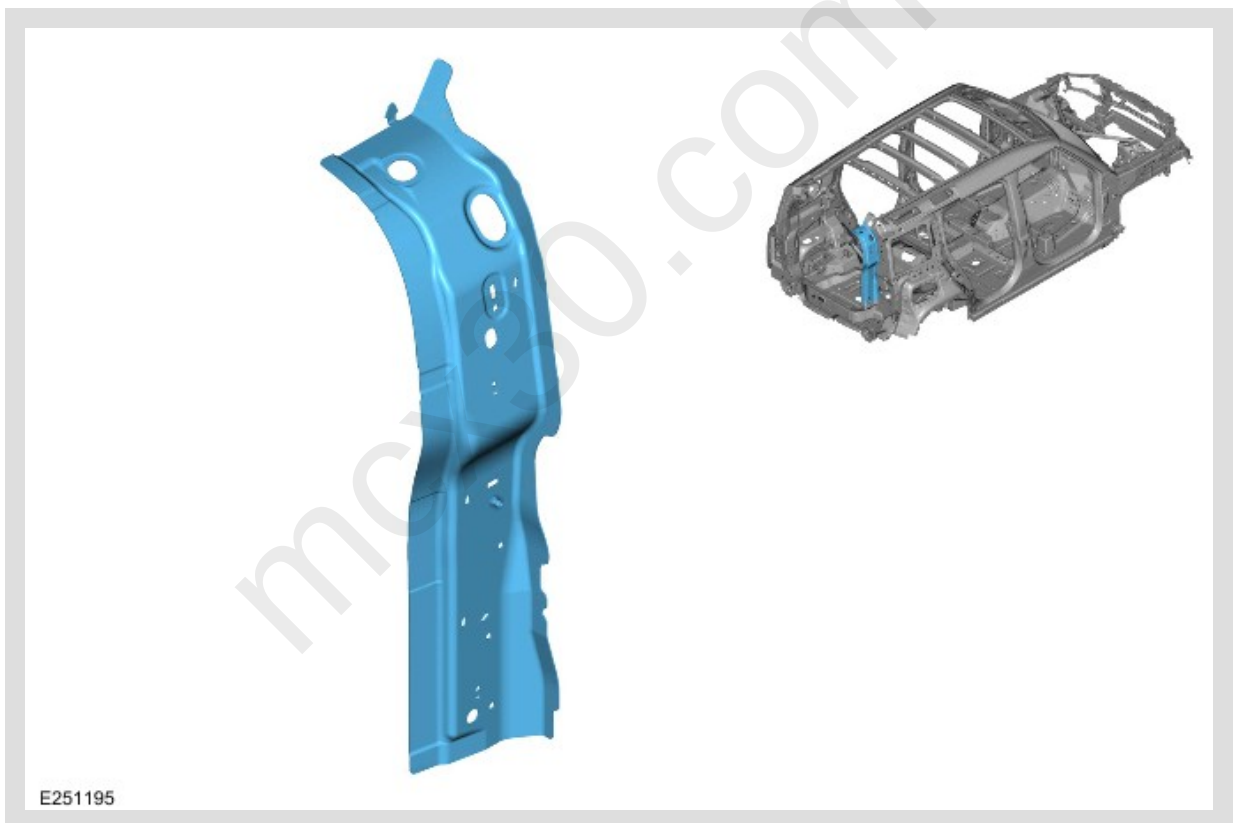
The tailgate opening panel right side is serviced as indicated.

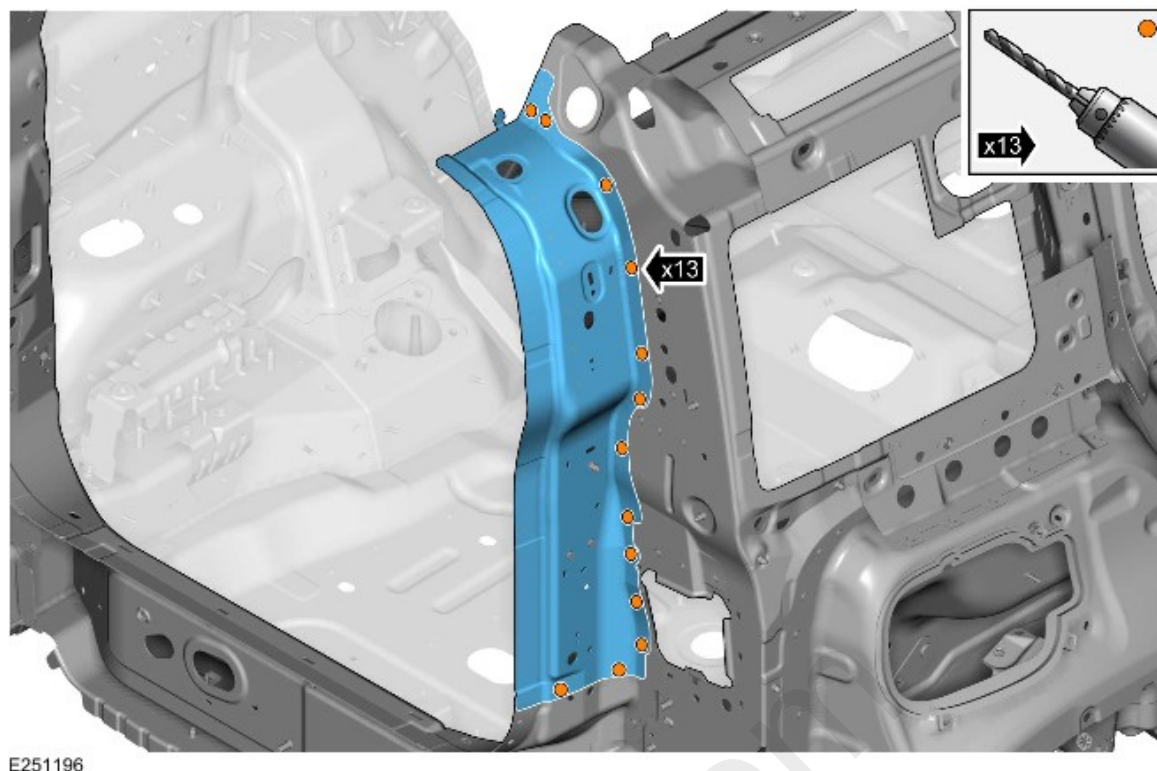
8.

Remove the self piercing rivets as indicated.

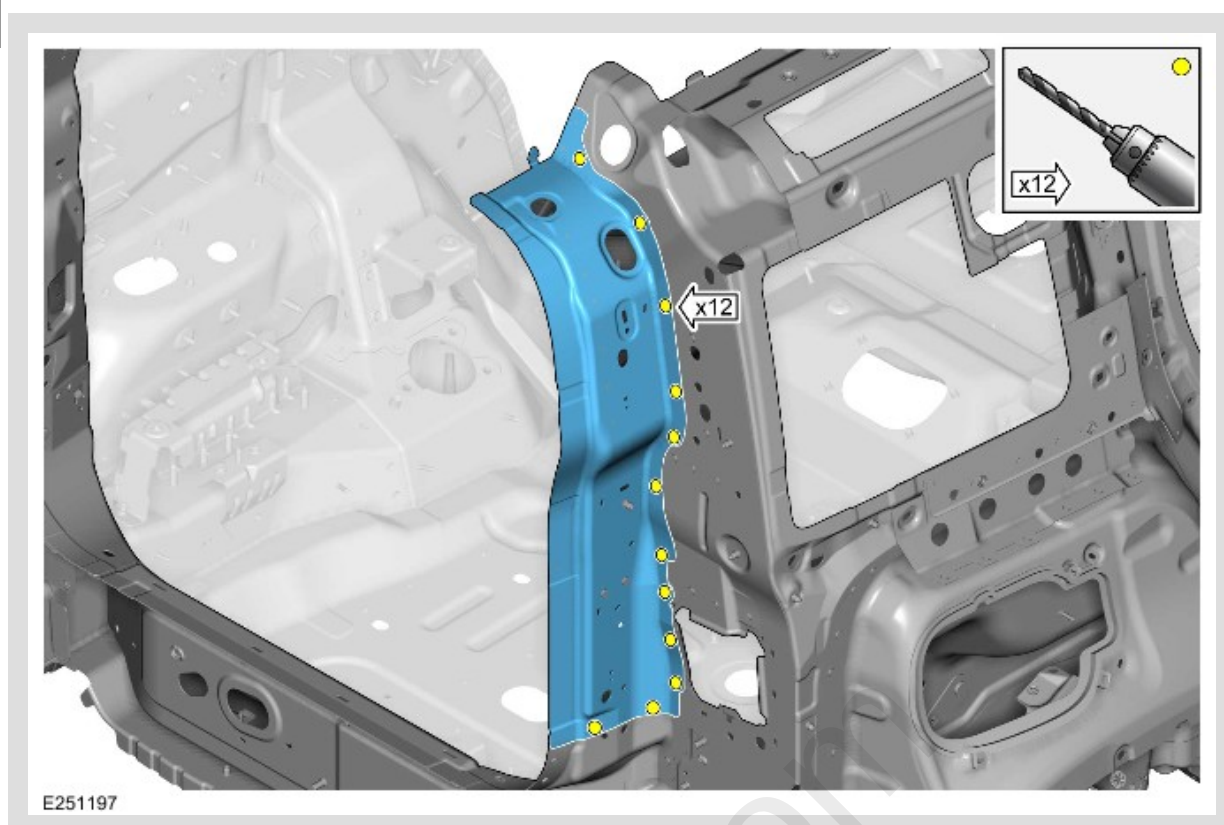
Drill holes where the Breakstem Fasteners (BSFs) are to be installed as indicated.

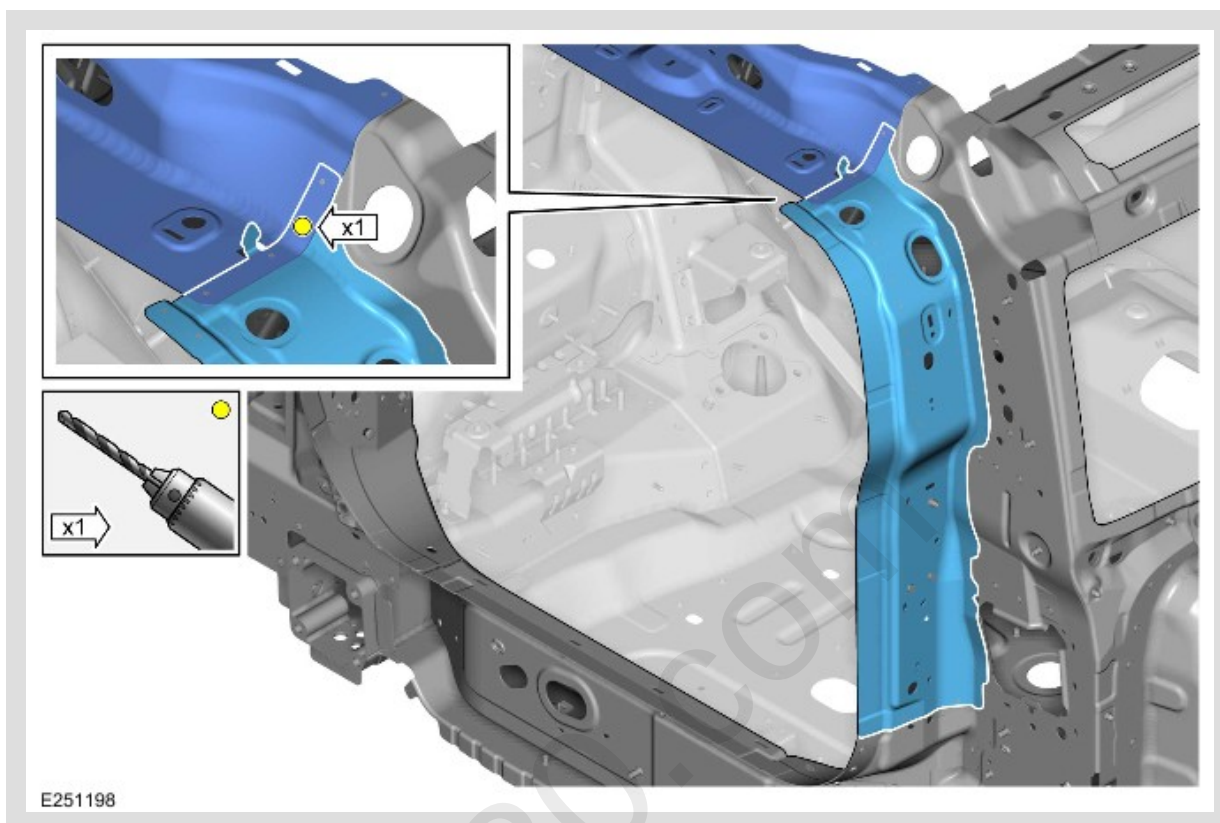
When installing the tailgate opening panel right side in conjunction with the rear header panel lower.

Drill a hole where the BSF is to be installed as indicated.

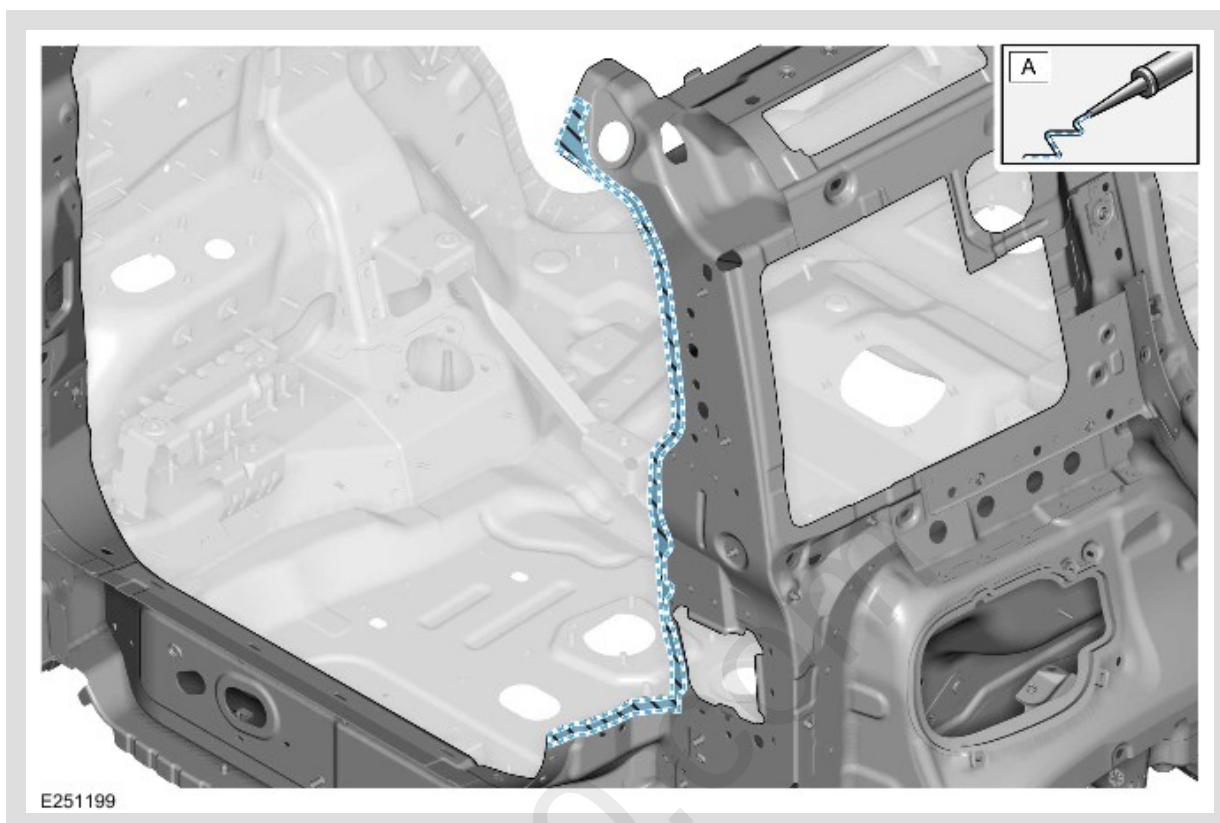
Make sure a continuous bead of adhesive surrounds fixing holes.

Apply a 5 mm zig zag bead of the Jaguar Land Rover (JLR) recommended bonding material as indicated.

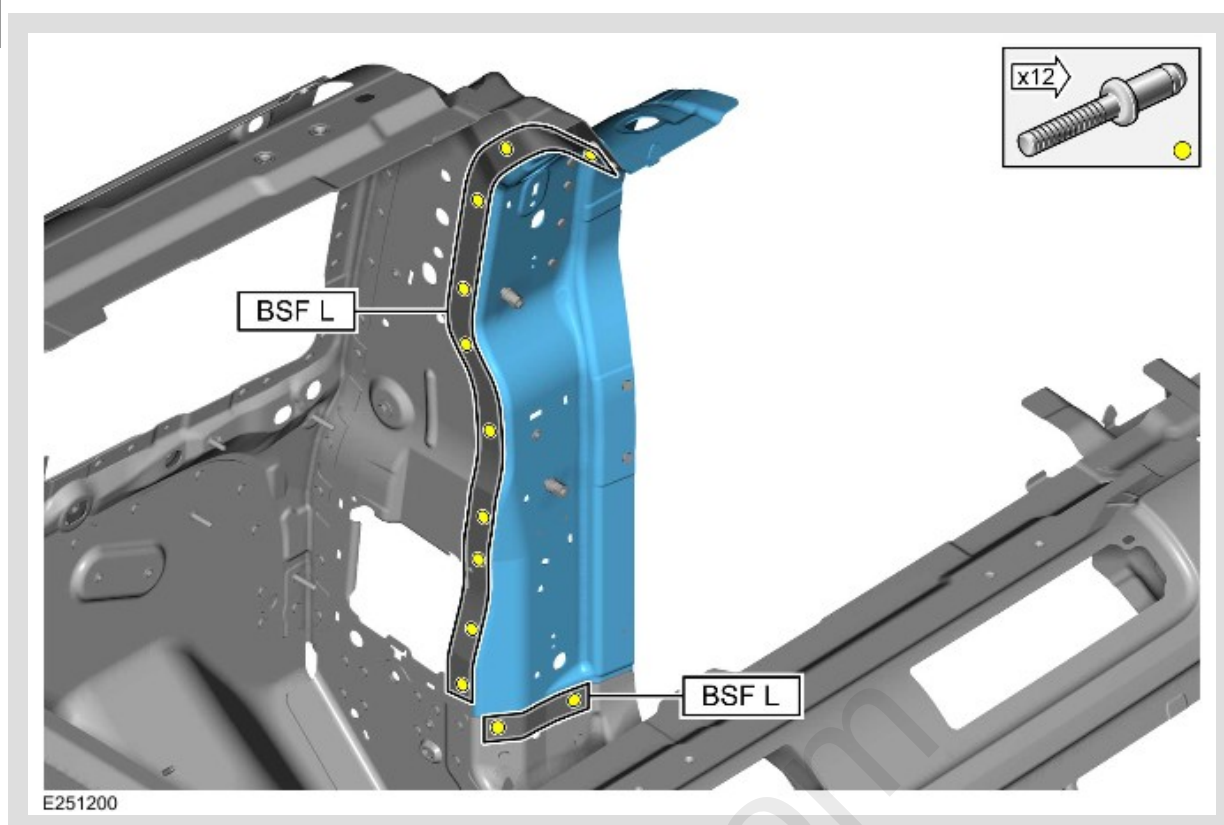
Install the BSFs as indicated.

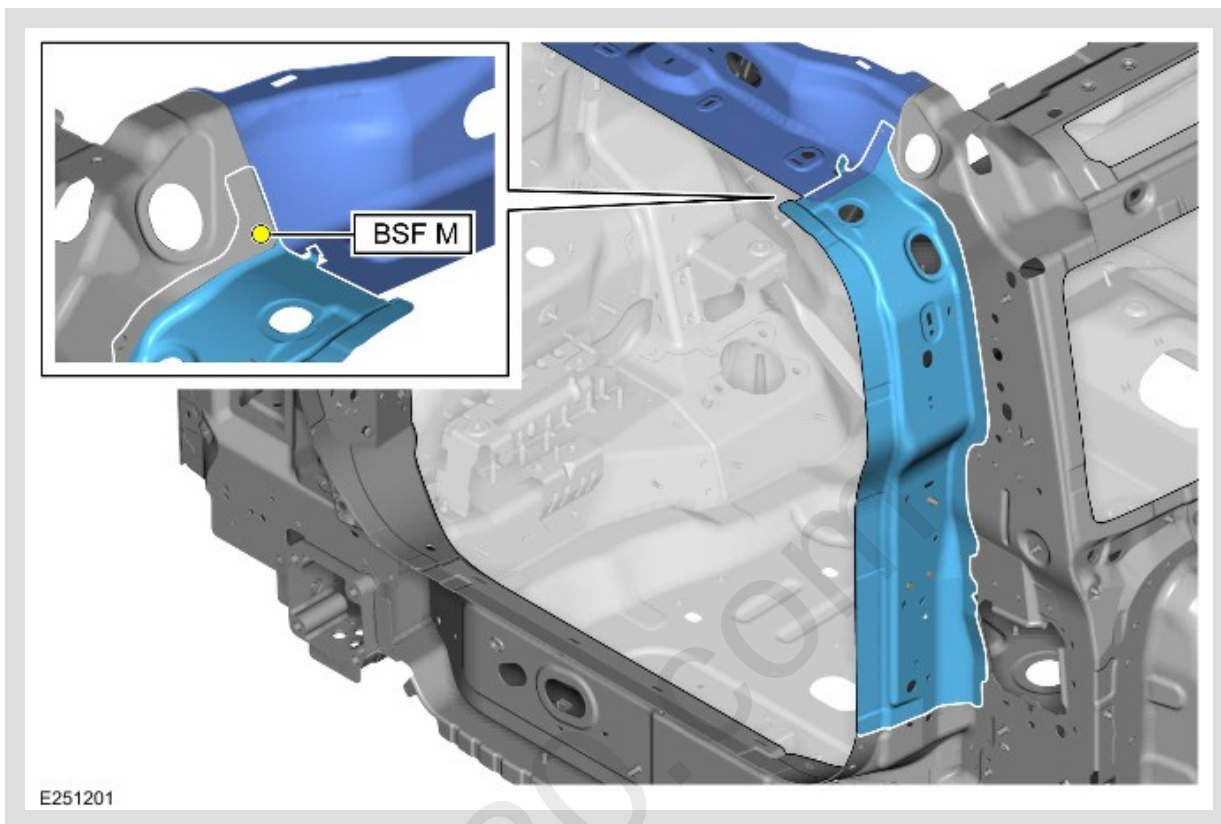
When installing the tailgate opening panel right side in conjunction with the rear header panel lower.

Install the BSF as indicated.
