PUBLISHED: 03-FEB-2020  
2020.0 DEFENDER (LE), 501-30

REAR END SHEET METAL REPAIRS

## OUTER TAIL LAMP INNER PANEL – 90 (G2452671)

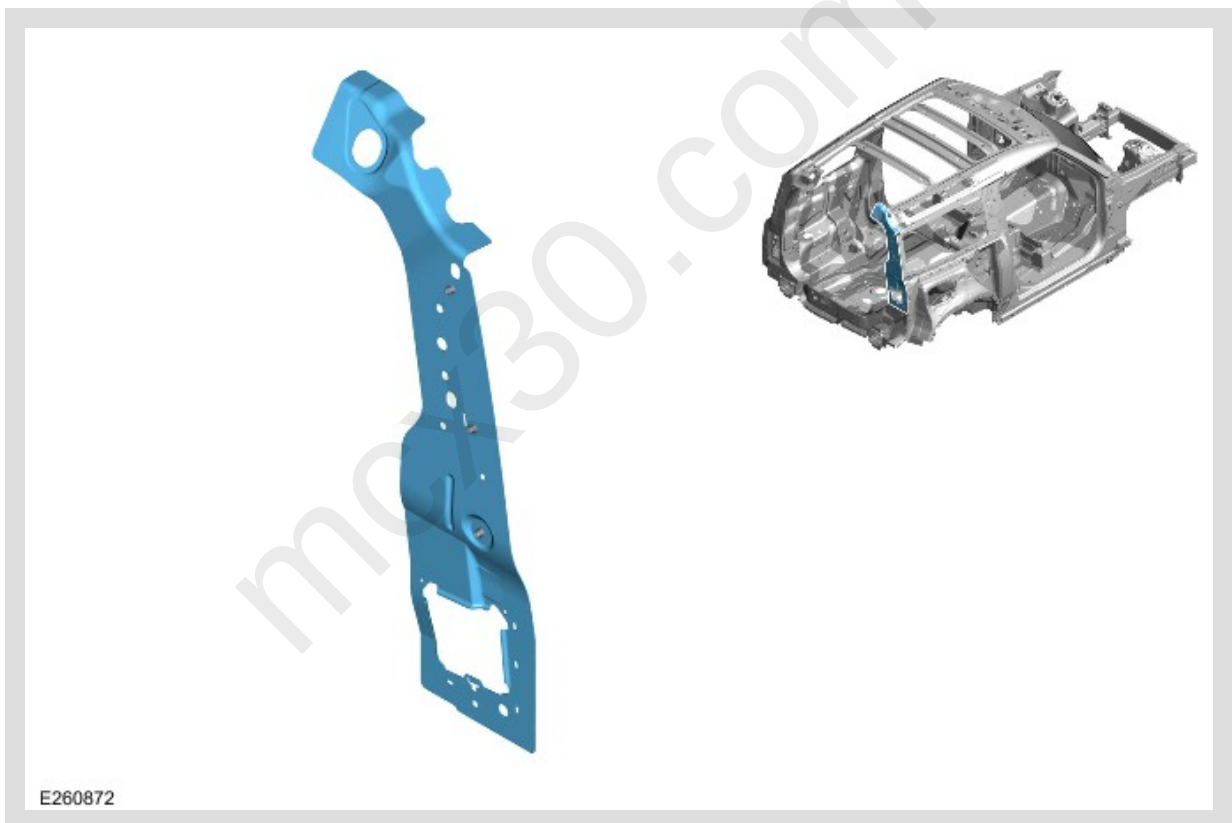
1.

The outer tail lamp inner panel is serviced as indicated.

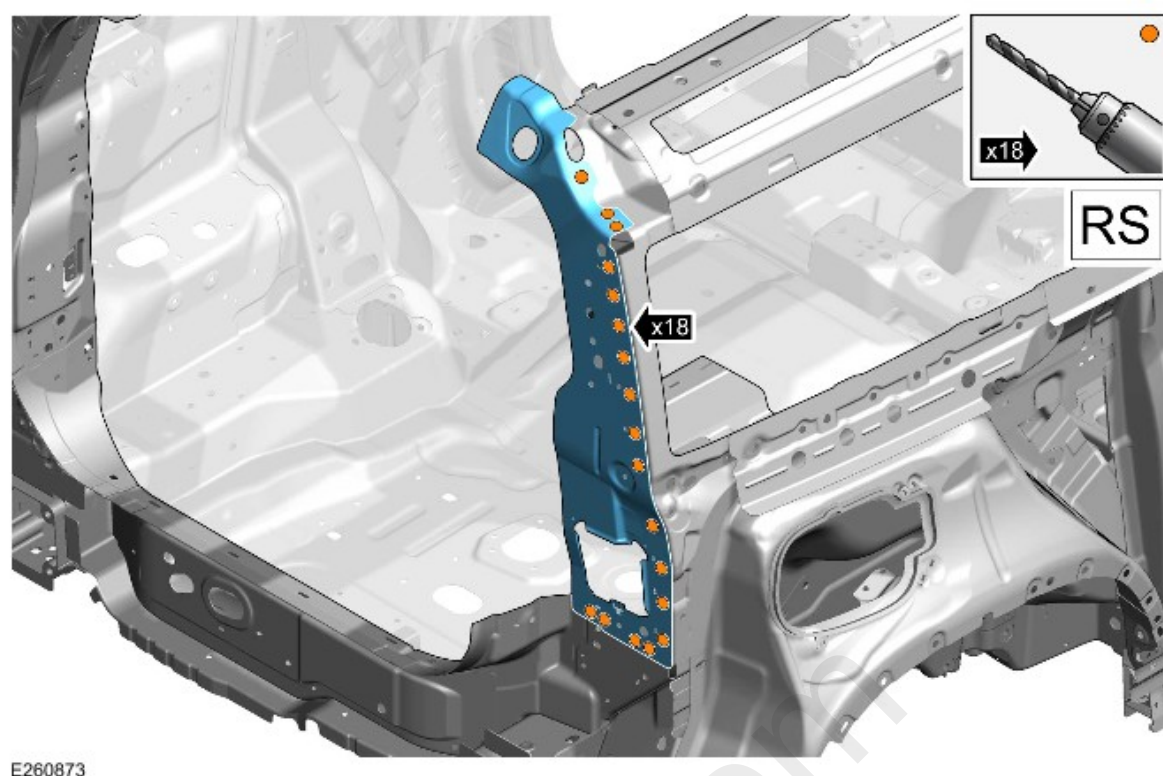
7.

Remove the Self Piercing Rivets (SPRs) as indicated.

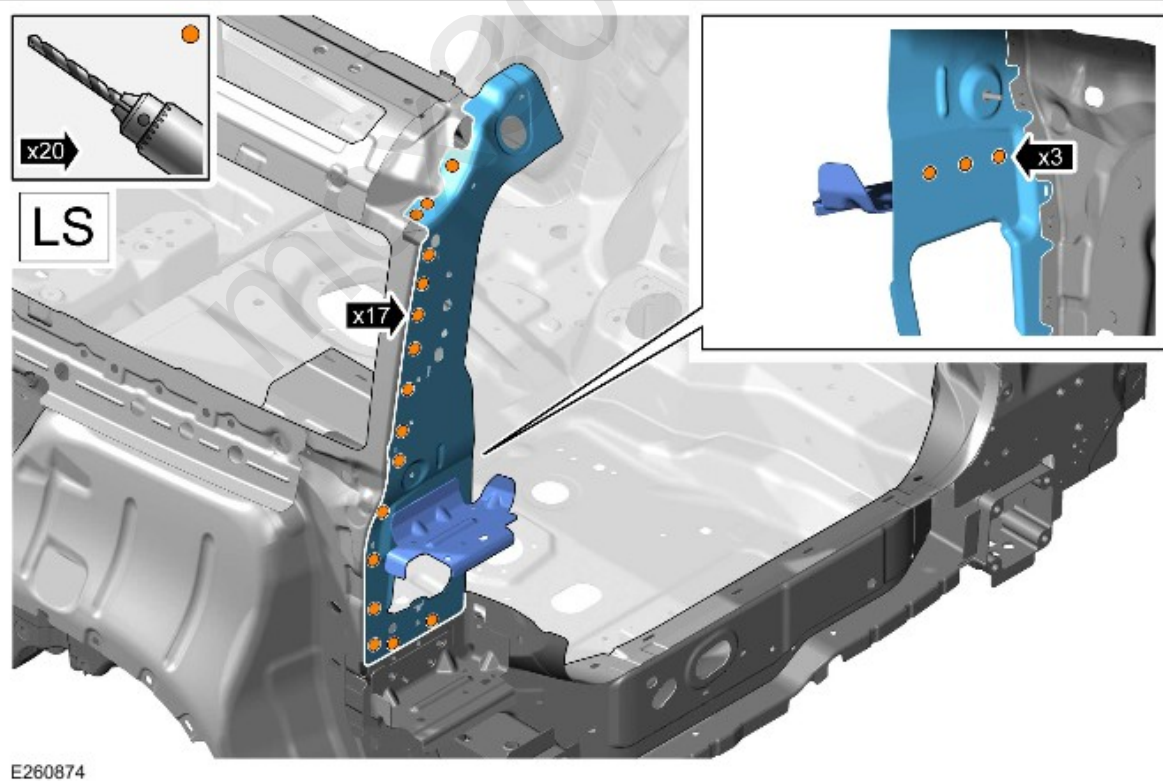
8.

Remove the SPRs as indicated.

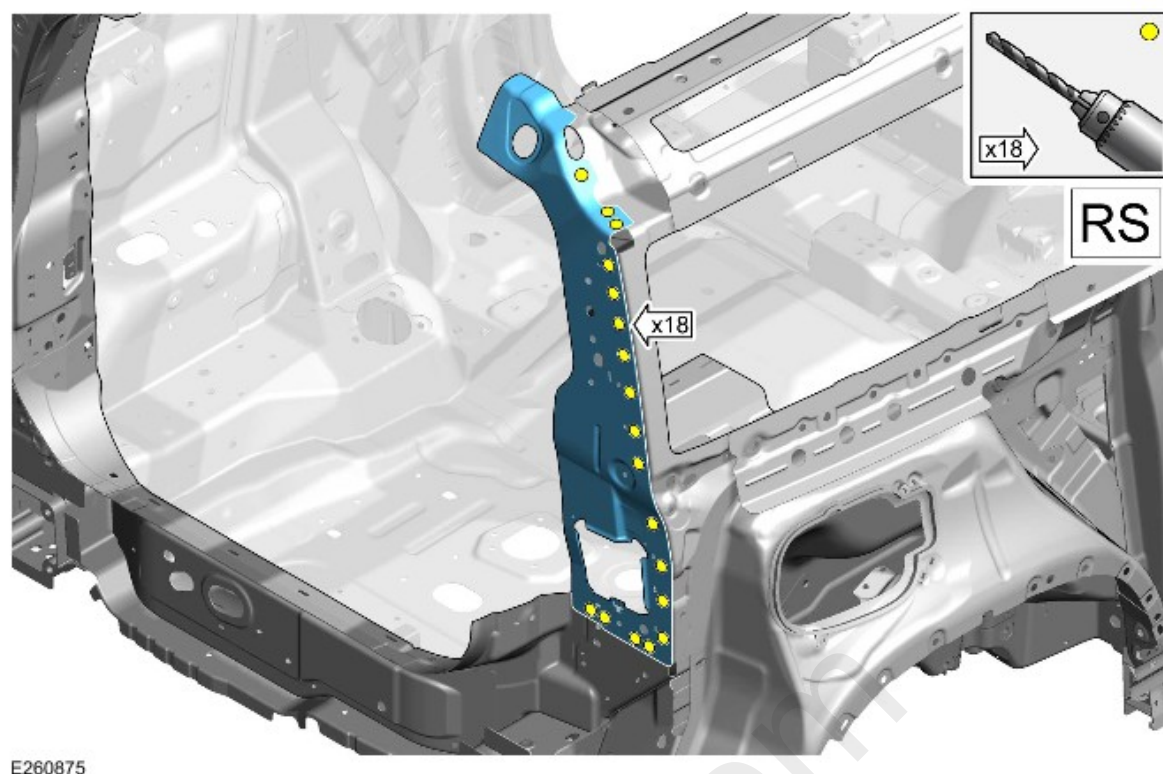
4.

Drill holes where the Breakstem Fasteners (BSFs) are to be installed as indicated.

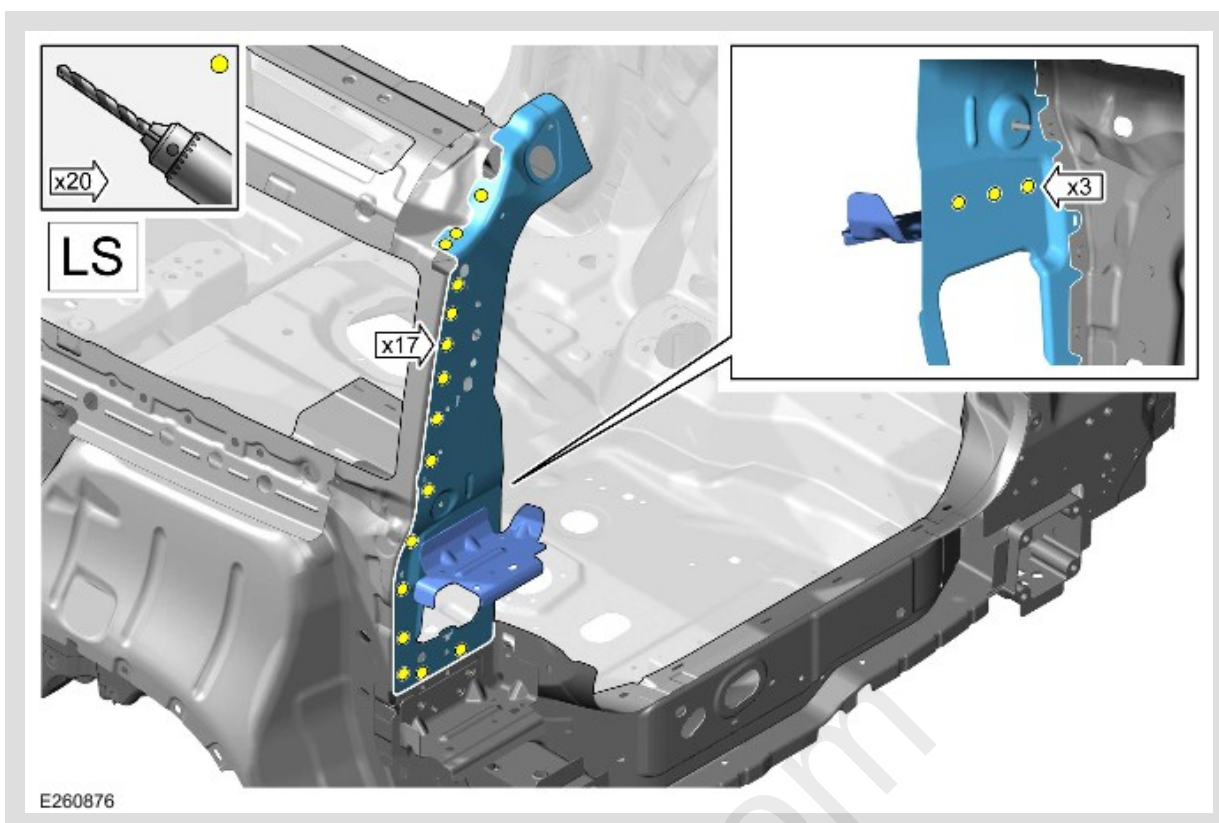
6.

Drill holes where the BSFs are to be installed as indicated.

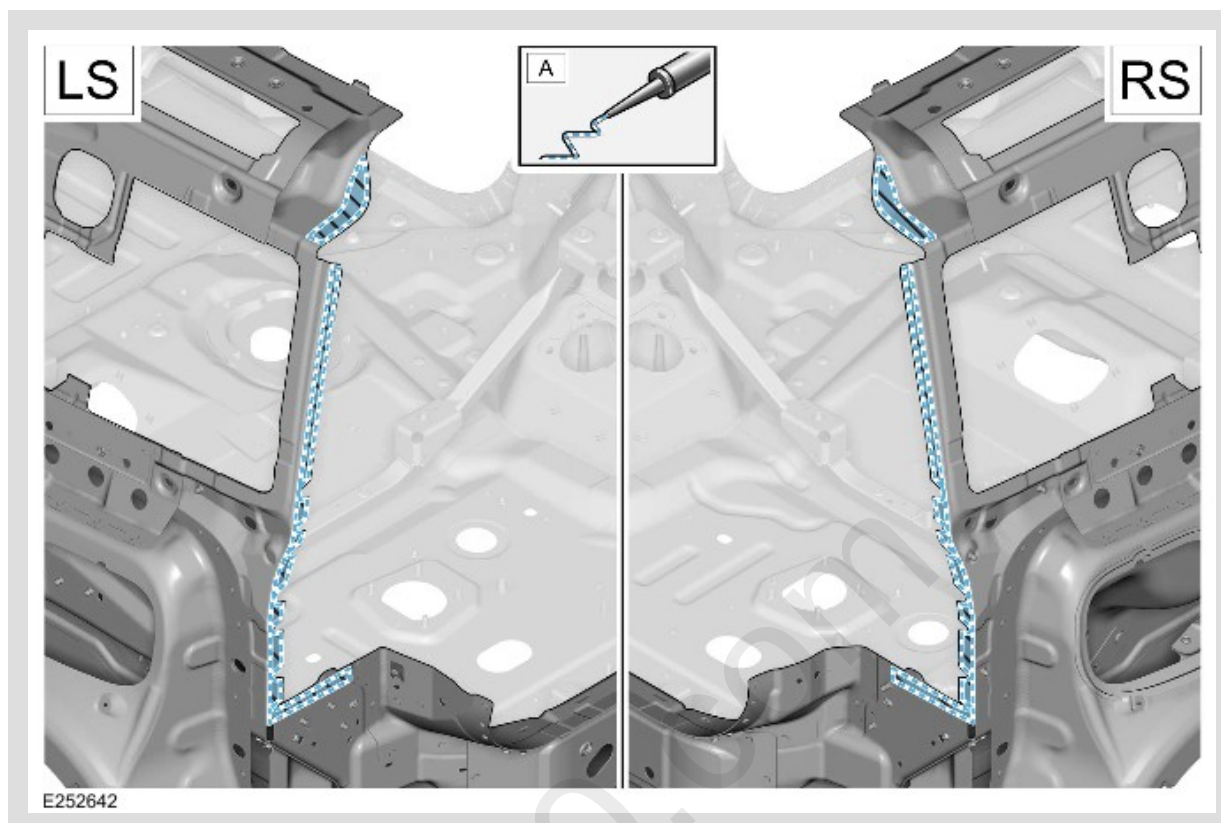
Make sure a continuous bead of adhesive surrounds the fixing holes.

Apply a 5 mm zig zag bead of the JLR recommended bonding material as indicated.

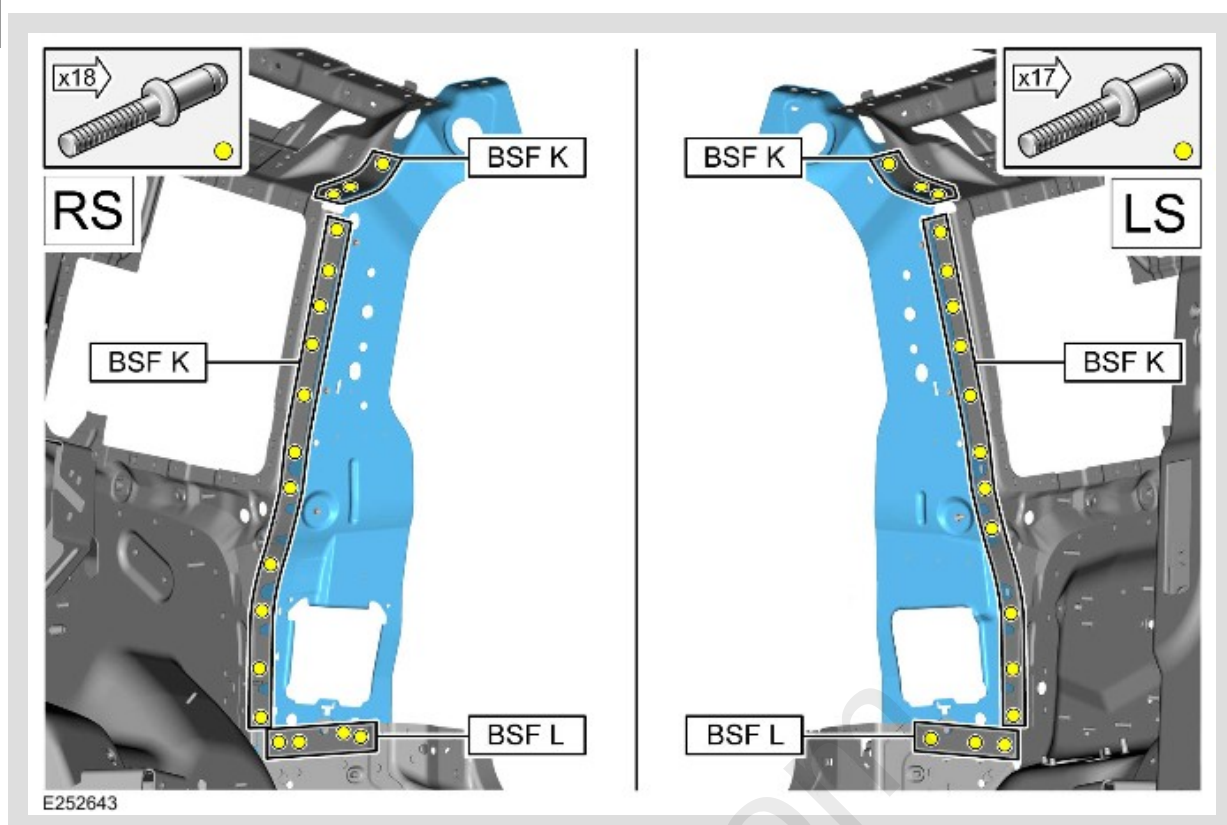
Install the BSFs as indicated.

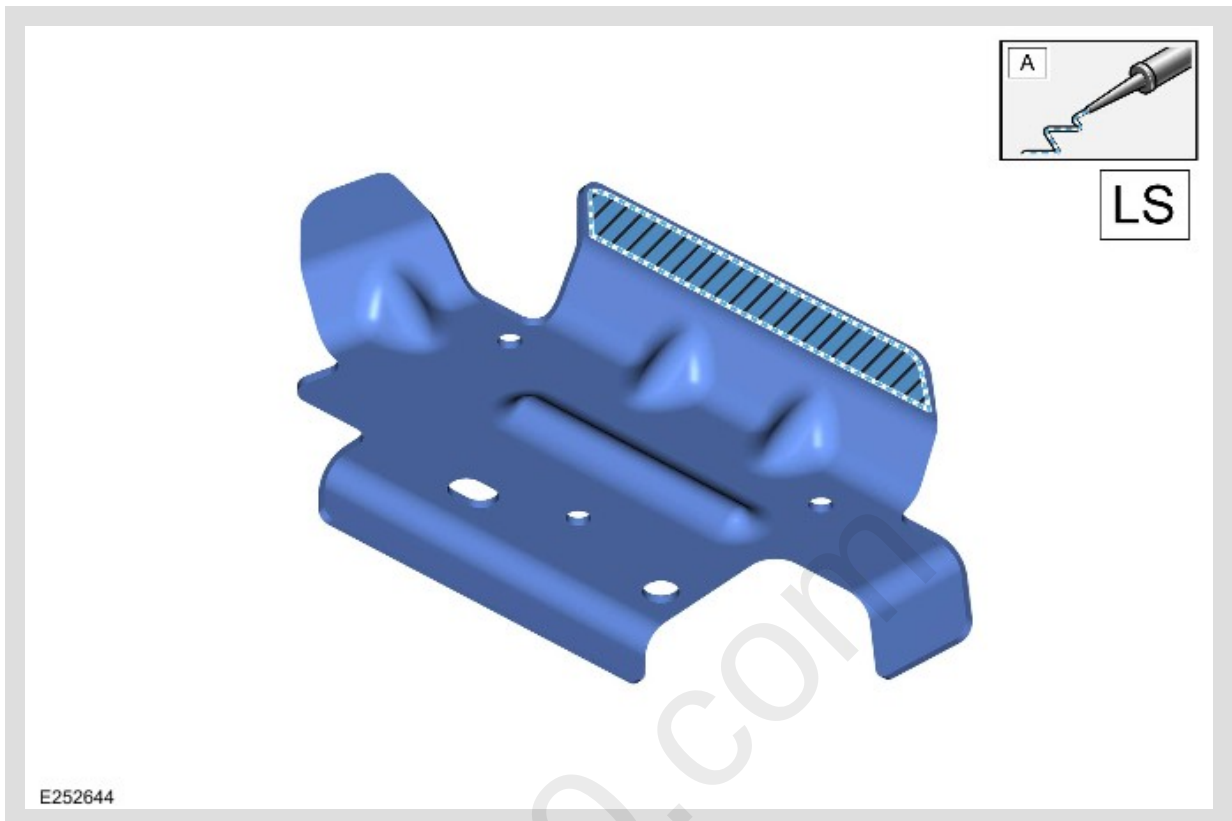
Make sure a continuous bead of adhesive surrounds fixing holes.

Apply a 5 mm zig zag bead of the JLR recommended bonding material as indicated.

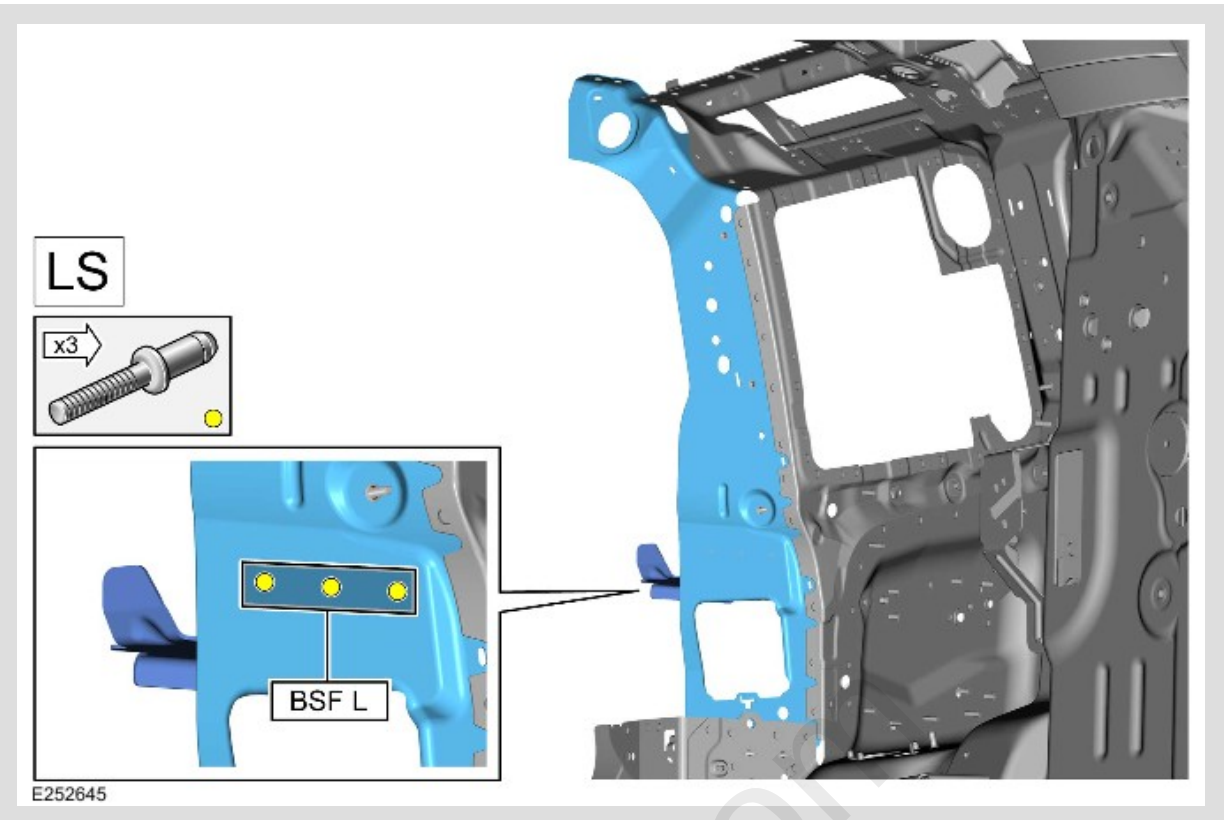
15.

Install the BSFs as indicated.
