# 2022 CHEVROLET CORVETTE SERVICE MANUAL

**Front Floor Rear Console Side Trim Panel Replacement - Right Side**

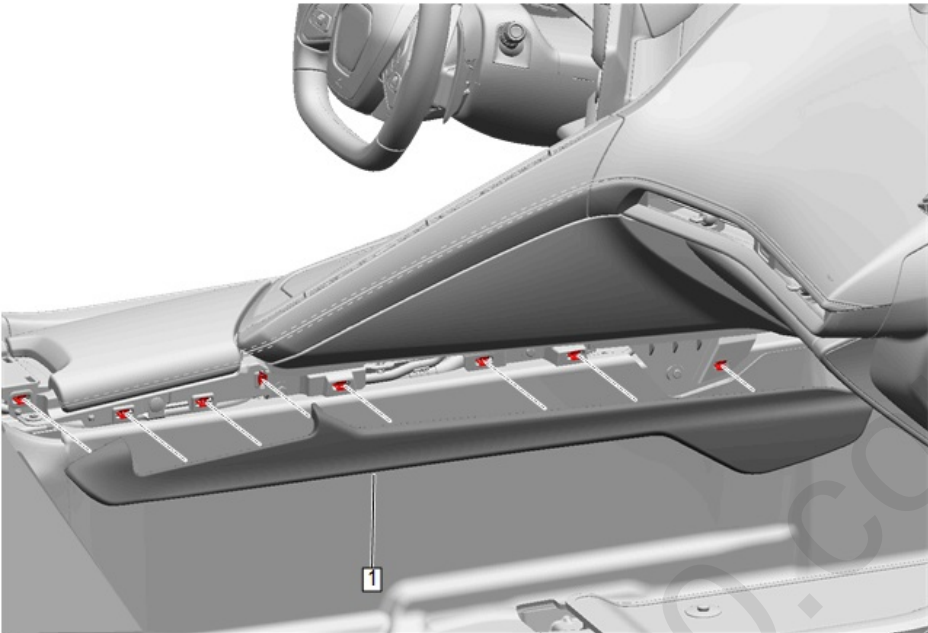
| Callout | Component Name |
|---|---|
| 1 | <div>Front Floor Rear Console Side Trim Panel - Right Side</div> <div>Note:<br/>Use care not to bend or deform the panel when removing.</div> <div>Procedure<br/>Starting at the front and working your way back, disengage the retainers using a flat-bladed plastic tool.</div> |
