# 2022 CHEVROLET CORVETTE SERVICE MANUAL

## Instrument Panel Outer Trim Cover Replacement

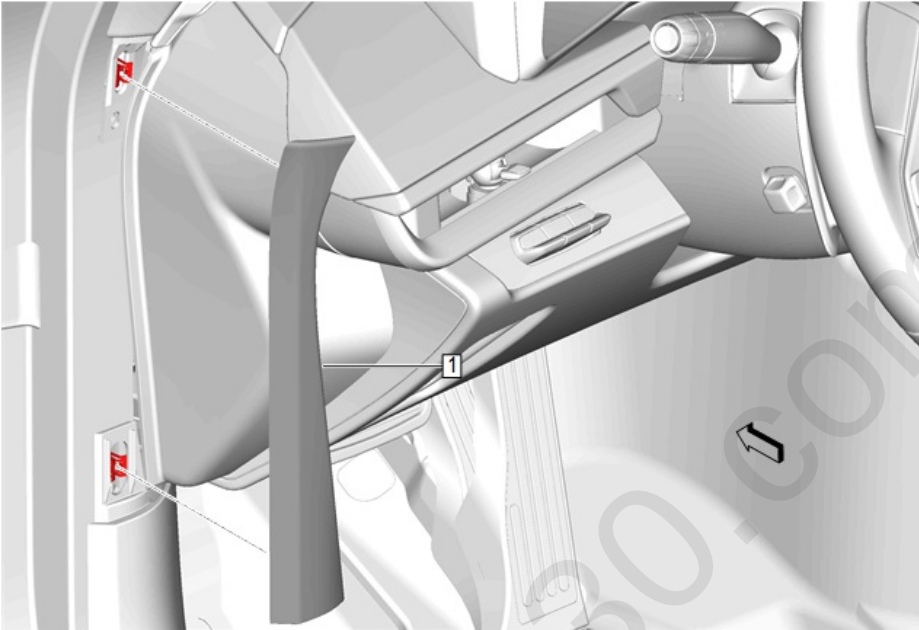
1. [Click here for full size](#)
2. Remove the left body hinge pillar garnish molding (1). [Body Hinge Pillar Garnish Molding Replacement](#)
3. Remove the left windshield garnish molding. [Windshield Garnish Molding Replacement](#)

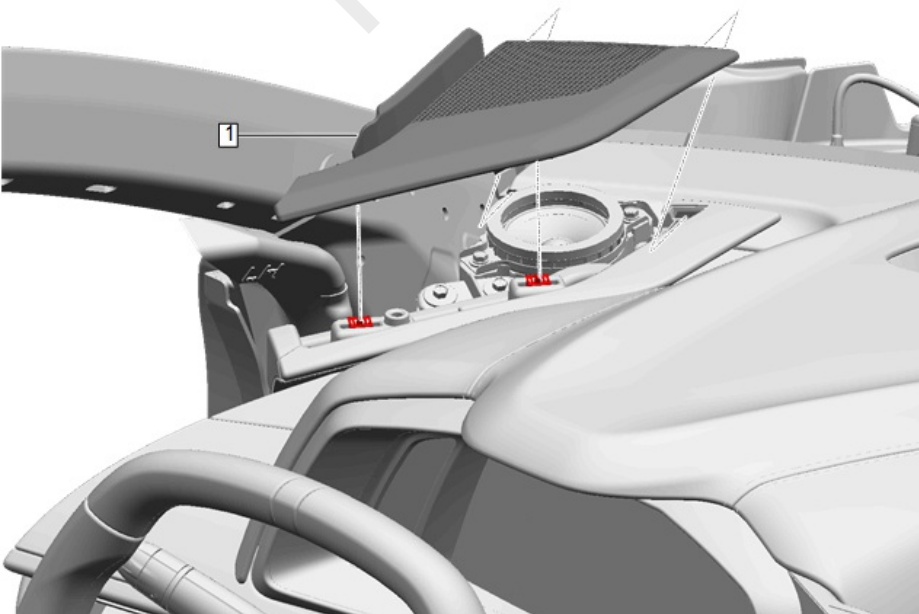
5. Remove the left instrument panel trim pad radio speaker opening cover (1).Instrument Panel Trim Pad Radio Speaker Opening Cover Replacement

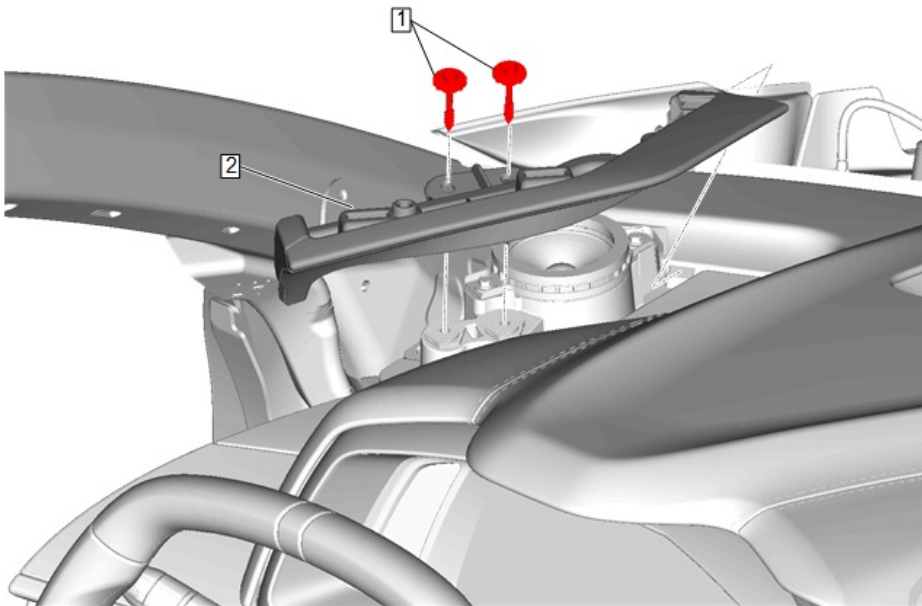
7. Remove the left radio front speaker grille molding (2).Radio Front Speaker Grille Molding Replacement

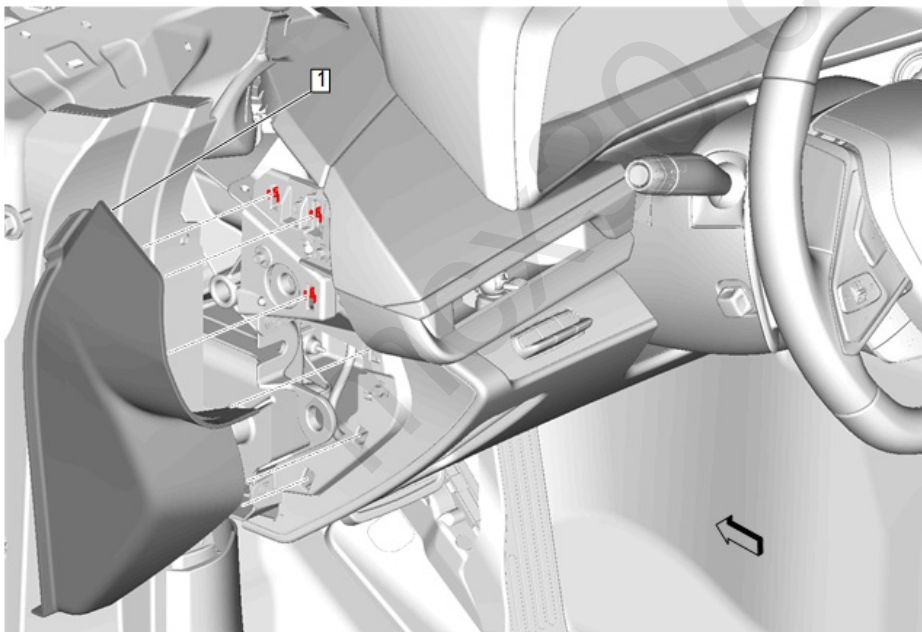
Use a flat bladed plastic trim tool.

10. Remove the left instrument panel outer trim cover (1).

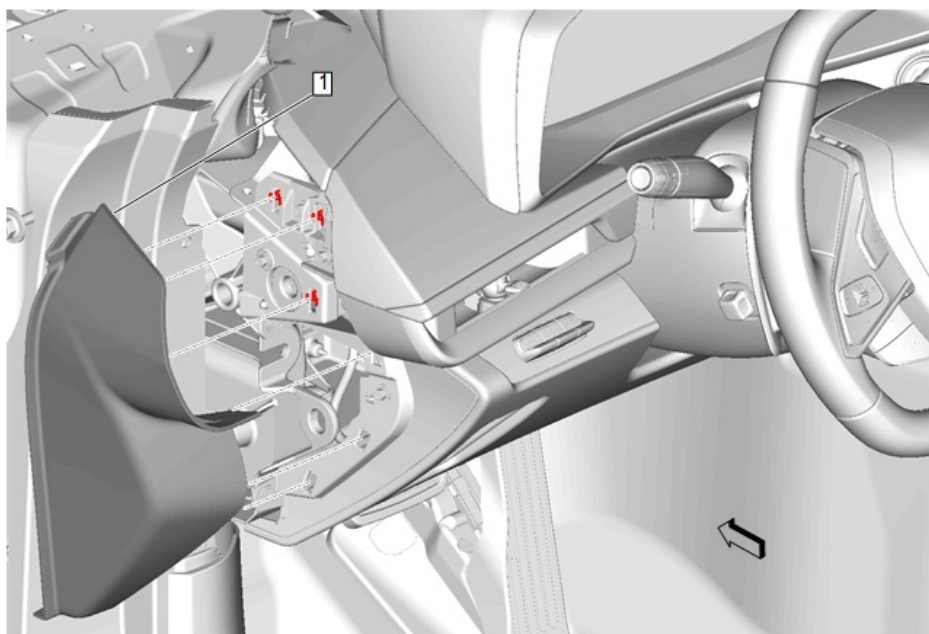
1.  
Click here for full size
2. Install the left instrument panel outer trim cover (1).

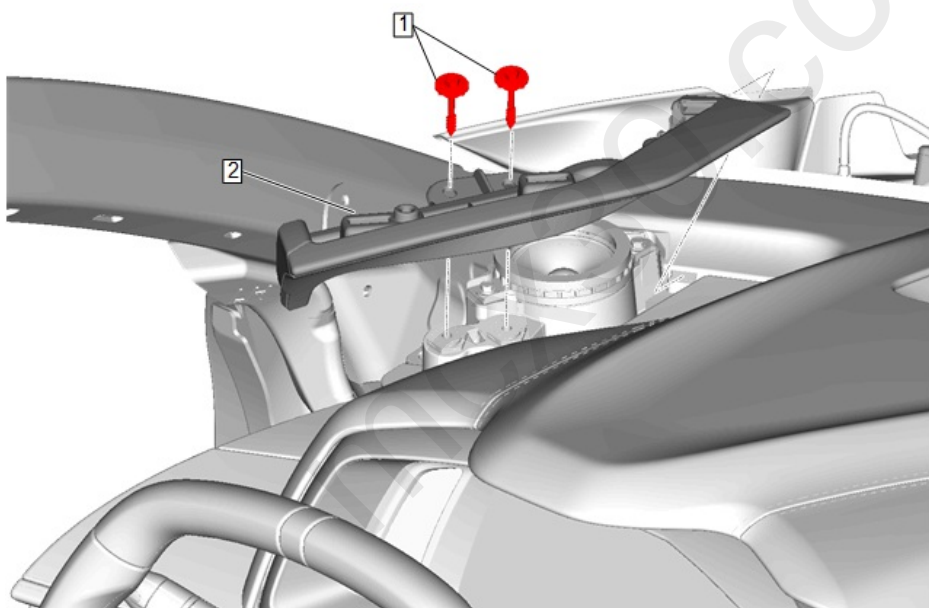
3.  
Click here for full size
4. Install the left radio front speaker grille molding (2).Radio Front Speaker Grille Molding Replacement

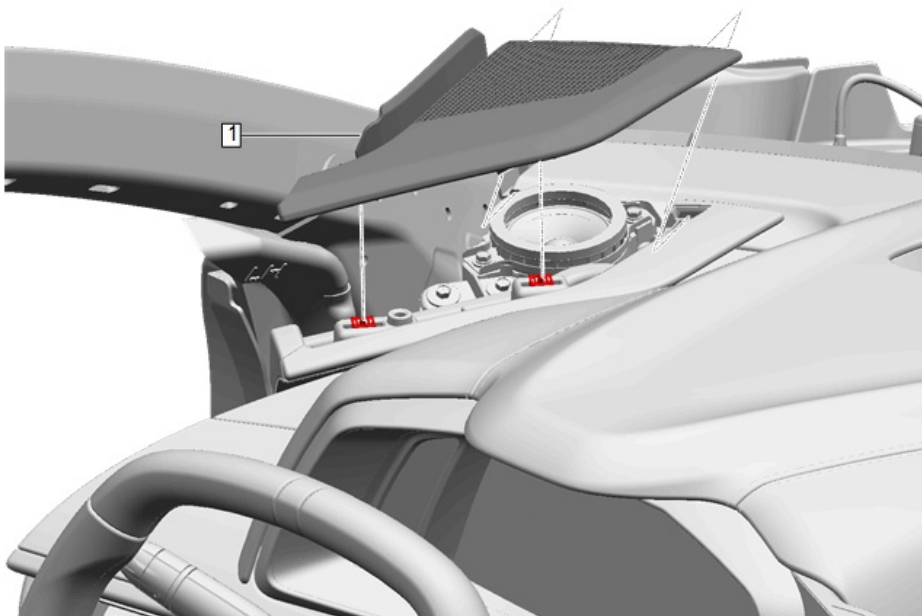
5. [Click here for full size](#)
6. Install the left instrument panel trim pad radio speaker opening cover (1).Instrument Panel Trim Pad Radio Speaker Opening Cover Replacement
7. Install the left windshield garnish molding.Windshield Garnish Molding Replacement

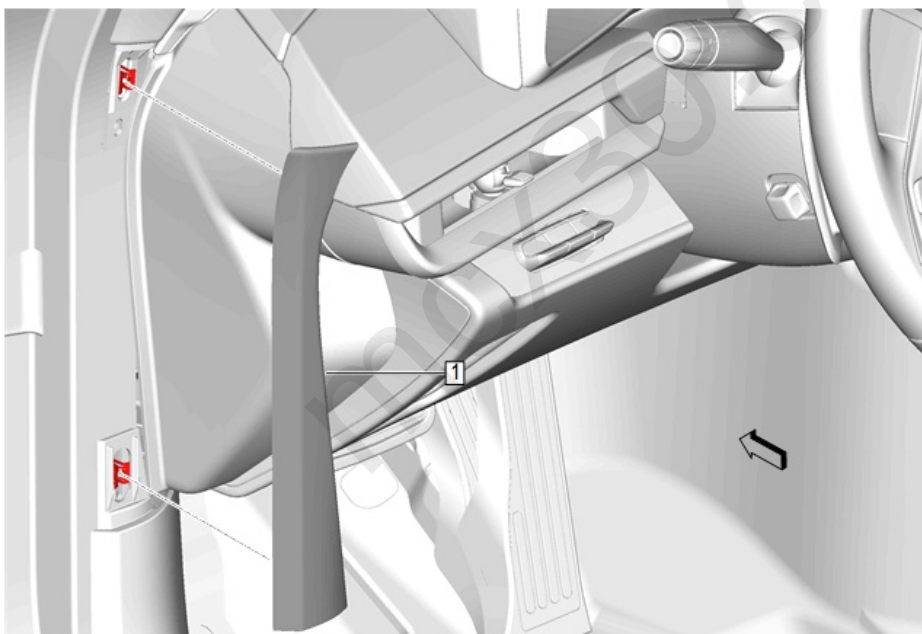
8. [Click here for full size](#)
9. Install the left body hinge pillar garnish molding (1).Body Hinge Pillar Garnish Molding Replacement
