# 2022 CHEVROLET CORVETTE SERVICE MANUAL

## Front Side Door Sill Garnish Molding Replacement

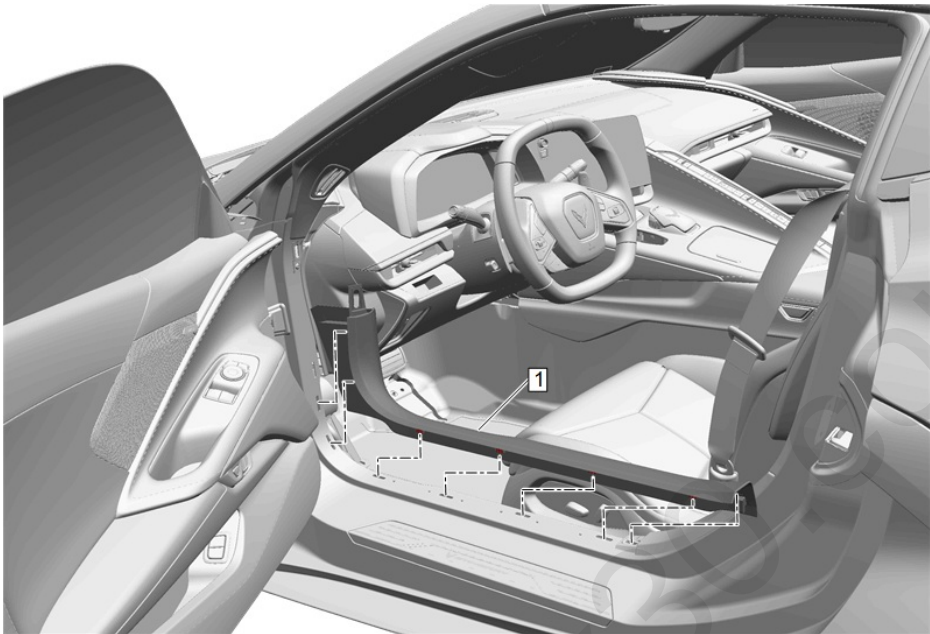
| Callout | Component Name |
|---|---|
| 1 | <div>Front Side Door Sill Garnish Molding</div> <div>Procedure</div> <div><div>1.</div><div>Starting at the rear of the garnish molding, pull upward at the B-Pillar joint to disengage garnish molding.</div></div> <div><div>2.</div><div>Work your way forward disengaging all of the garnish molding clips then pull rearward and towards center console to disengage the clips on the forward vertical wall .</div></div> <div><div>3.</div><div>Reposition the front floor panel carpet as needed.</div></div> |
