# 2022 CHEVROLET CORVETTE SERVICE MANUAL

## Instrument Panel Outer Air Outlet Replacement - Left Side

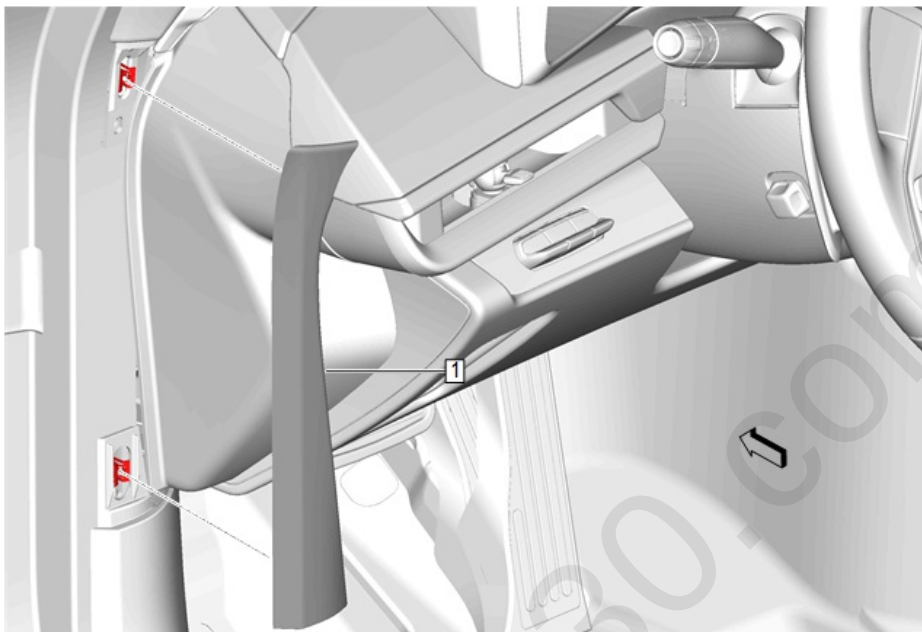
1. [Click here for full size](#)
2. Remove the left body hinge pillar garnish molding (1).Body Hinge Pillar Garnish Molding Replacement

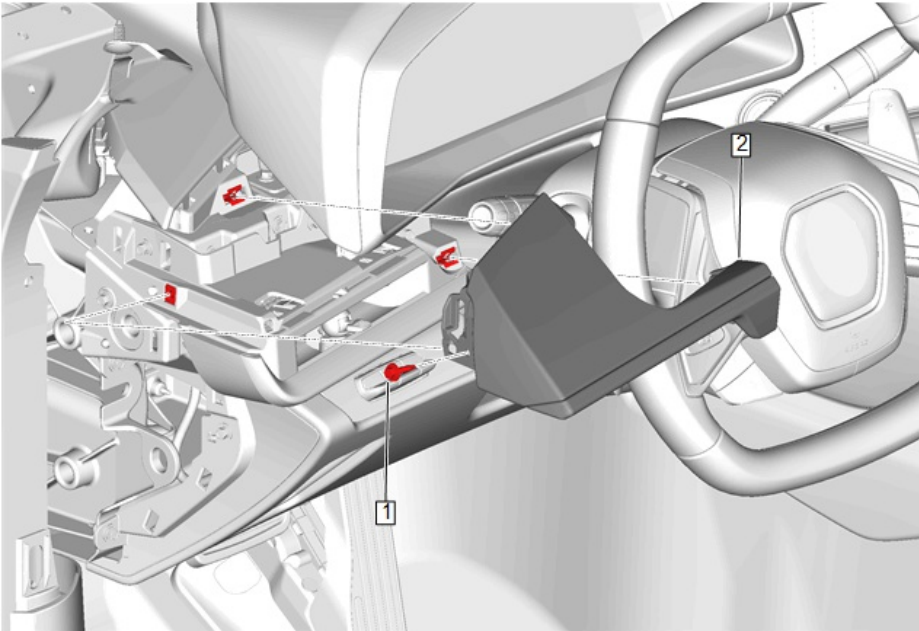
12. Instrument Panel Accessory Bezel (2) >> Remove - Instrument Panel Accessory Bezel Replacement

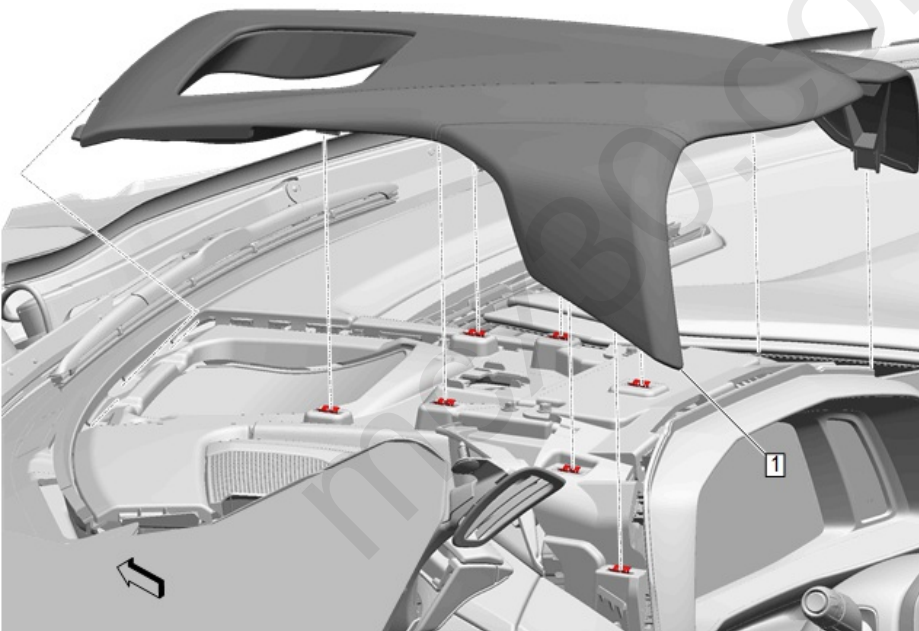
14. Instrument Panel Instrument Cluster Hood (1) >> Remove - Instrument Panel Instrument Cluster Hood Replacement

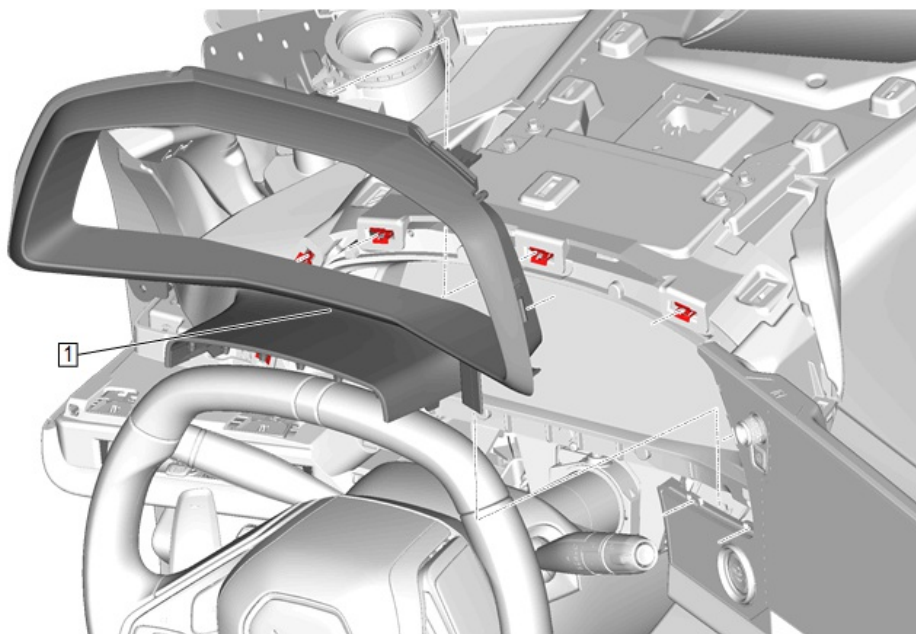
16. Instrument Panel Cluster Trim Plate (1) >>> Remove - Instrument Panel Cluster Trim Plate Replacement

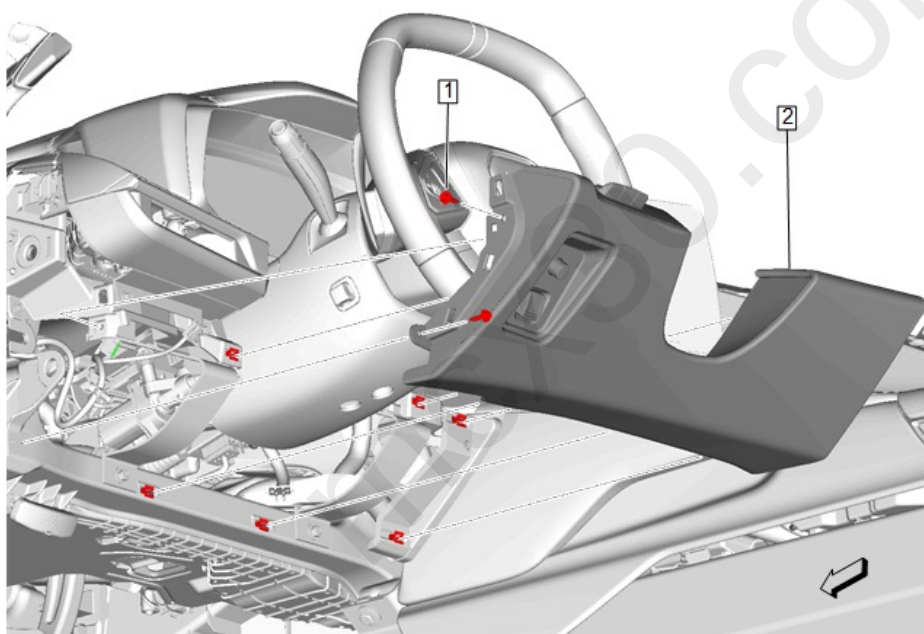
18. Instrument Panel Knee Bolster (2) >>> Remove - Instrument Panel Knee Bolster Replacement

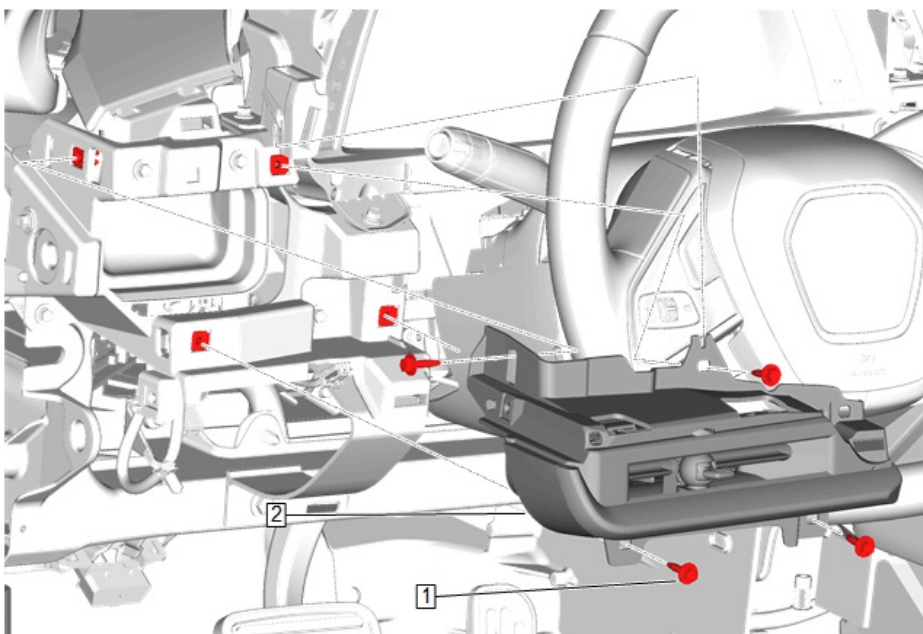
20. Instrument Panel Air Outlet Bezel - Left Side (2) >> Remove - Instrument Panel Air Outlet Bezel Replacement - Left Side

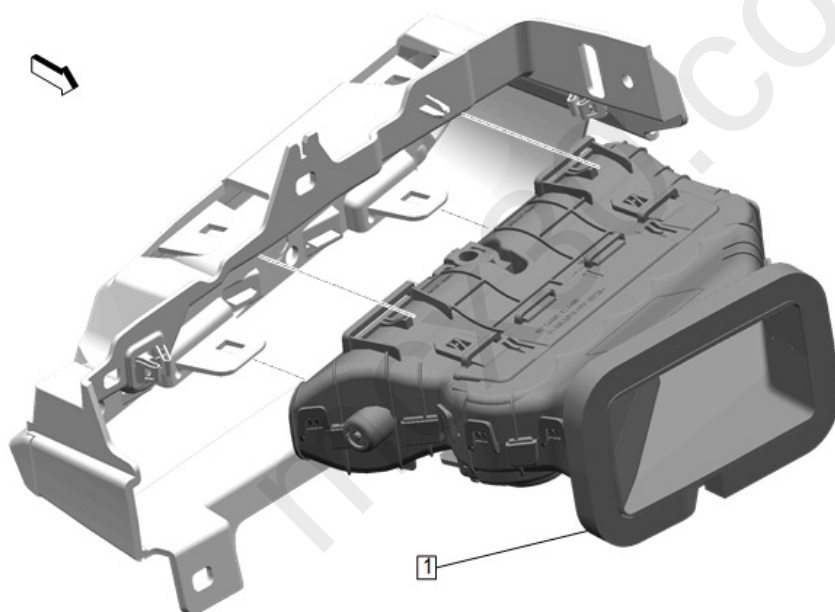
22. Instrument Panel Outer Air Outlet (1) >> Remove

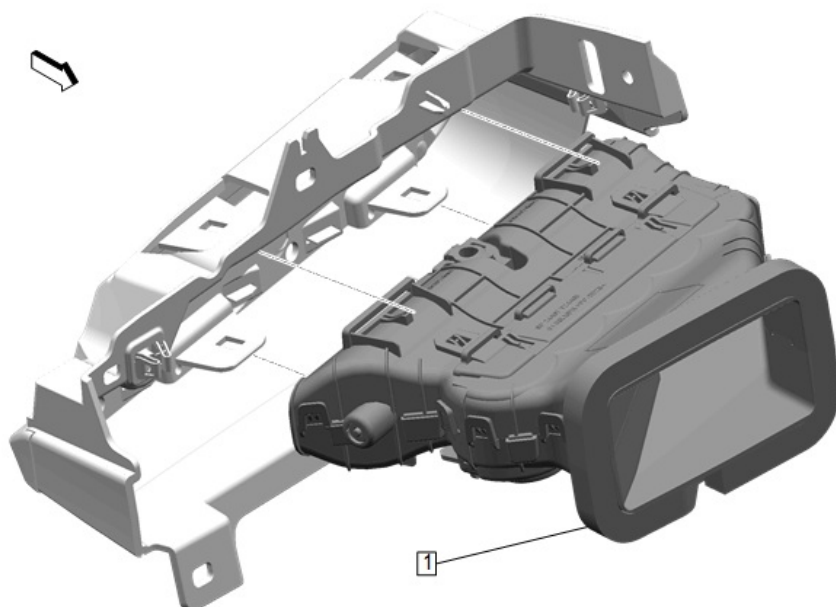
1. [Click here for full size](#)
2. Instrument Panel Outer Air Outlet (1) >> Install

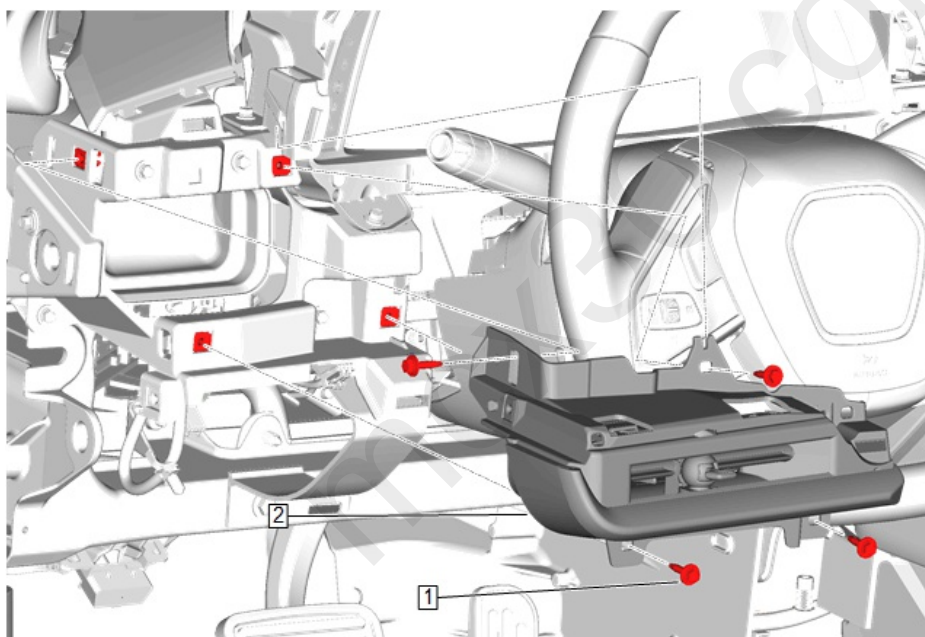
3. [Click here for full size](#)
4. Instrument Panel Air Outlet Bezel - Left Side (2) >> Install - Instrument Panel Air Outlet Bezel Replacement - Left Side

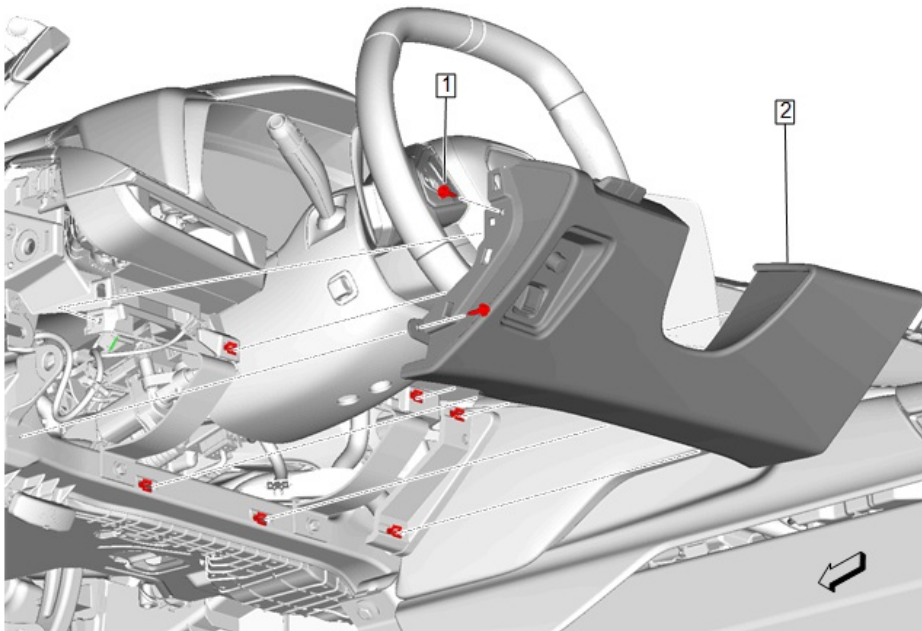
6. Instrument Panel Knee Bolster (2) >> Install - Instrument Panel Knee Bolster Replacement

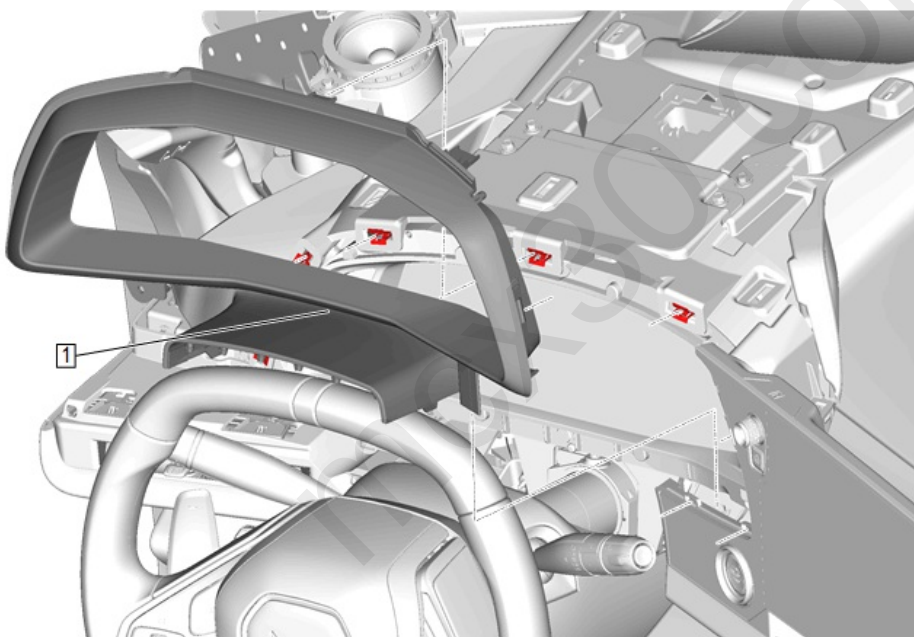
8. Instrument Panel Cluster Trim Plate (1) >> Install - Instrument Panel Cluster Trim Plate Replacement

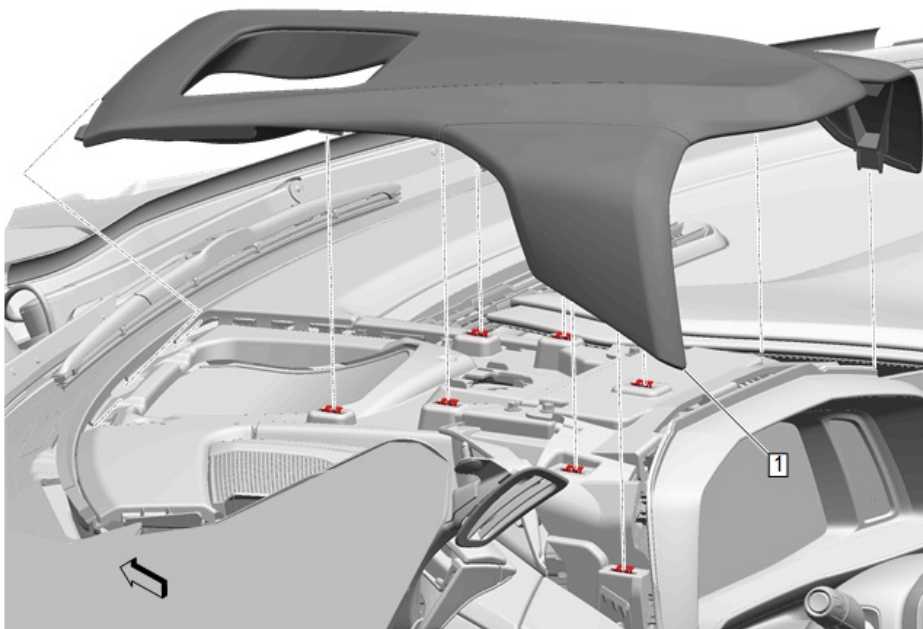
10. Instrument Panel Instrument Cluster Hood (1) >> Install - Instrument Panel Instrument Cluster Hood Replacement

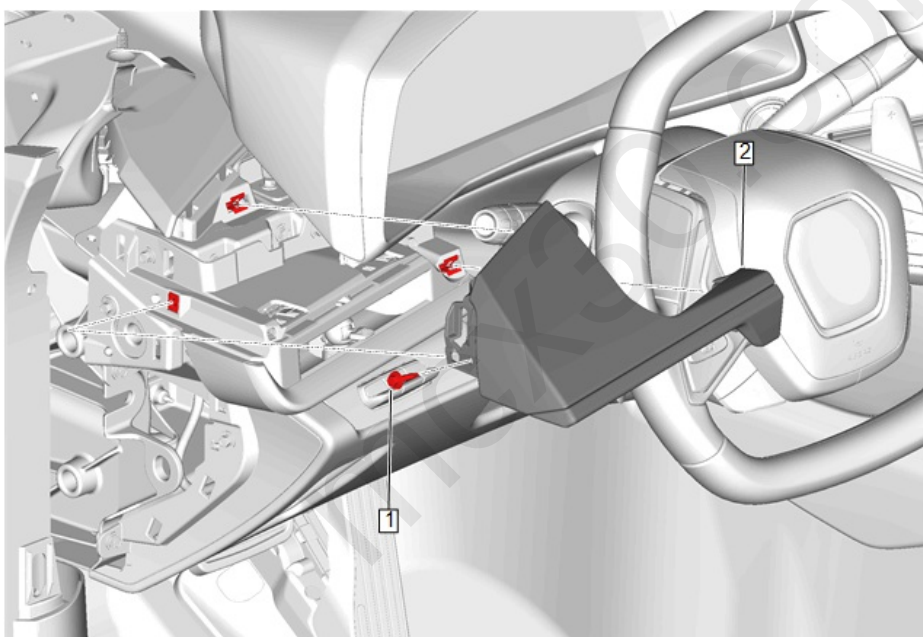
12. Instrument Panel Accessory Bezel (2) >> Install - Instrument Panel Accessory Bezel Replacement

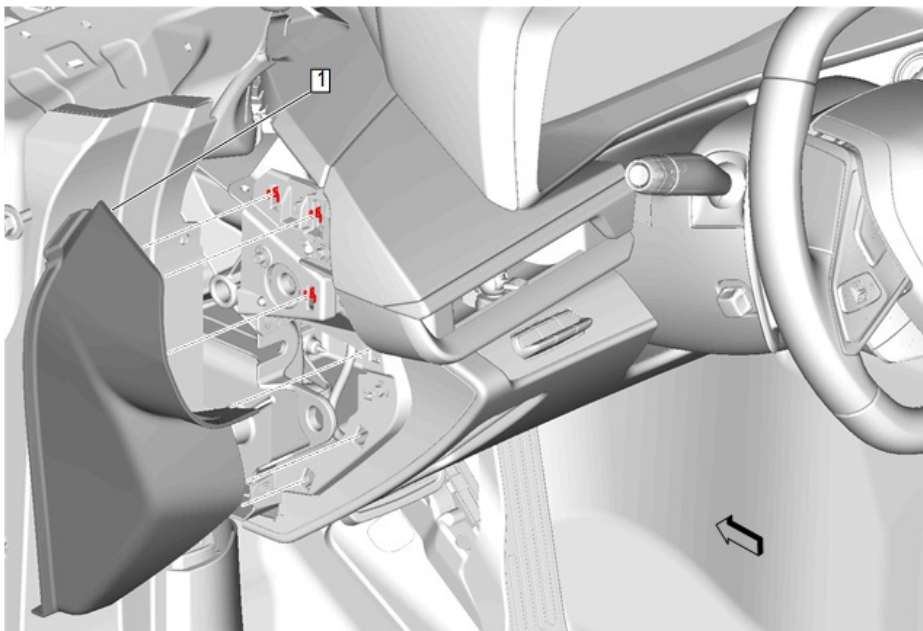
14. Install the left instrument panel outer trim cover (1).Instrument Panel Outer Trim Cover Replacement

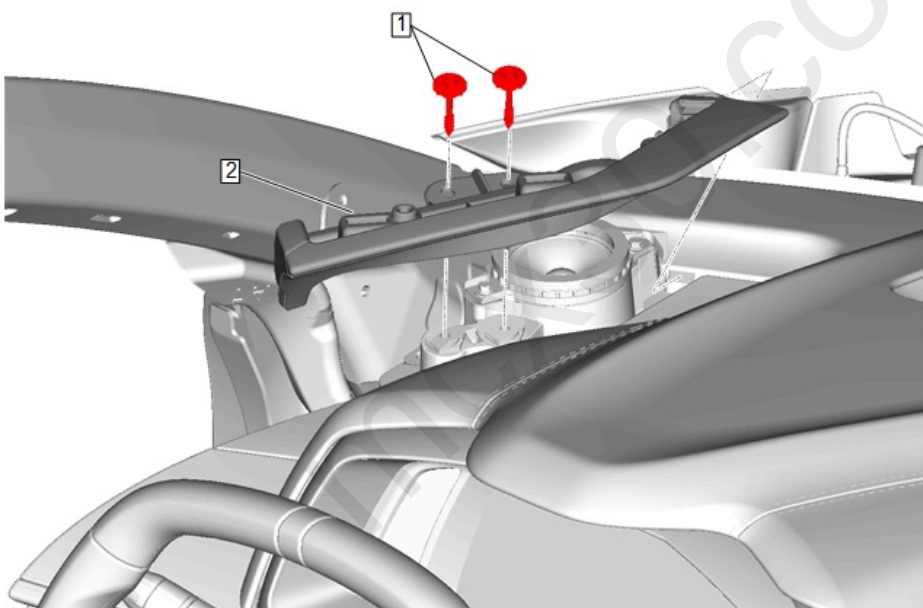
16. Install the left radio front speaker grille molding (2).Radio Front Speaker Grille Molding Replacement

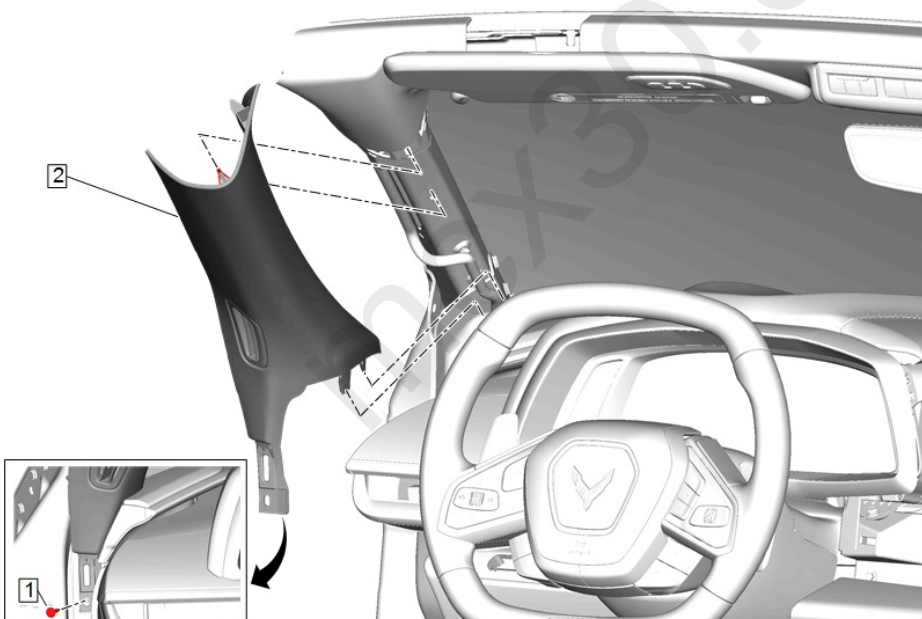
20. Install the left windshield garnish molding (2).Windshield Garnish Molding Replacement
