# 2022 CHEVROLET CORVETTE SERVICE MANUAL

## Radio Cooling Duct Replacement (Right Hand Drive)

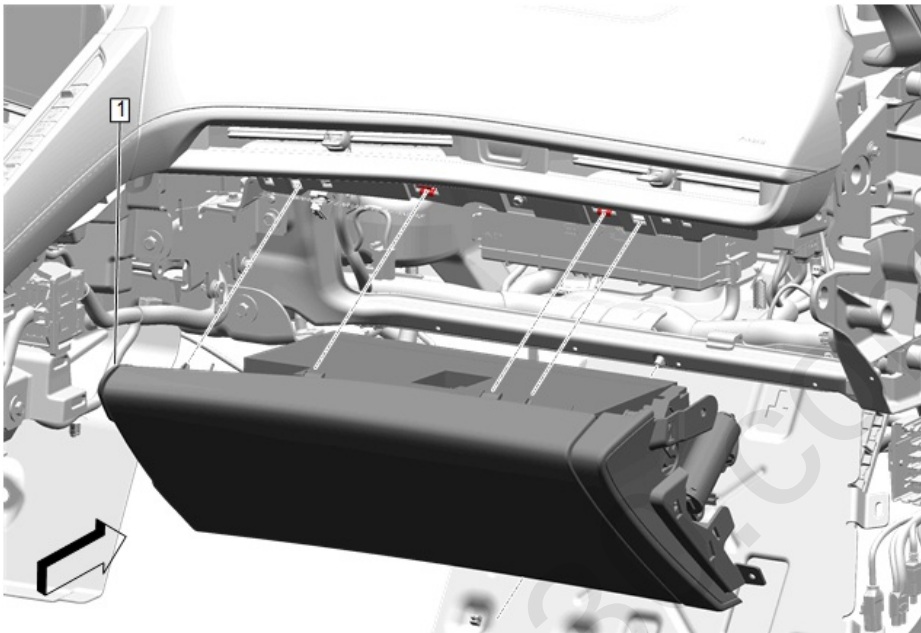
Left hand drive vehicle shown, right hand drive vehicle similar.

3. Instrument Panel Compartment (1) >> Remove - Instrument Panel Compartment Replacement

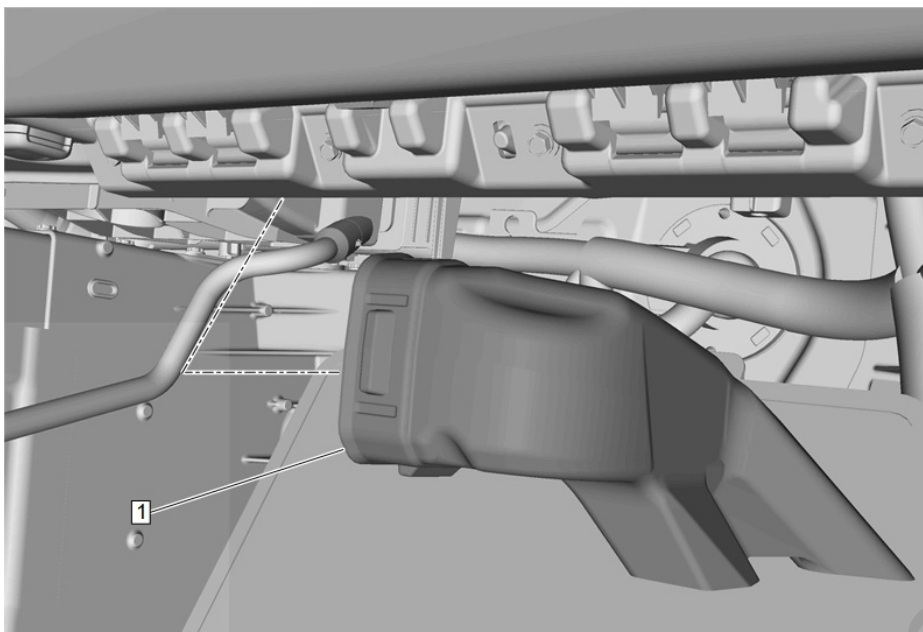
7. Floor Front Air Outlet Duct - Right Side (1) >> Install - Floor Front Air Outlet Duct Replacement - Right Side

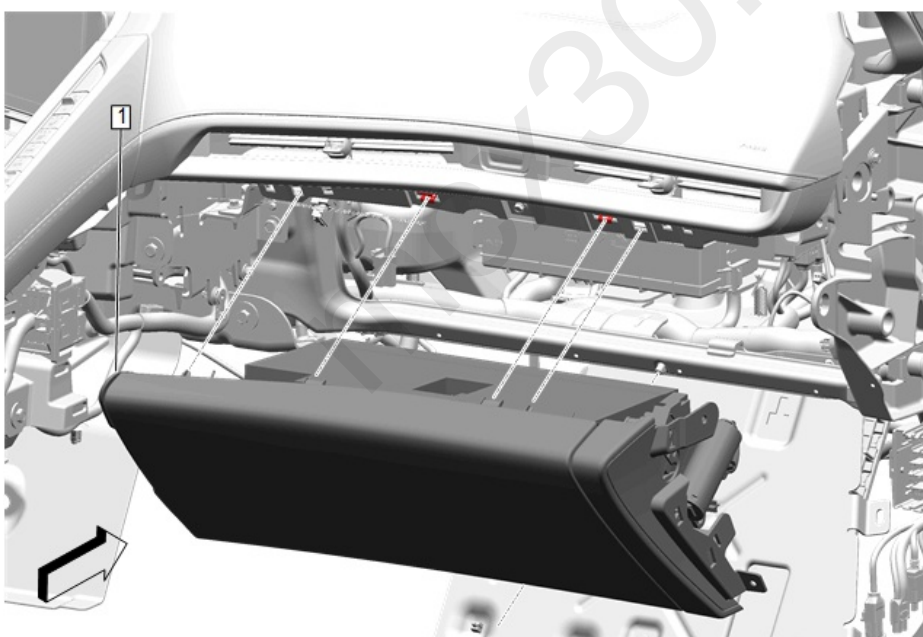
9. Instrument Panel Compartment (1) >> Install - Instrument Panel Compartment Replacement
