# 2022 CHEVROLET CORVETTE SERVICE MANUAL

## Temperature Valve Actuator Replacement - Left Side (Right Hand Drive)

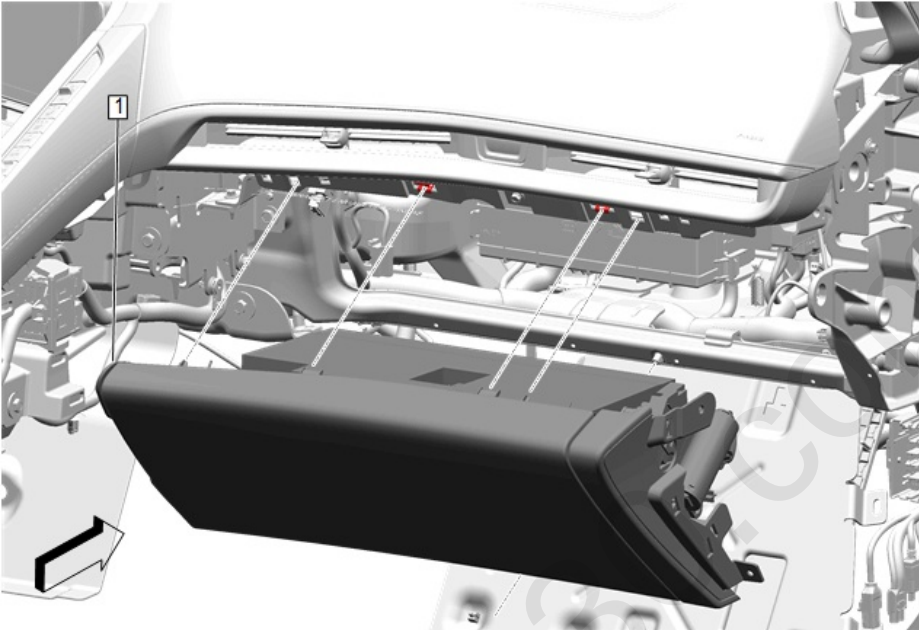
1. [Click here for full size](#)
2. Note:  
Left hand drive vehicle shown, right hand drive vehicle similar.
3. Instrument Panel Compartment (1) >> Remove - Instrument Panel Compartment Replacement

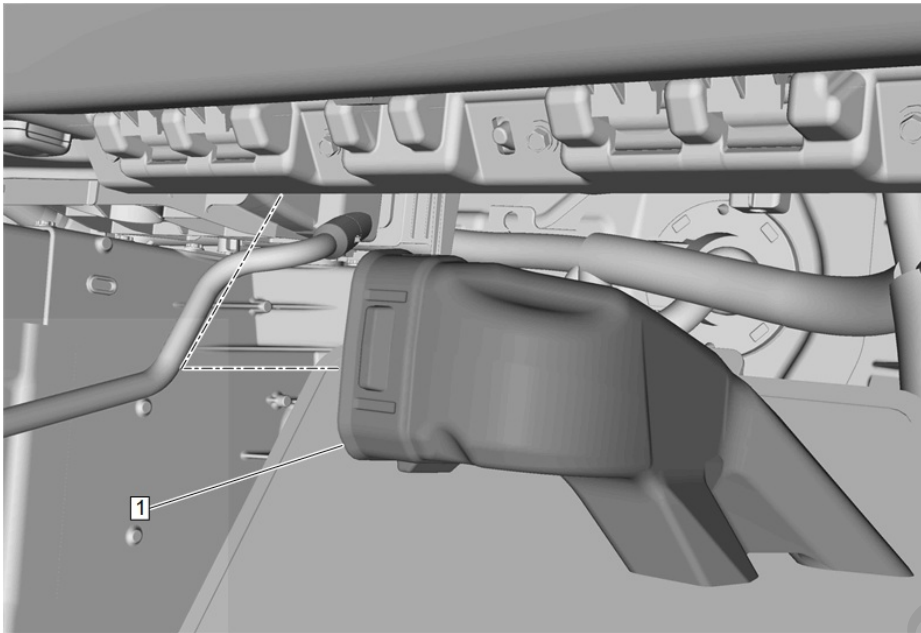
4. [Click here for full size](#)
5. Note:  
Left hand drive vehicle shown, right hand drive vehicle similar.
6. Floor Front Air Outlet Duct - Right Side (1) >>> Remove - Floor Front Air Outlet Duct Replacement - Right Side
7. [Click here for full size](#)
8. Temperature Valve Actuator Bolt (1) >>> Remove [2x]
9. [Click here for full size](#)
10. Temperature Valve Actuator - Left Side (1) >>> Remove
11. Disconnect the electrical connector.

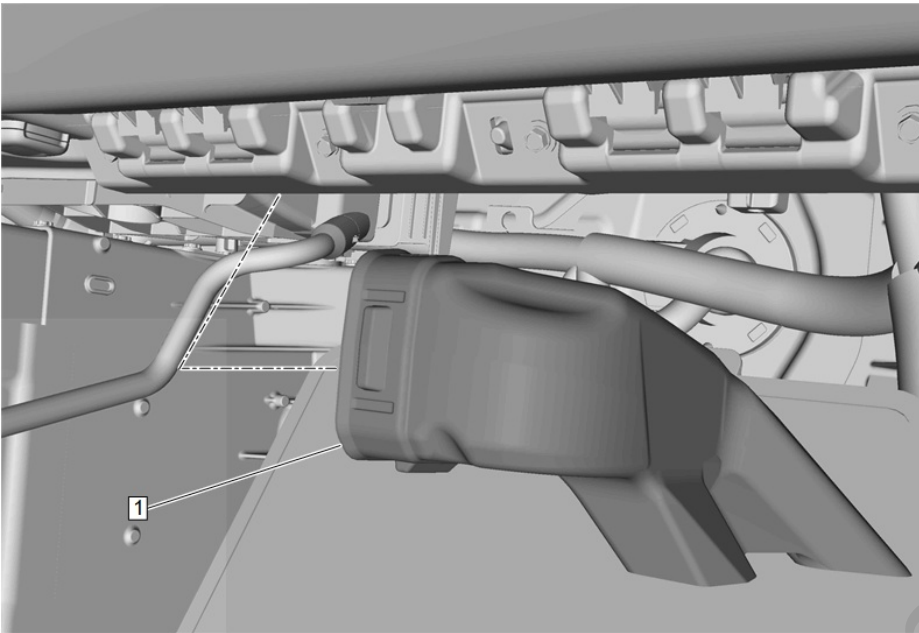
8. Floor Front Air Outlet Duct - Right Side (1) >> Install - Floor Front Air Outlet Duct Replacement - Right Side

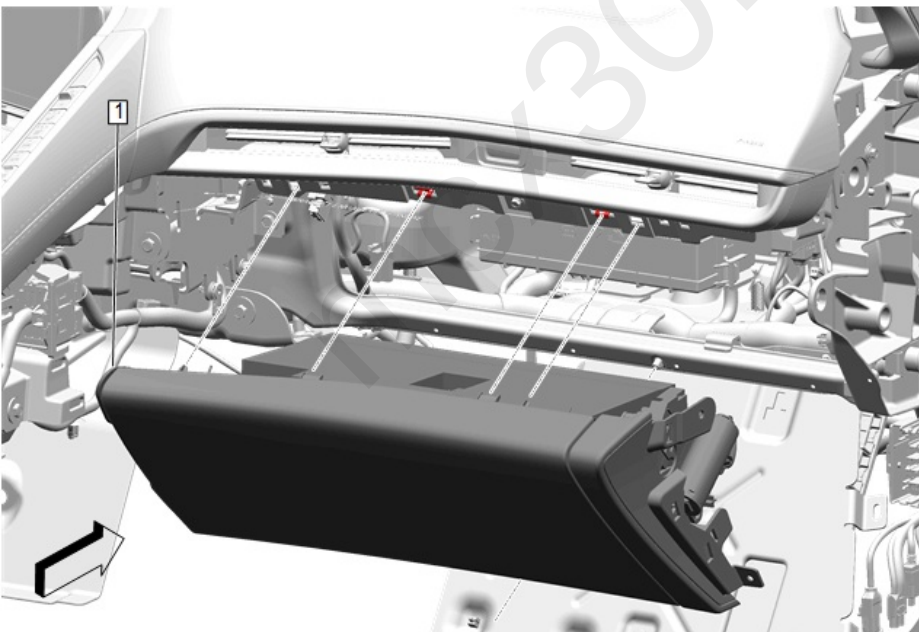
10. Instrument Panel Compartment (1) >> Install - Instrument Panel Compartment Replacement
