# 2022 CHEVROLET CORVETTE SERVICE MANUAL

## Body Wiring Harness Junction Block Replacement

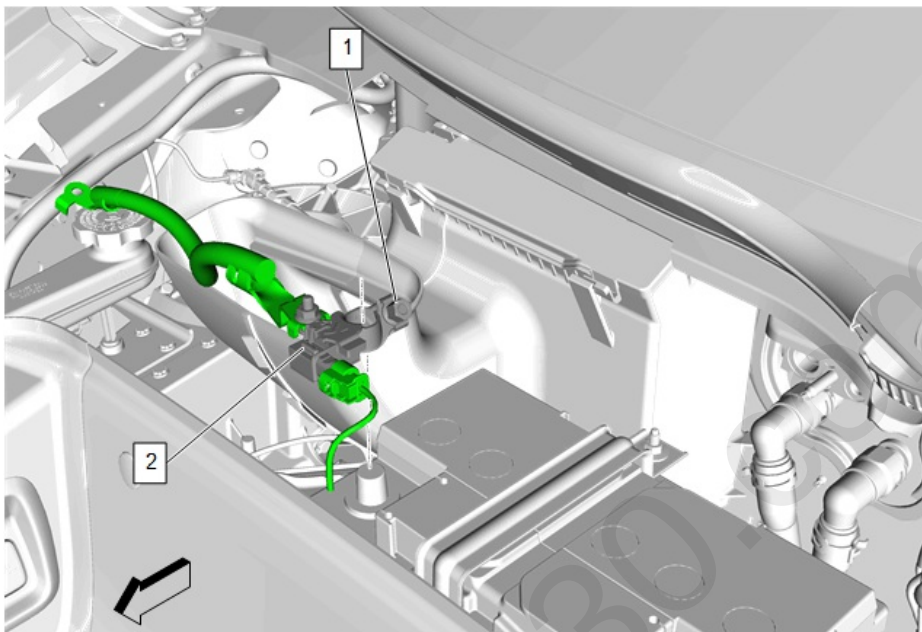
1. [Click here for full size](#)
2. Disconnect the negative battery cable (2). Battery Negative Cable Disconnection and Connection

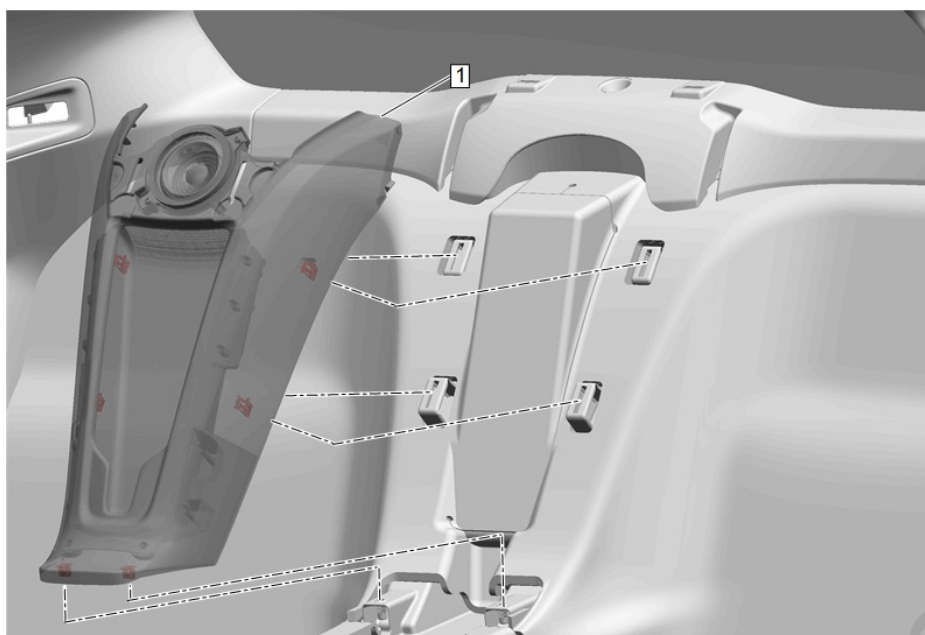
4. Rear Compartment Closeout Panel (1) >> Remove - Rear Compartment Closeout Panel Replacement

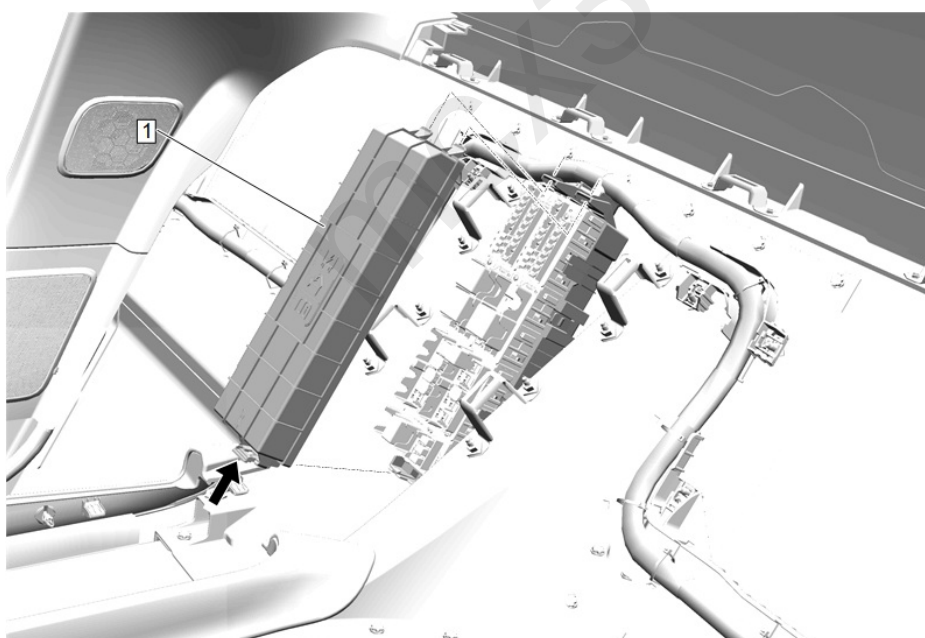
6. Body Wiring Harness Junction Block Cover (1) >> Remove

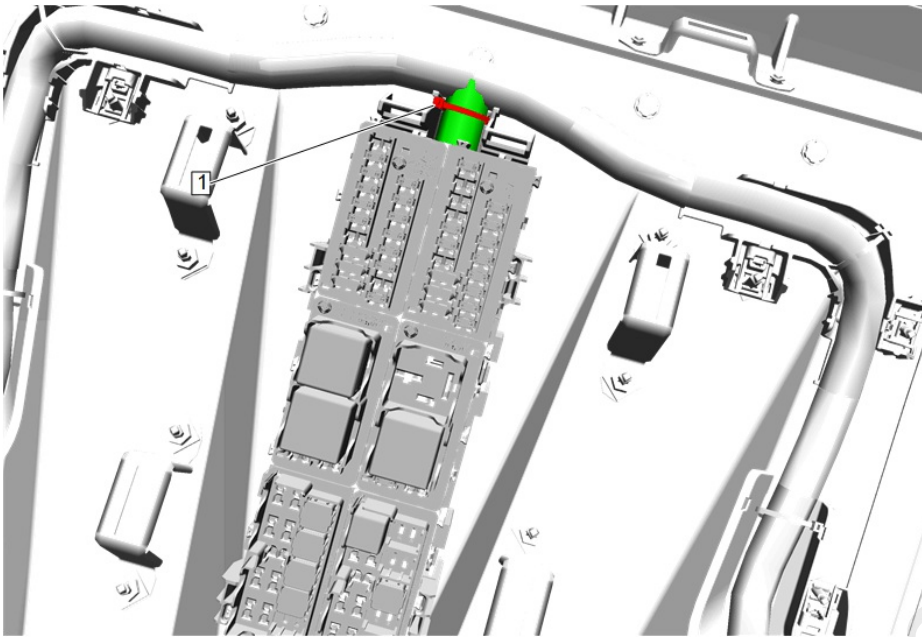
7. [Click here for full size](#)
8. Using the appropriate tool, cut the wiring harness tie strap (1).

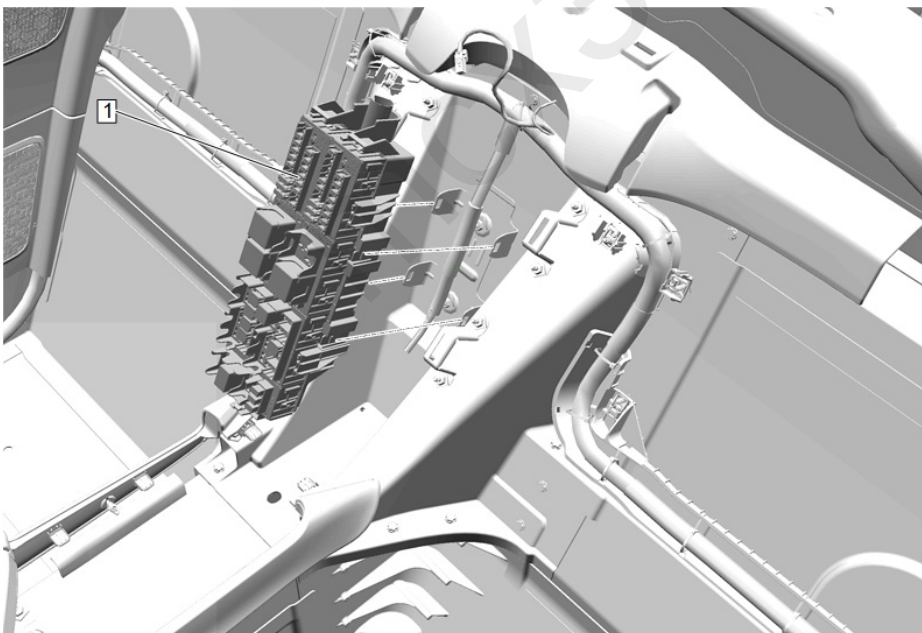
9. [Click here for full size](#)
10. Release the 4 body wiring harness junction block bracket tabs and reposition the body wiring harness junction block.
11. Release the fuse block terminals. Terminal Removal

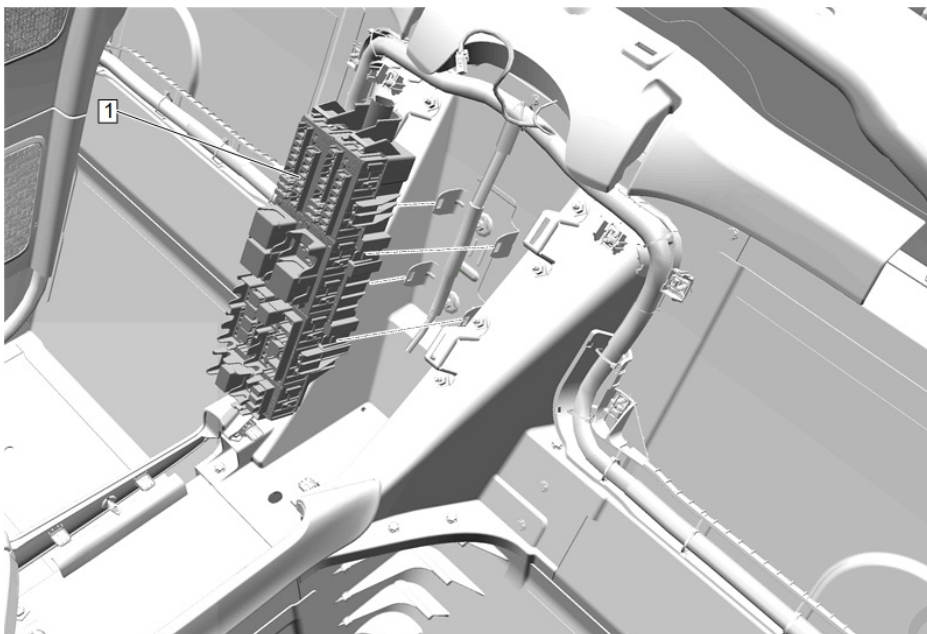
1. [Click here for full size](#)
2. Install the fuse block terminals.
3. Install the body wiring harness junction block (1) to the body wiring harness junction block bracket tabs.

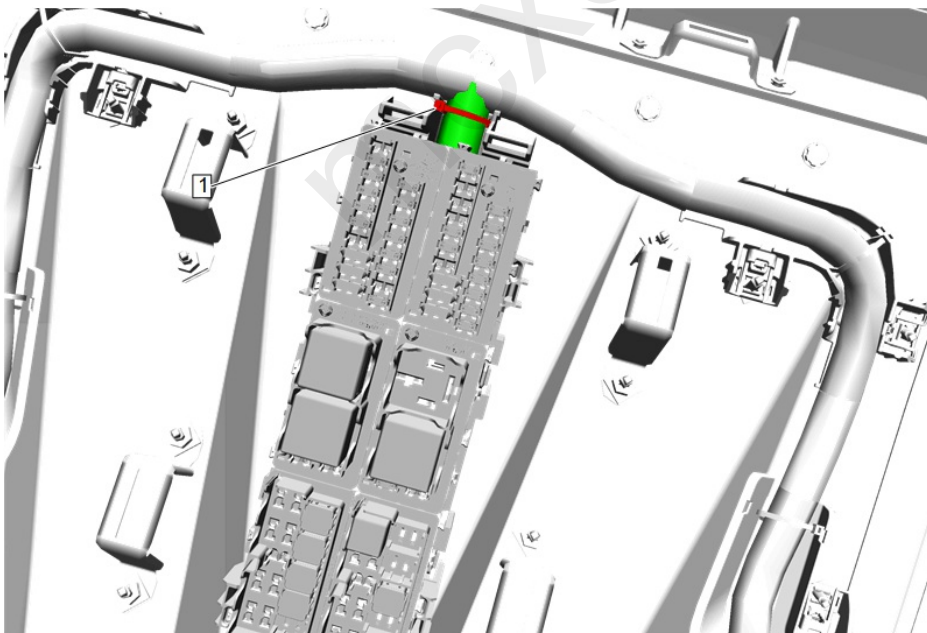
4. [Click here for full size](#)
5. Install a NEW wiring harness tie strap (1).

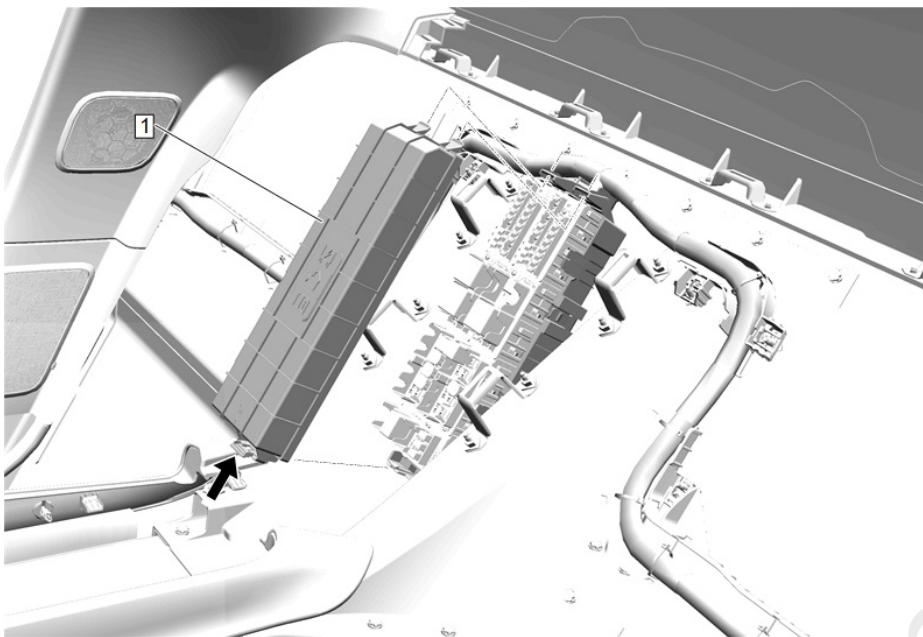
7. Body Wiring Harness Junction Block Cover (1) >> Install

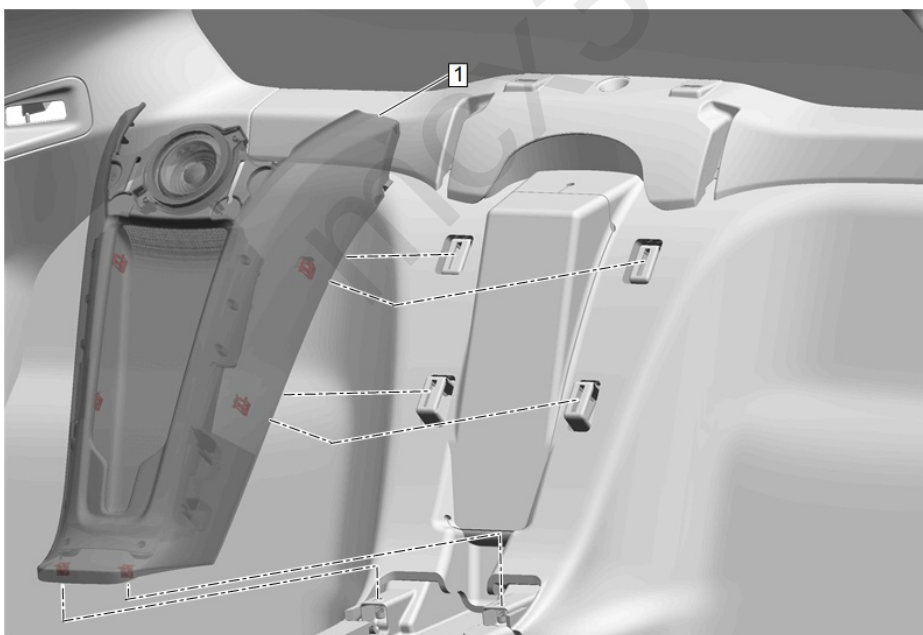
9. Rear Compartment Closeout Panel (1) >> Install - Rear Compartment Closeout Panel Replacement

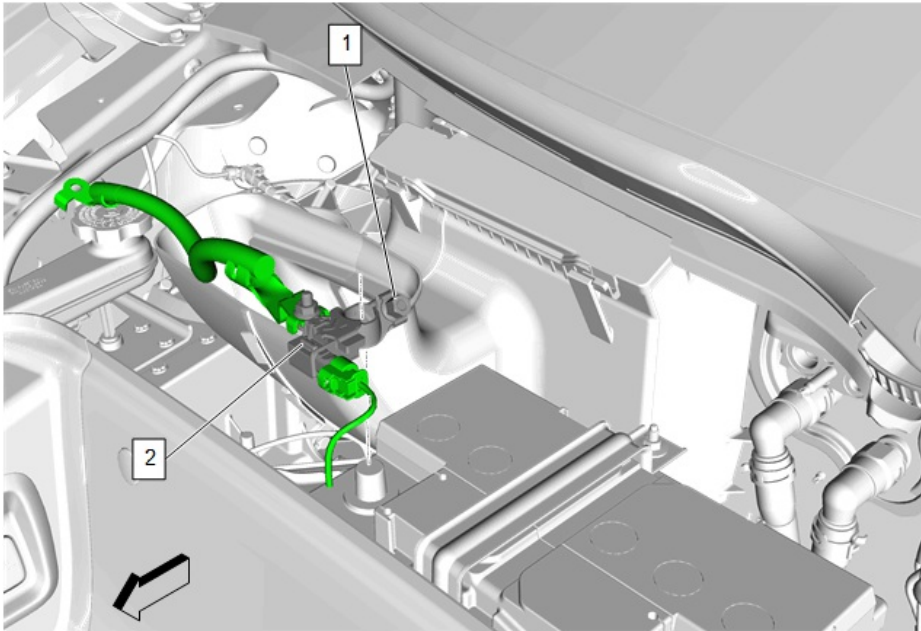
11. Connect the negative battery cable (2). Battery Negative Cable Disconnection and Connection
