# 2022 CHEVROLET CORVETTE SERVICE MANUAL

## Low Frequency Body Side Antenna Replacement - Right Side

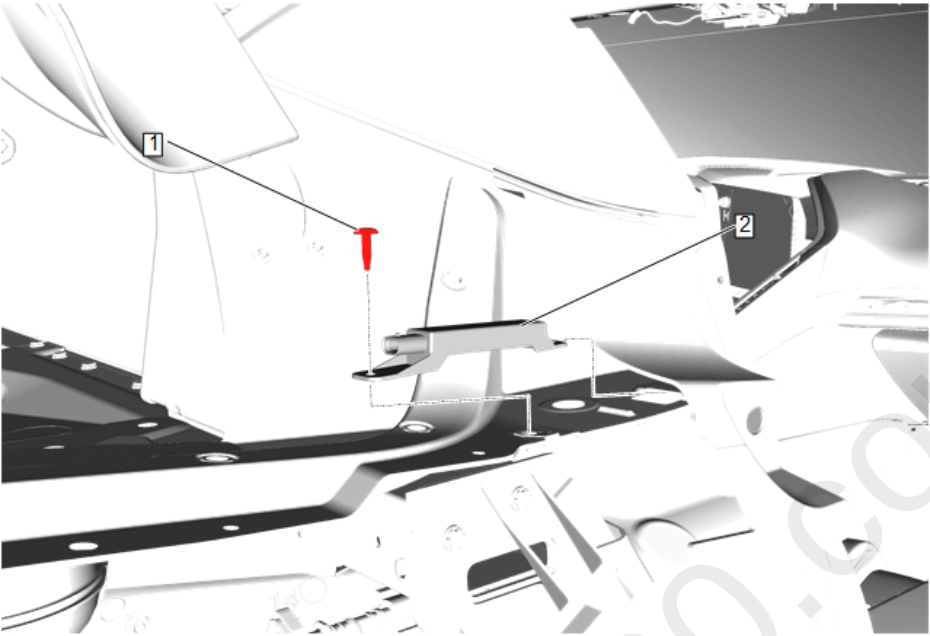
[Click here for full size](#)  
Quarter Outer Panel Replacement - Right Side

2.5N-m (22 lb in)

| Callout | Component Name |
|---|---|
| 1 | Low Frequency Body Side Antenna Bolt<br><br>Caution:<br><br>Refer to |
| 2 | Low Frequency Body Side Antenna<br><br>Procedure<br><br>Disconnect the electrical connector. |
