# 2022 CHEVROLET CORVETTE SERVICE MANUAL

## Front Side Door Wiring Harness Replacement

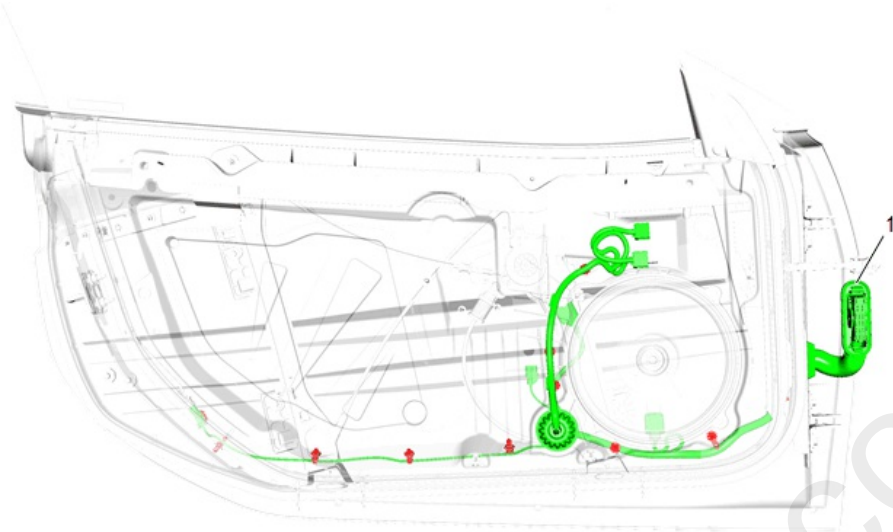
| Callout | Component Name |
|---|---|
| 1 | <p data-bbox="177 120 496 147">Front Side Door Wiring Harness</p> <p data-bbox="177 176 236 203">Note:</p> <p data-bbox="177 232 1023 259">Typical wiring harness shown, individual harness may be different due to option content.</p> <p data-bbox="240 291 344 318">Procedure</p> <ol data-bbox="209 347 798 495" style="list-style-type: none"> <li data-bbox="209 347 587 374">1. Disconnect all electrical connectors.</li> <li data-bbox="209 405 798 432">2. Remove the front side door wiring harness from the door.</li> <li data-bbox="209 463 472 490">3. Enable the SIR System.</li> </ol> |
