# 2022 CHEVROLET CORVETTE SERVICE MANUAL

## Radio Front Speaker Replacement

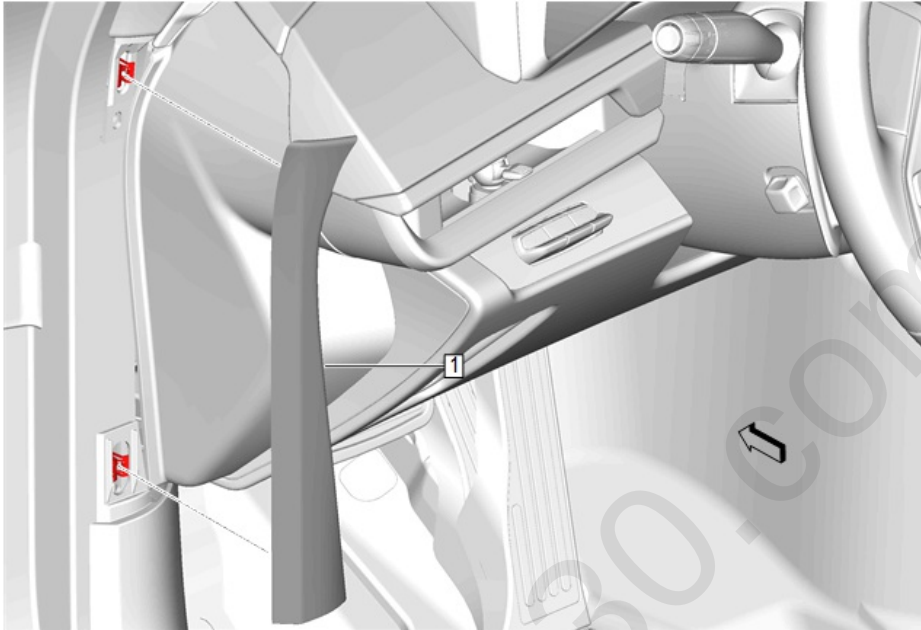
1. [Click here for full size](#)
2. Remove the left body hinge pillar garnish molding (1).Body Hinge Pillar Garnish Molding Replacement

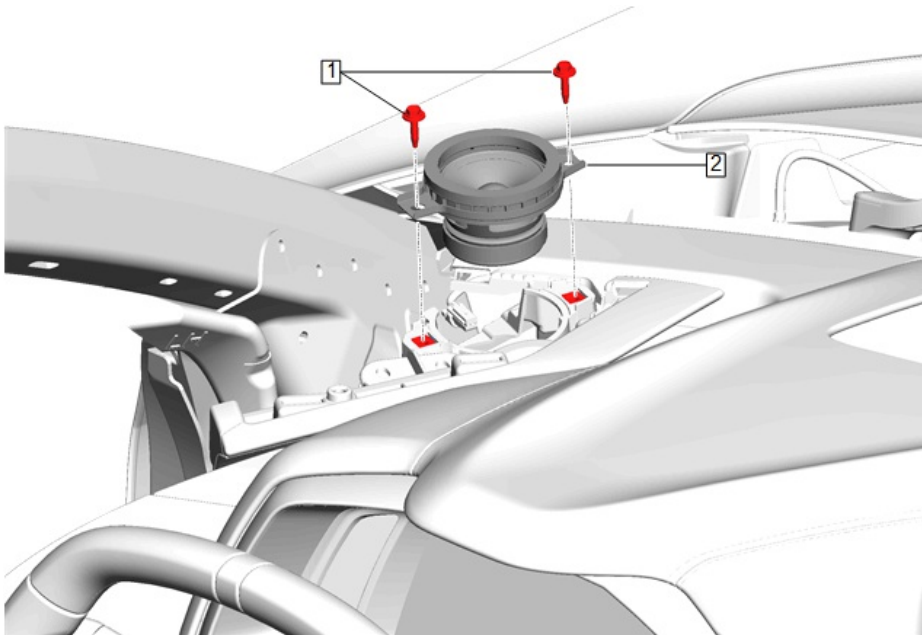
7. [Click here for full size](#)
8. Radio Front Speaker Bolt (1) >> Remove [2x]
9. Disconnect the electrical connector.
10. Radio Front Speaker (2) >> Remove

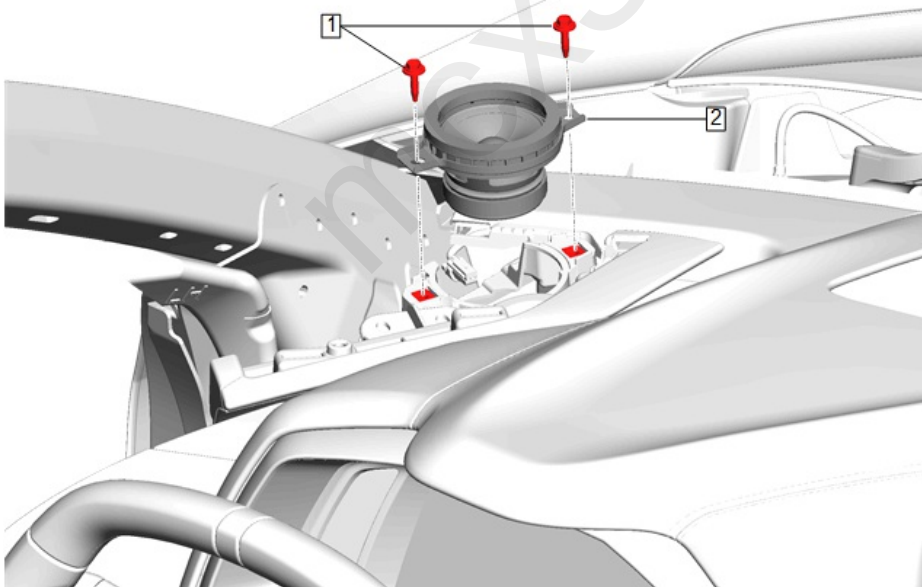
2. [Click here for full size](#)
3. Radio Front Speaker (2) >> Install
4. Caution:  
Refer to Fastener Caution.
5. Radio Front Speaker Bolt (1) >> Install and tighten [2x]2.5N-m (22 lb in)

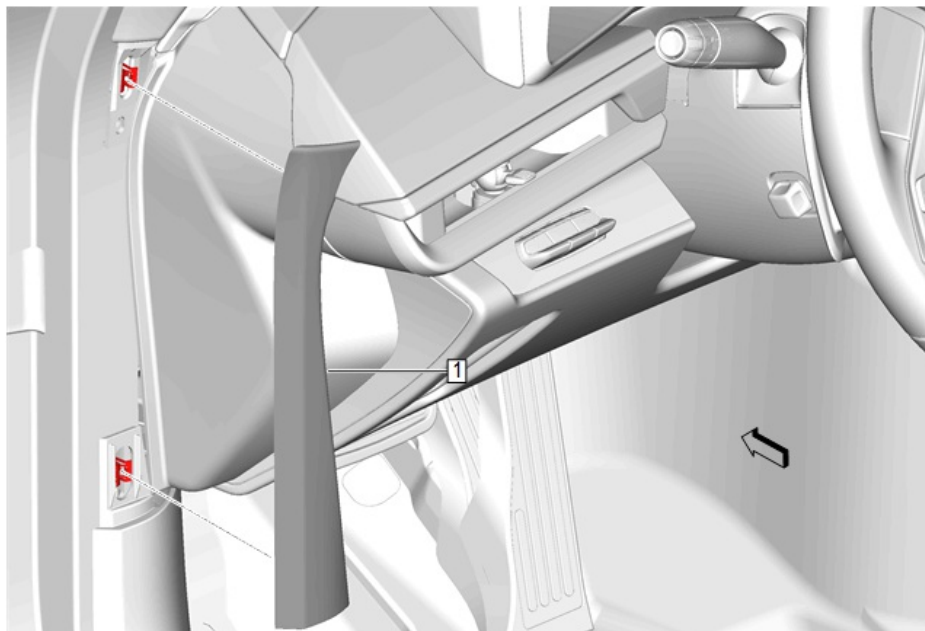
11. Install the left body hinge pillar garnish molding (1).Body Hinge Pillar Garnish Molding Replacement
