# 2022 CHEVROLET CORVETTE SERVICE MANUAL

## **Head-Up Display Switch Replacement**

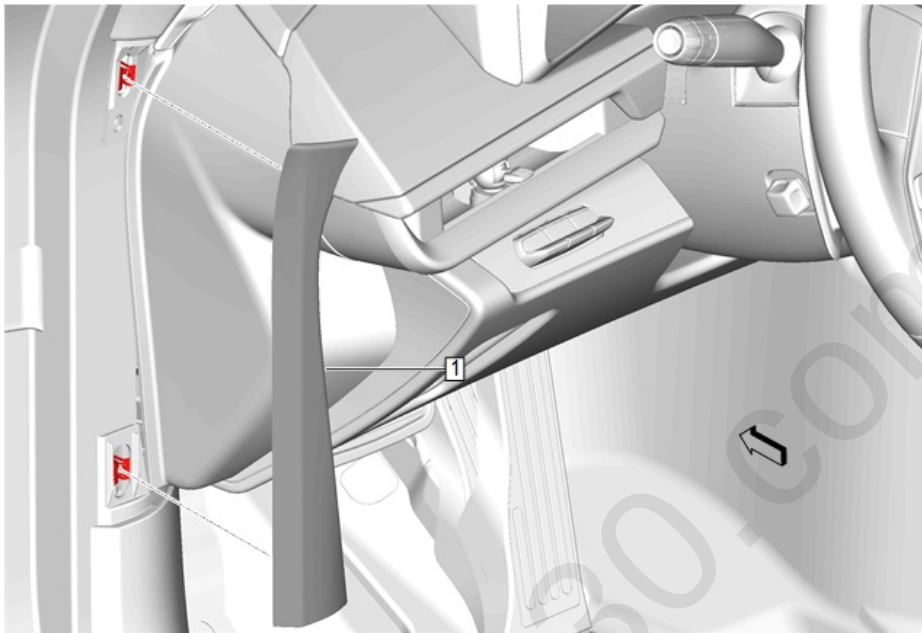
1. [Click here for full size](#)
2. Remove the left body hinge pillar garnish molding (1).Body Hinge Pillar Garnish Molding Replacement

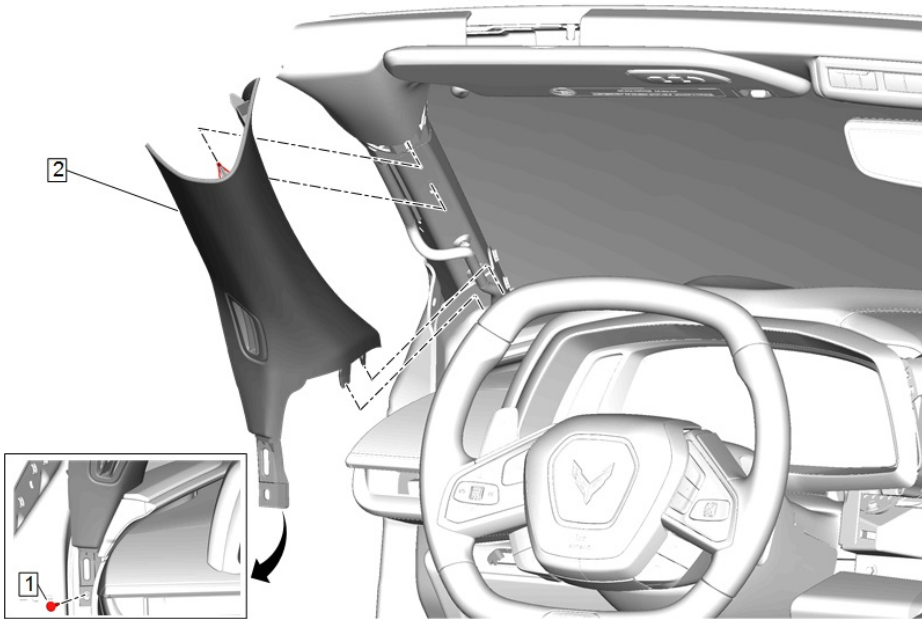
4. Remove the left windshield garnish molding (2). Windshield Garnish Molding Replacement

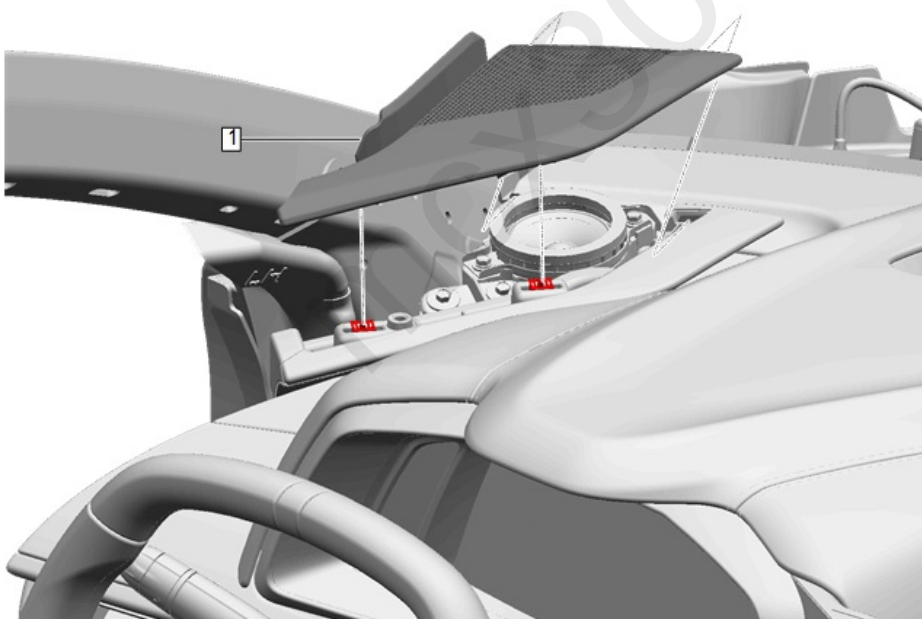
6. Remove the left instrument panel trim pad radio speaker opening cover (1). Instrument Panel Trim Pad Radio Speaker Opening Cover Replacement

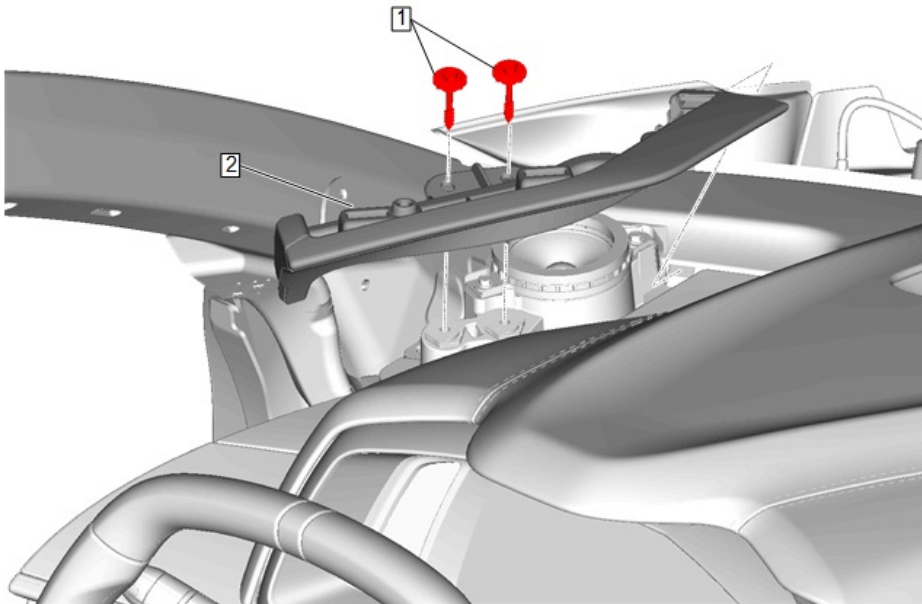
8. Remove the left radio front speaker grille molding (2).Radio Front Speaker Grille Molding Replacement

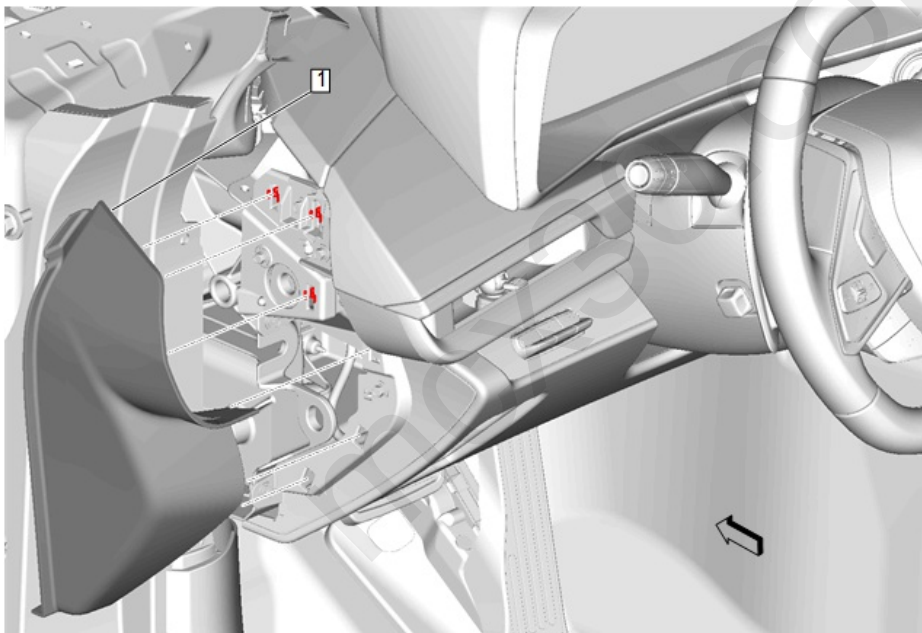
10. Remove the left instrument panel outer trim cover (1).Instrument Panel Outer Trim Cover Replacement

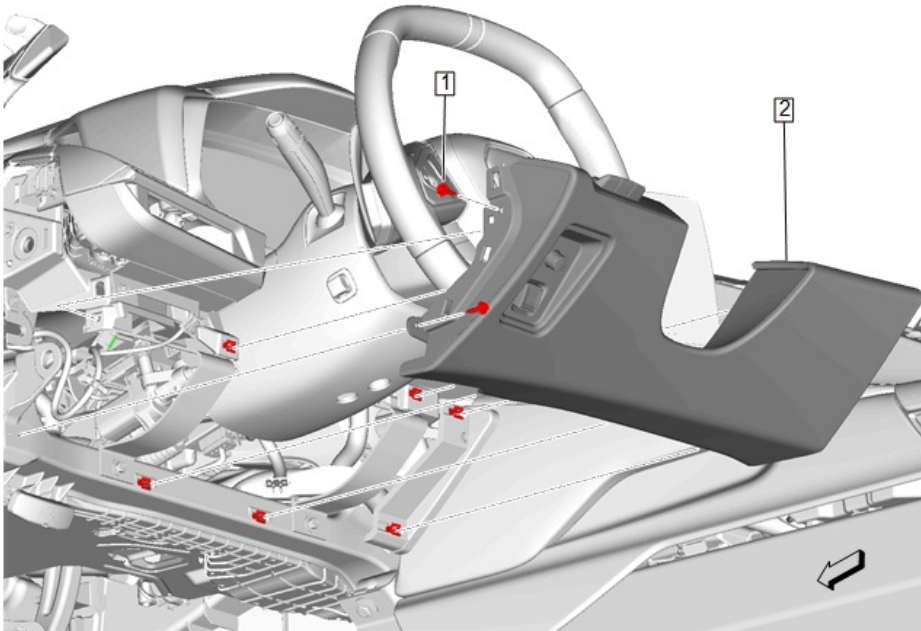
12. Instrument Panel Knee Bolster (2) >> Remove - Instrument Panel Knee Bolster Replacement

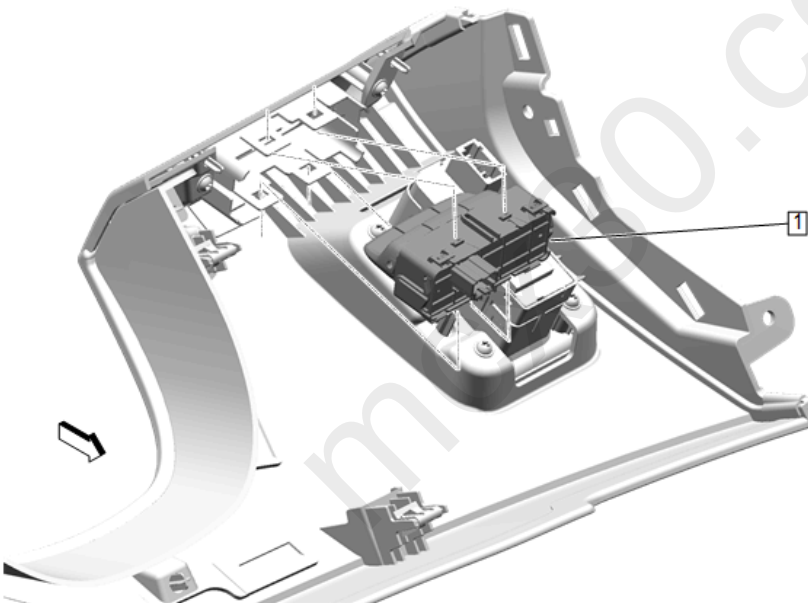
14. Release the tabs of the head-up display switch (1) from the instrument panel switch trim plate.

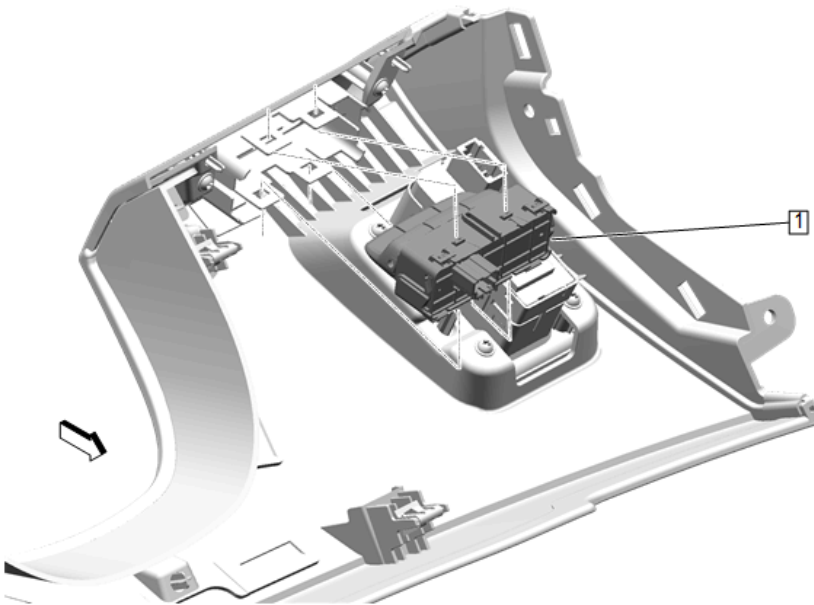
1. [Click here for full size](#)
2. Install the head-up display switch (1) to the instrument panel switch trim plate.

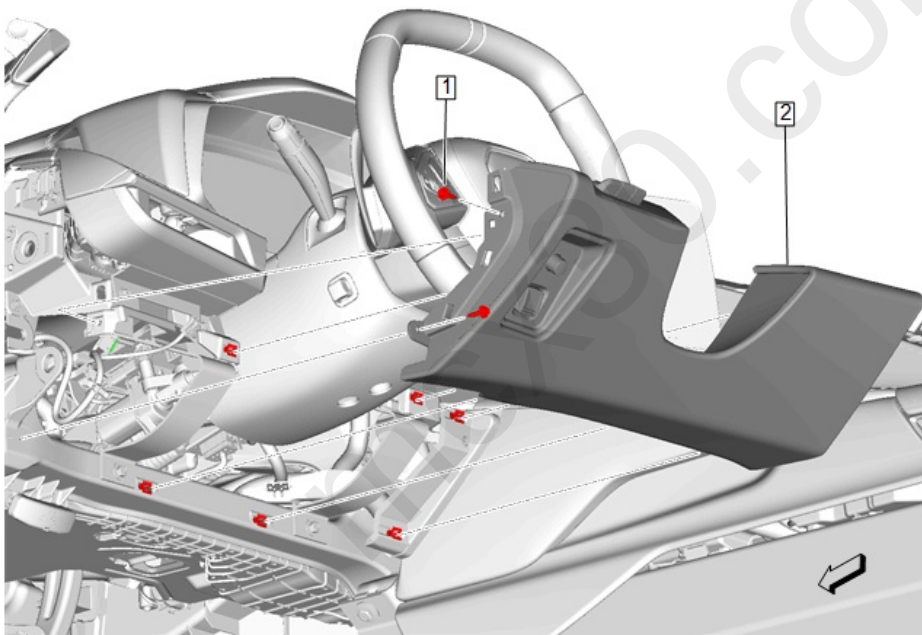
3. [Click here for full size](#)
4. Instrument Panel Knee Bolster (2) >> Install - Instrument Panel Knee Bolster Replacement

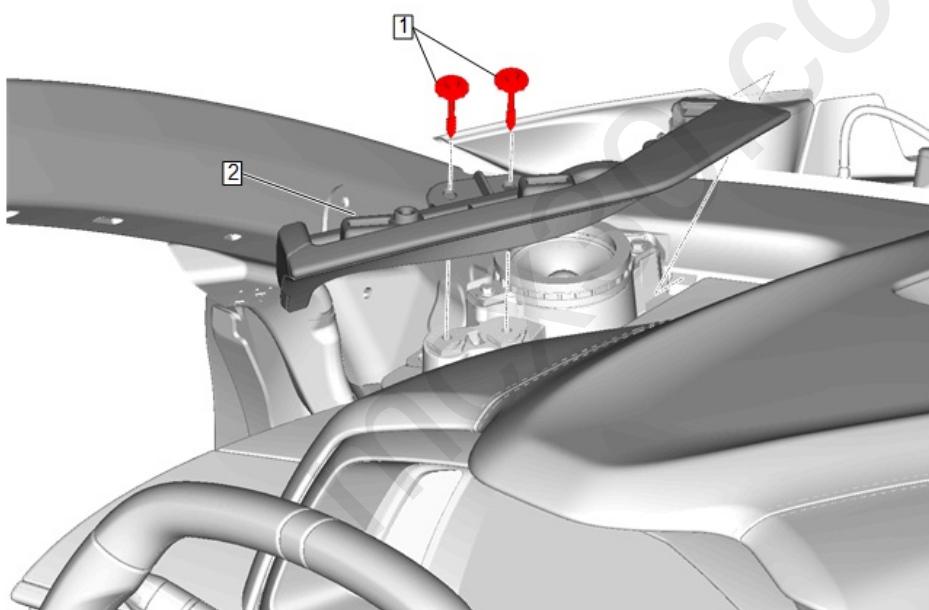
8. Install the left radio front speaker grille molding (2).Radio Front Speaker Grille Molding Replacement

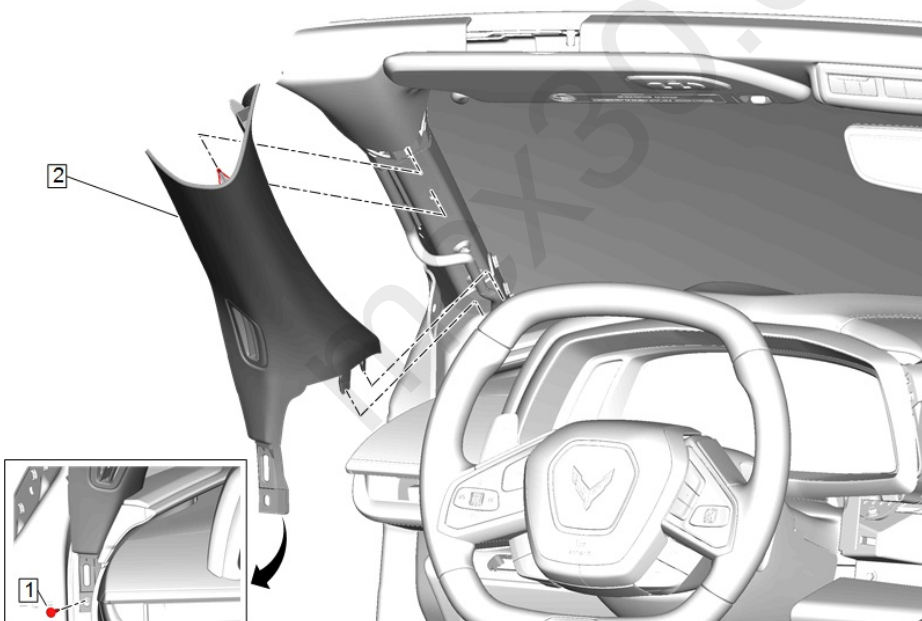
12. Install the left windshield garnish molding (2).Windshield Garnish Molding Replacement

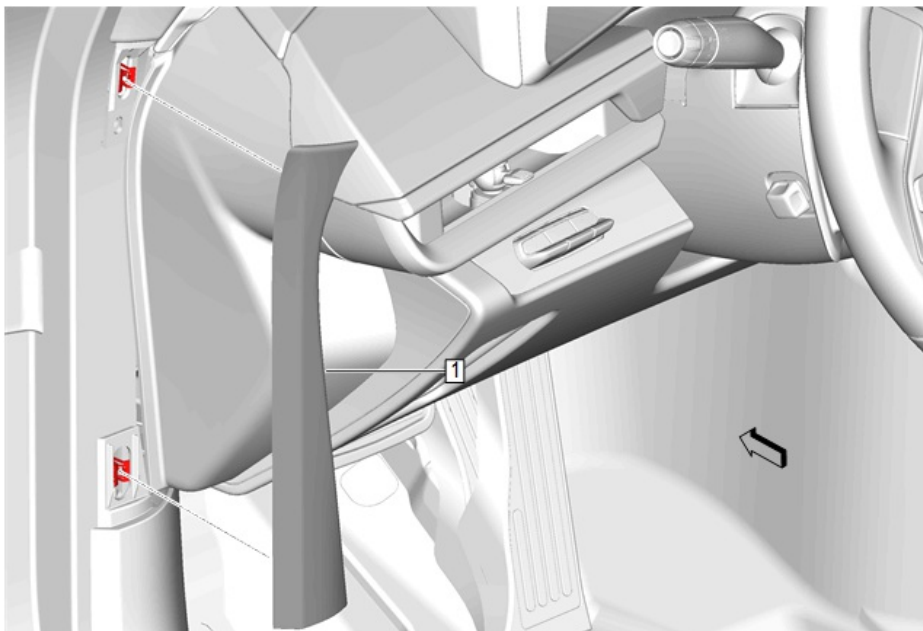
14. Install the left body hinge pillar garnish molding (1).Body Hinge Pillar Garnish Molding Replacement
